Intel[®] 80303 and 80302 I/O Processors

Specification Update

May 6, 2003

Order Number: [273355-010](#)

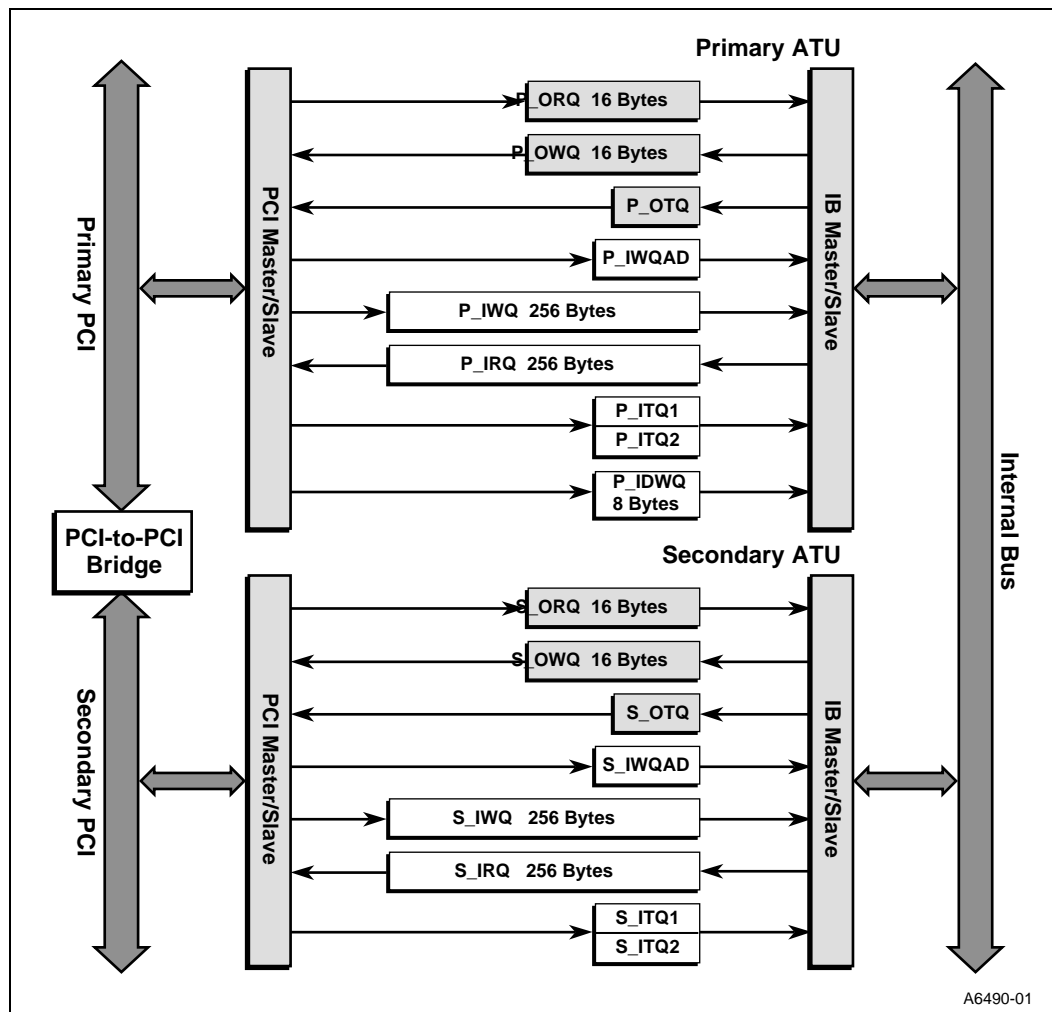
5. **Figure 15-2 on pg 15-3 did not print correctly**

Problem: Figure 15-2 on pg 15-3 did not print correctly.

Workaround: Replace Figure 15-2 with the following:

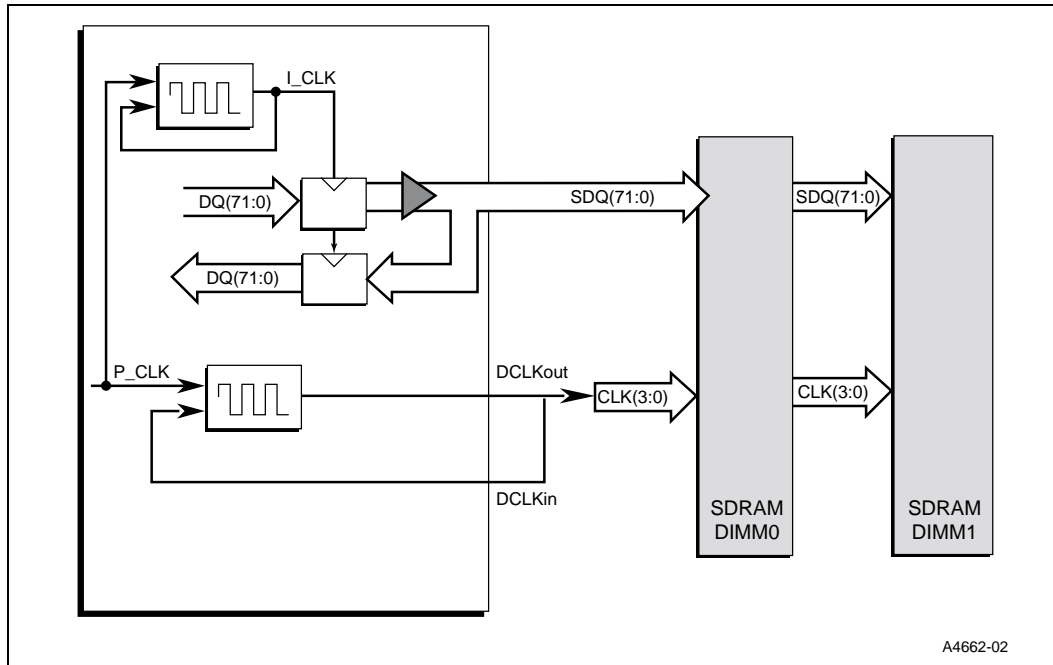
Problem: Figure 25-2 on pg 25-2 did not print correctly.

Workaround: Replace Figure 25-2 with the following:

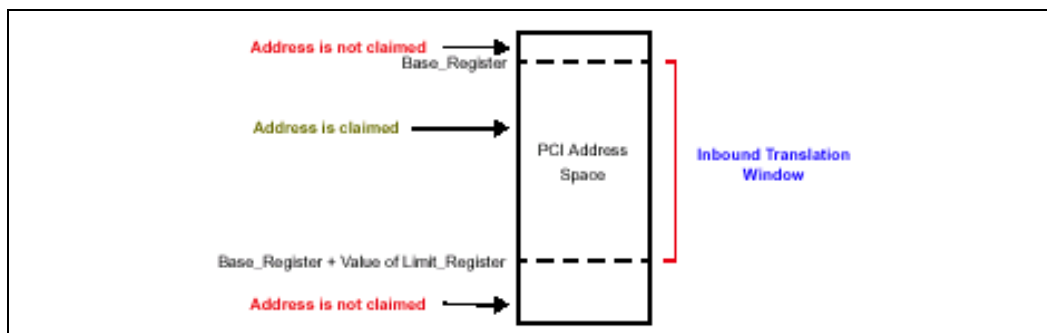
18. Figure 15-3 on page 15-7 has missing text

Problem: The figure shows 'se_Register + Value of Limit_Register'. It should be 'Base_Register + Value of Limit_Register'.

Workaround: Replace Figure 15-3 with the following:
