## **Recommended Server Inspection Procedure following Customer Application or Virtualization Engine Server Outage**

### Virtualization Engine for Tape TS7520 and TS7530

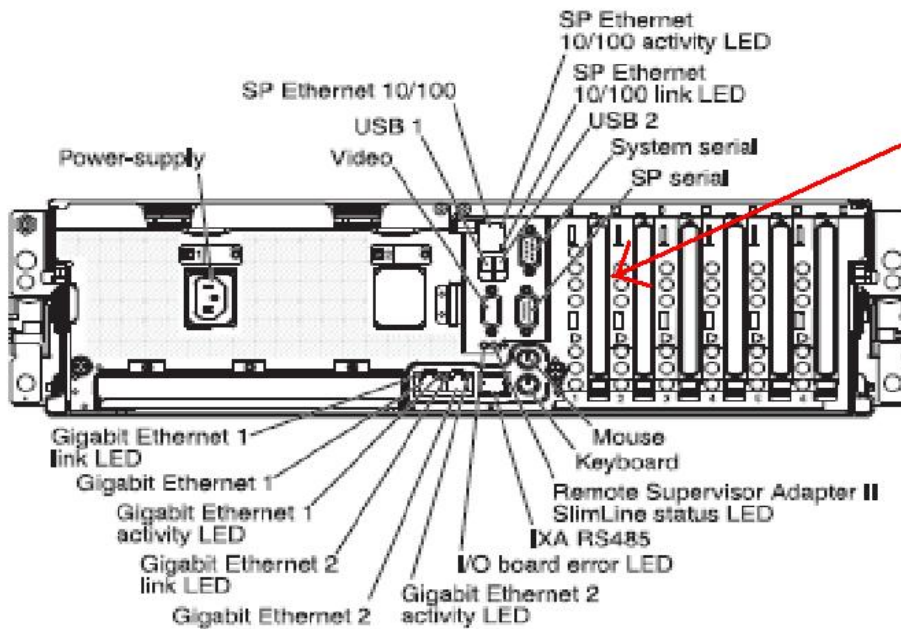
- Fibre channel adapter card in slot 1 LEDs – The fibre channel adapter card LEDs of interest will be in slot 1, the top port (of two) for the 3954 CV6; and in slot 1, the top port (of four) for the 3954 CV7. Figure 1 shows the slot that the dual port fibre channel card in question would occupy for a 3954 CV6.

**Figure 1: Rear View of the 3954 CV6 - The arrow points to slot 1**

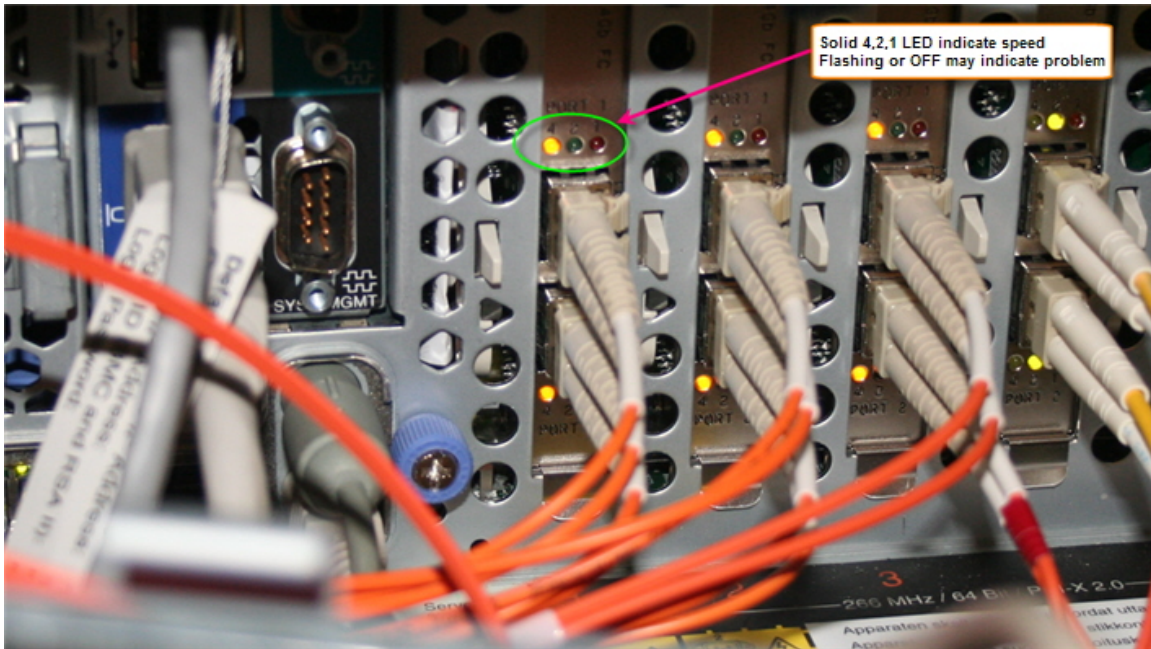
Figure 2 shows an image of the 3954 CV6 with the LEDs above the cable to examine.

Figure 2: Picture showing LEDs to examine in a 3954 CV6

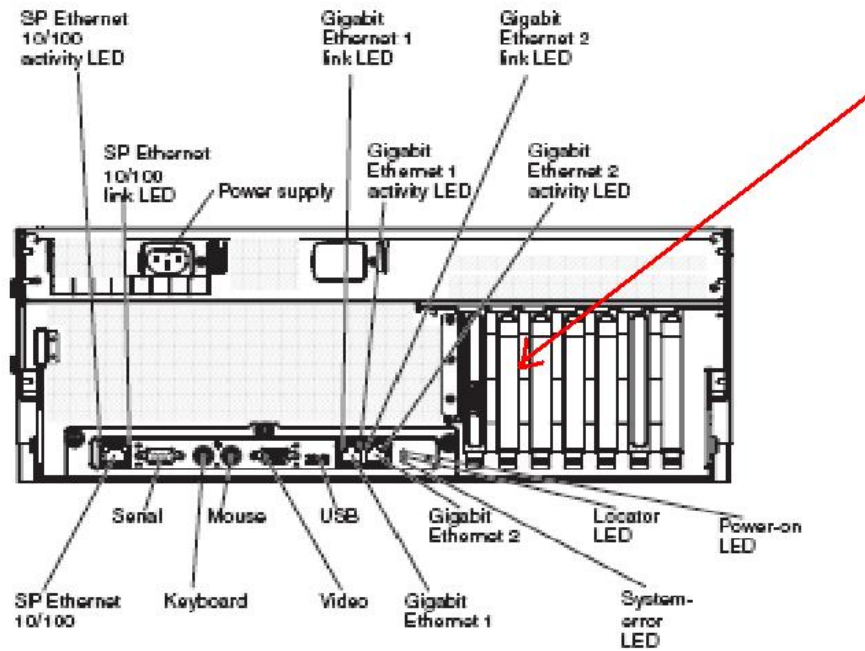
For a 3954 CV7, the fibre channel port that should be checked is contained in the first Quad Port fibre channel adapter. This card can be found in slot 1 as shown in Figure 3. Figure 4 shows an example Quad Port fibre channel card with the port to check and LEDs to check denoted by arrows.

Figure 3: Rear View of the 3954 CV7 - The arrow points to slot 1

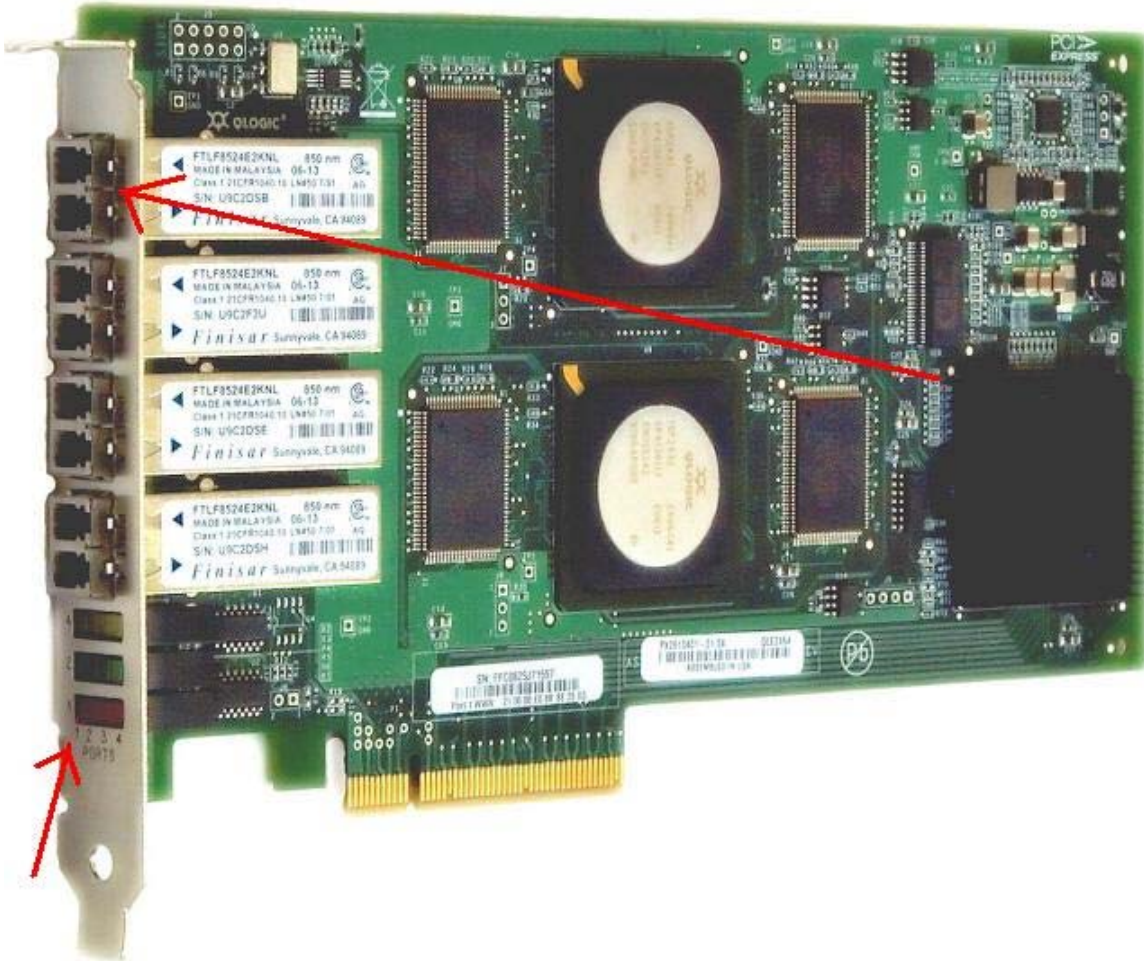
**Figure 4:** A quad port fibre channel card with the top arrow pointing to port number 1 and the bottom arrow pointing to the column of the LEDs to examine

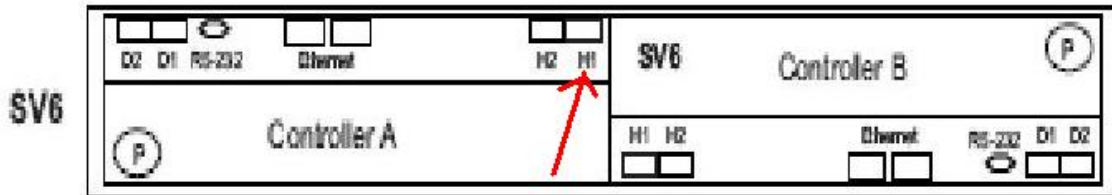
- DS4200 Controller A LEDs – In a system without fibre channel switches, the fibre channel boot port (slot 1, port 1) will be directly connected to H1 (or Ch1) of Controller A of the SV6 it is associated with as its primary controller (see figure below). For a Ltd. Edition TS7520, there is a maximum of one 3955 SV6, so there is only one possible Controller A connection to check. For a standalone Enterprise Edition TS7520/TS7530, the port that should be checked is contained in the Controller A of the lower 3955 SV6. For a High Availability TS7520/TS7530 system, the H1 (or Ch1) port of Controller A corresponding to the server should be checked (for the lower server, check the lower 3955 SV6 in the same frame, and for the upper server check the upper 3955 SV6 in the same frame). Figure 5 gives a diagram of the back of a 3955 SV6 cache controller and Figure 6 gives a picture of an actual 3955 SV6 and illustrates the H1/Ch1 port.

Figure 5: Rear View of the 3955 SV6 - The arrow points to H1 of Controller A

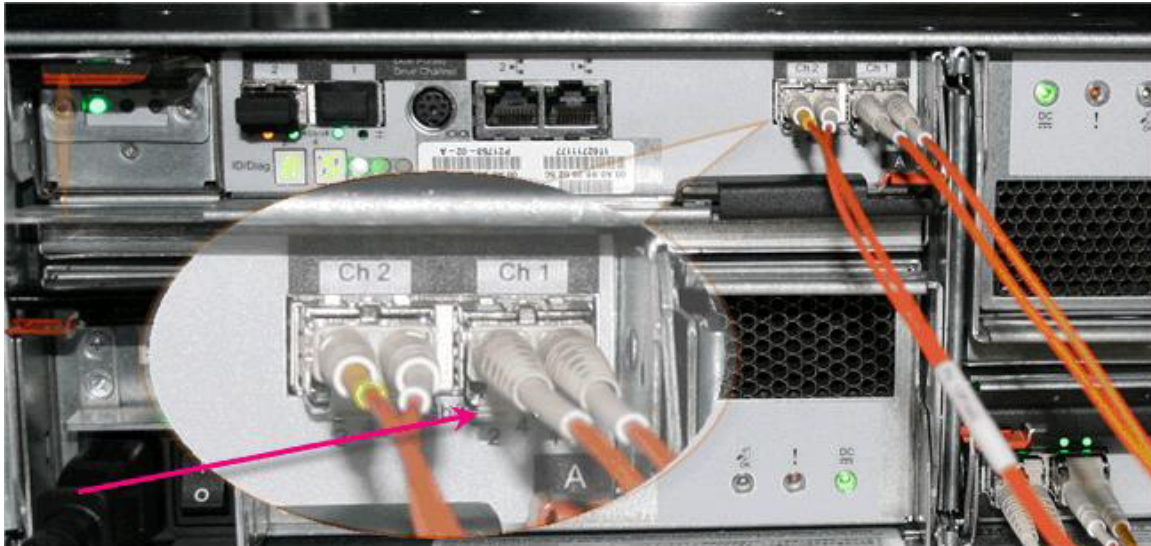
Figure 6: Picture of the back of a 3955 SV6 cache controller with the H1/Ch1 port denoted

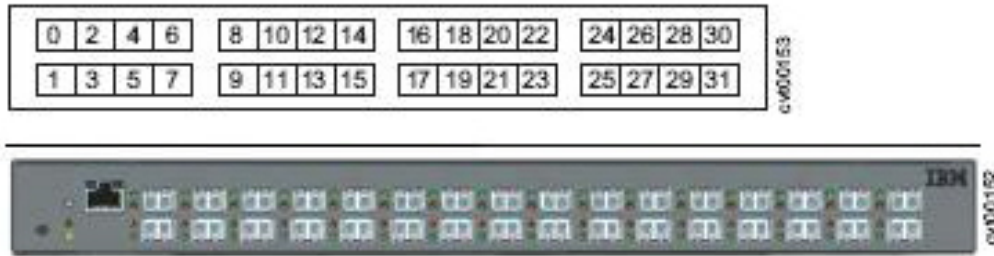
**Figure 7: 1907 Fibre channel Switch**

- (If applicable) check the internal fibre channel switch LEDs – For systems with the internal fibre channel switches, there are two types of switches that can be found and there will always be two switches together (both of the same type). Figure 7 gives a diagram illustrating the port numbers as well as a picture of the back of the switch for a 1907 fibre channel switch. Figure 8 gives a diagram showing the port numbering as well as a diagram of the actual 1910 fibre channel switch.
