*This document is an English translation of the Final Report on the accident on 10 April 2010, on Smolensk "Severny" airdrome, to the Tupolev Tu-154M tail number 101 of the Republic of Poland.*

**INTERSTATE AVIATION COMMITTEE  
AIR ACCIDENT INVESTIGATION COMMISSION**

**FINAL REPORT**

Type of occurrence	Accident
Type of aircraft	Airplane, Tu-154M
Registration	Tail number 101, Republic of Poland
Owner	Republic of Poland
Operator	Ministry of Defense, Republic of Poland
Site of occurrence	Between the middle marker and runway 26 threshold, Smolensk "Severny" Airdrome, N 54°49.450' and E 32°03.041'
Date and time	10.04.2010, 06:41 UTC, 10:41 local time, daytime

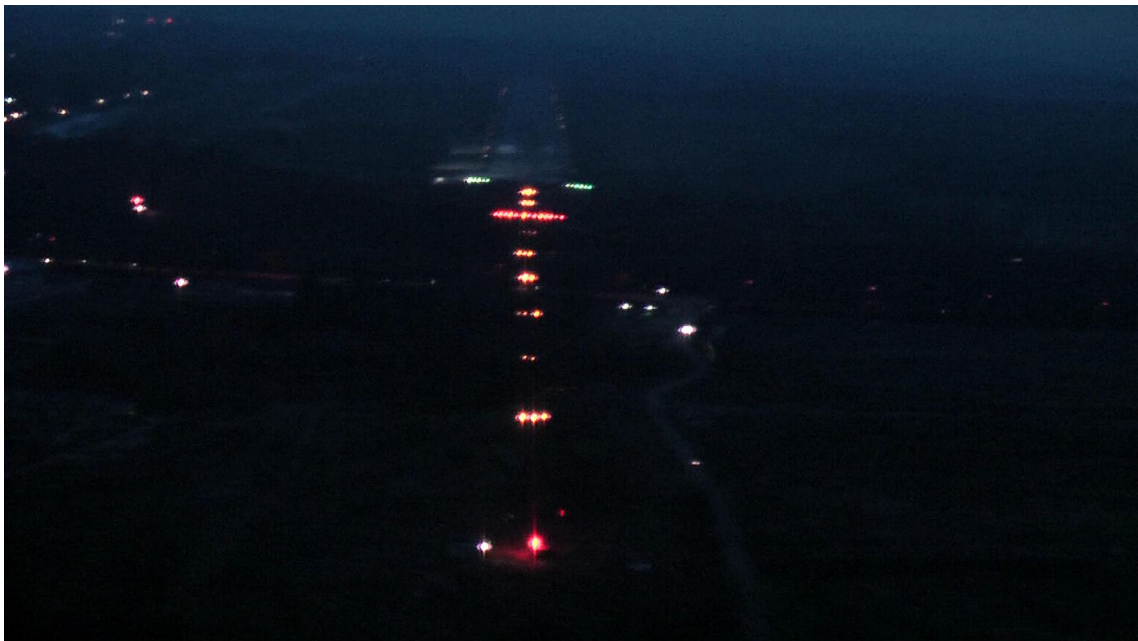
The fly-around check on 15.04.2010 (Figure 12, Figure 13) revealed that in comparison with the shown scheme, there is one more light line at a distance of 100 m from RWY 26 threshold, the actual number of threshold lights (green) is 6 instead of the 8 lights specified in the RTP. The lighting equipment check also revealed that depending on the aircraft position and

The lighting system was recovered on 14.04.2010 which is confirmed with the data of a fly-around on 15.04.2010.

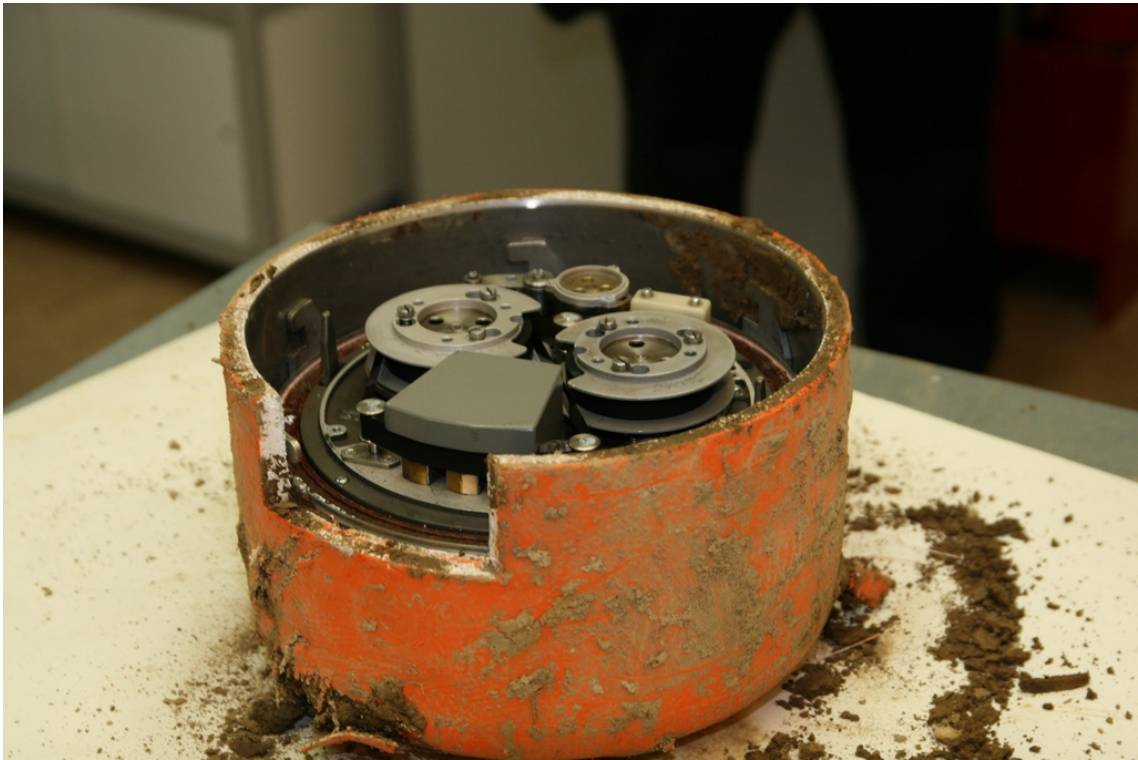
**Figure 18**

The opening revealed that the tape was in good condition, loaded in the recording track, springs armed (Figure 18).

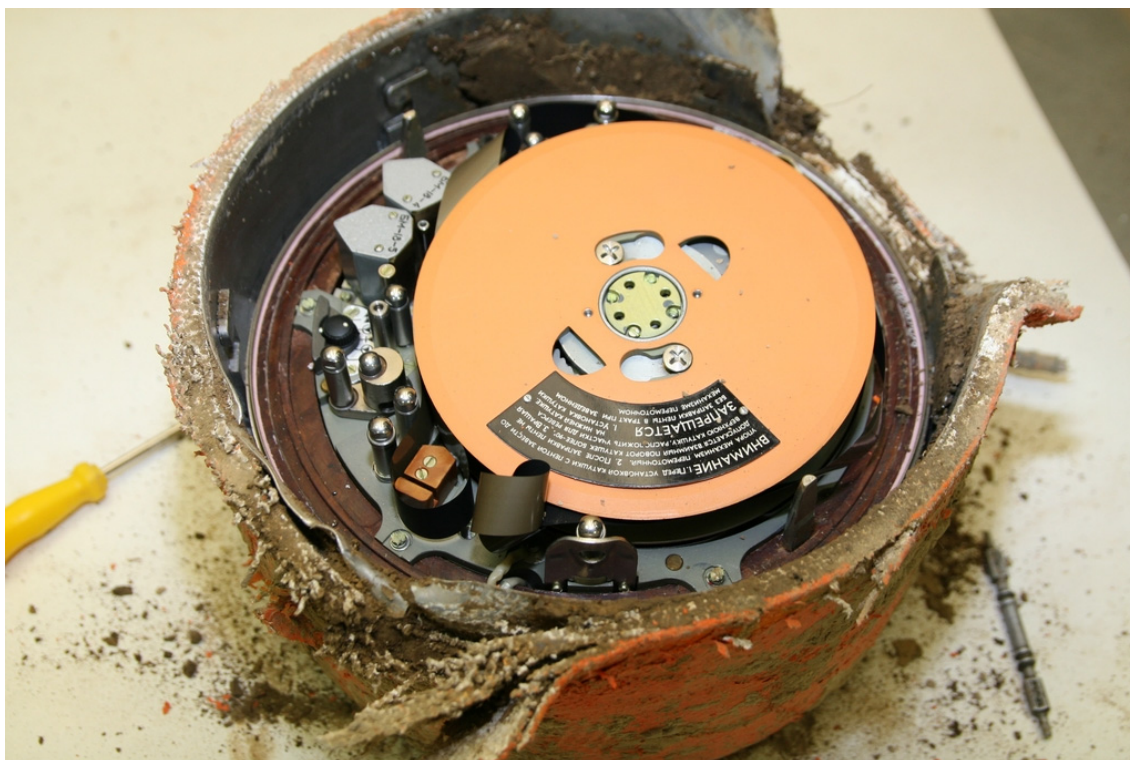
**Figure 19**

The casing of the protected MLP-14-5 № 90969 was significantly damaged mechanically, the mounting frame and casing lid were missing, the linkages were torn. The catch gear was filled with earth (Figure 17). The visual examination of the FDR after the opening revealed that the tape was on spools, but out of the recording track. The tape was in good condition, the mode switch in Automatic position (Figure 19).

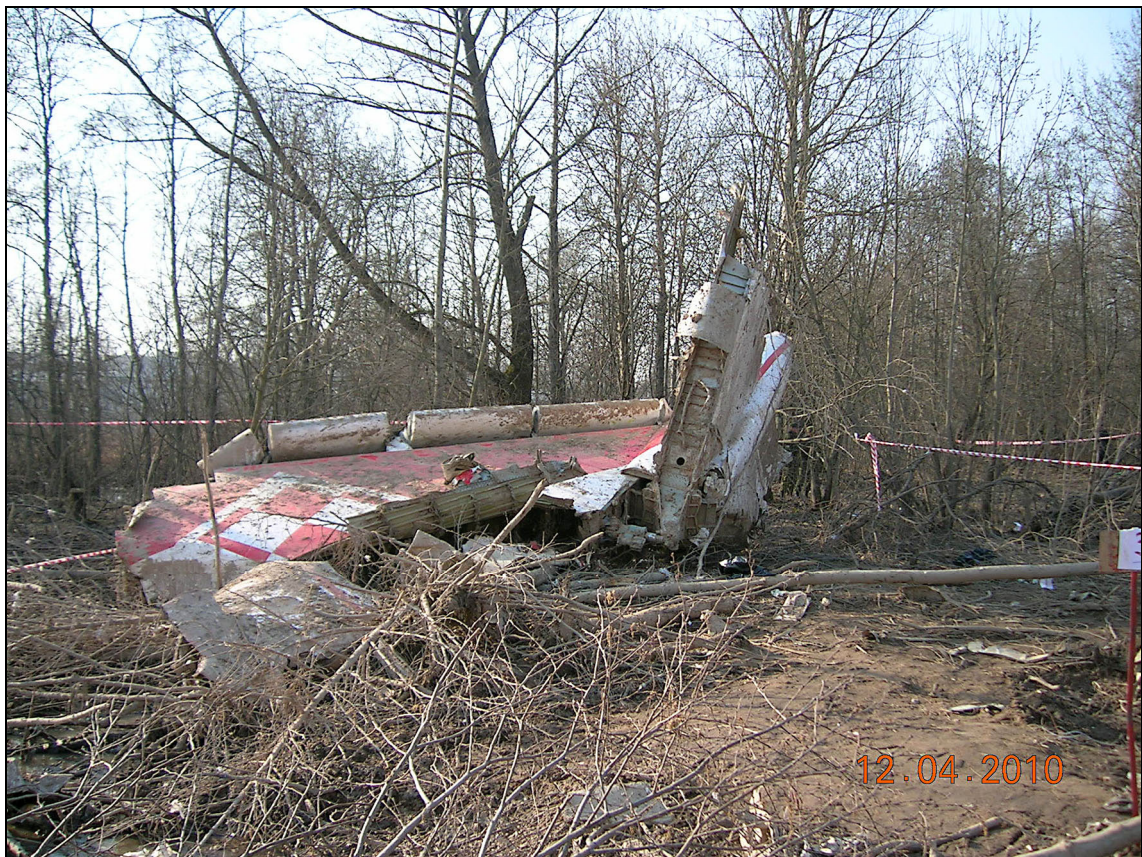
**Figure 31**

On impact the right stabilizer panel with elevator, the fin with rudder (Figure 31), tail cone and stabilizer roots were ripped off and found 590-620 m from the point of the first impact.

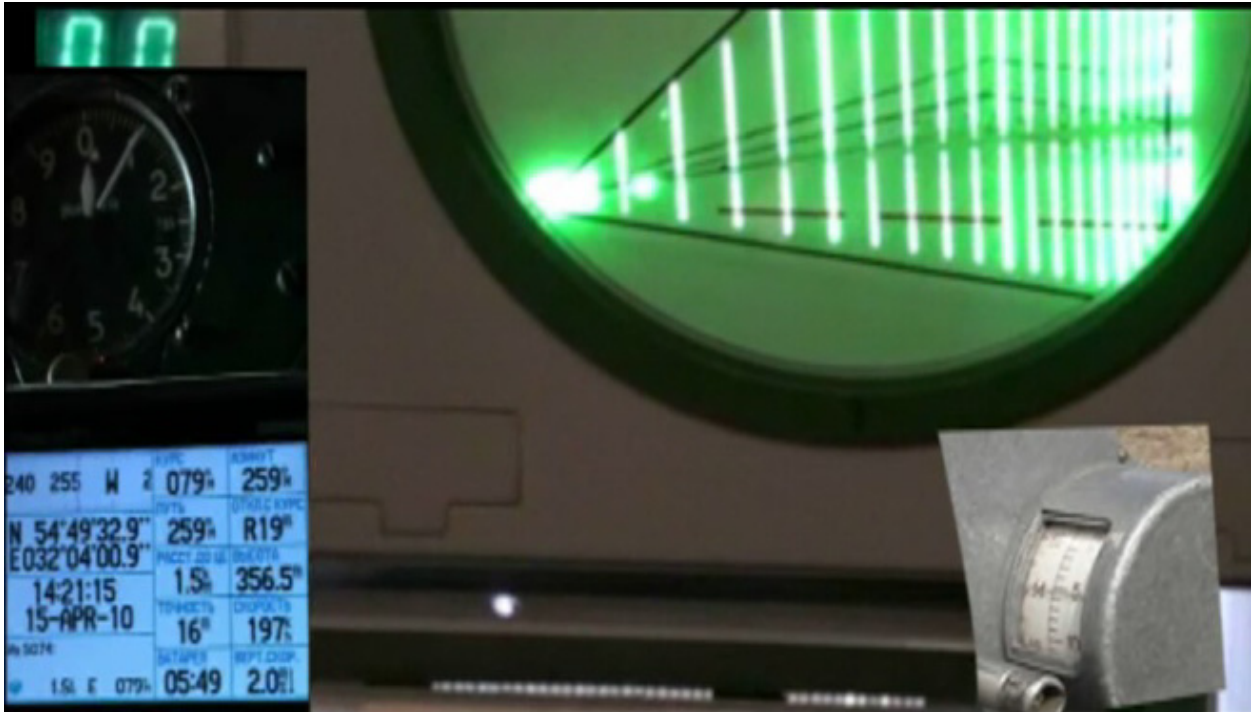
**Figure 38**

The minimum required landing radar range of 1.5 km in the passive mode (used in the accident flight) (Figure 38) and of 1 km in the active and moving aim selection modes is provided. In the passive mode the blip disappears about 1.2 km from RWY 26 threshold (Figure 39).
