National Transportation Safety Board
Washington, D.C. 20594

Marine Accident Brief

Accident No.: DCA-01-MM-022
Accident Type: Collision
Time and Date: 1343 Hawaiian standard time (24-hour clock), February 9, 2001
Location: Pacific Ocean 9 miles south of Oahu, Hawaii

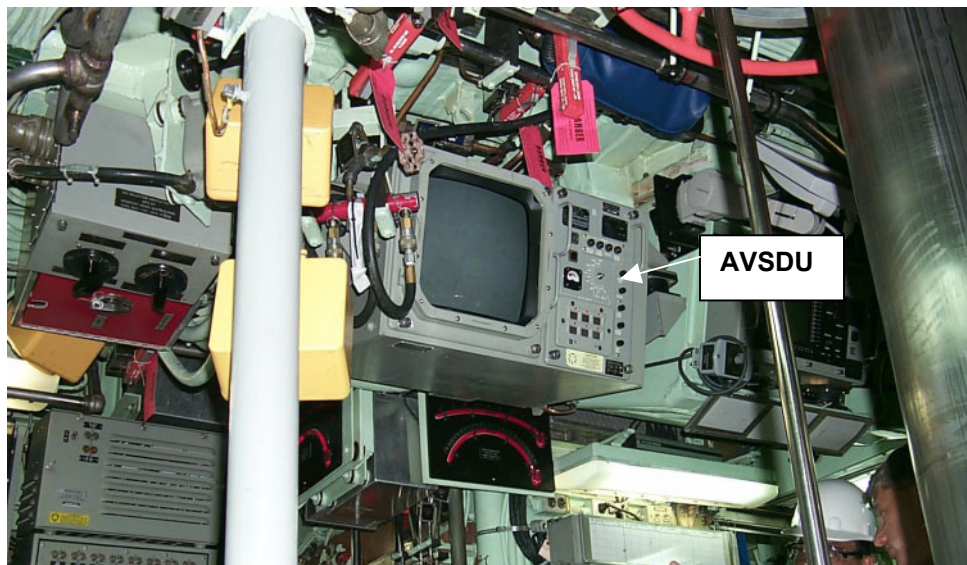
The OOD-2 said that he learned the Analog-Video Signal Display Unit (figure 4), or AVSDU, was not working when he reported to the control room for his watch. The AVSDU duplicated the contact data displayed on the monitors in the sonar room and permitted the conning officer to observe the vessels being tracked without leaving the control room. The navigator had noted that the AVSDU was inoperable and had reported its status to the CO before the *Greeneville* had sailed that morning; however, the malfunction of the sonar repeater did not meet the criteria for a significant equipment casualty that would have precluded the submarine from sailing.⁹

Figure 4. The Analog-Video Signal Display Unit, or AVSDU, was a sonar repeater installed near the *Greeneville*'s periscope platform. On the day of the accident, the AVSDU was not working. (U.S. Navy photo)

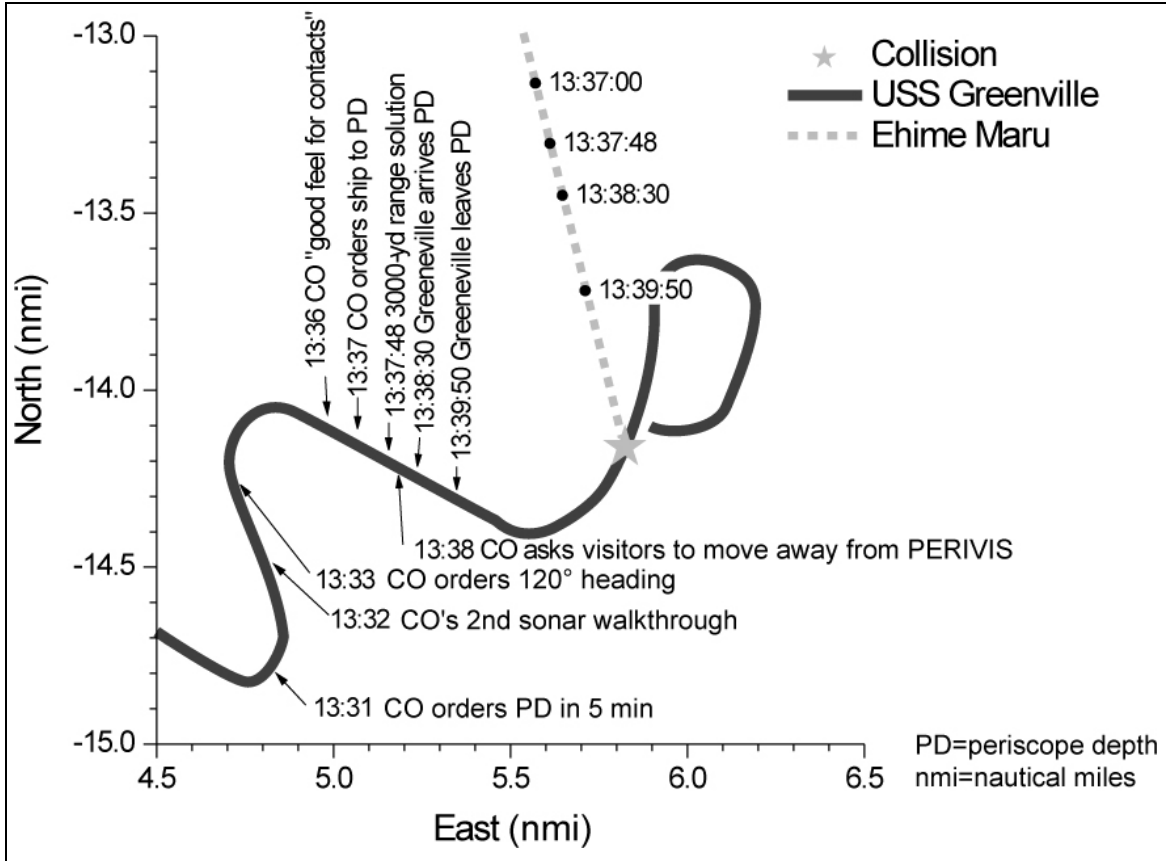
Figure 8. Plot showing the tracks of the *Greeneville* and the *Ehime Maru*. The *Greeneville* track is annotated with key events on the submarine beginning at 1331. The *Ehime Maru* track is annotated with the position of the fishing vessel at some corresponding times.

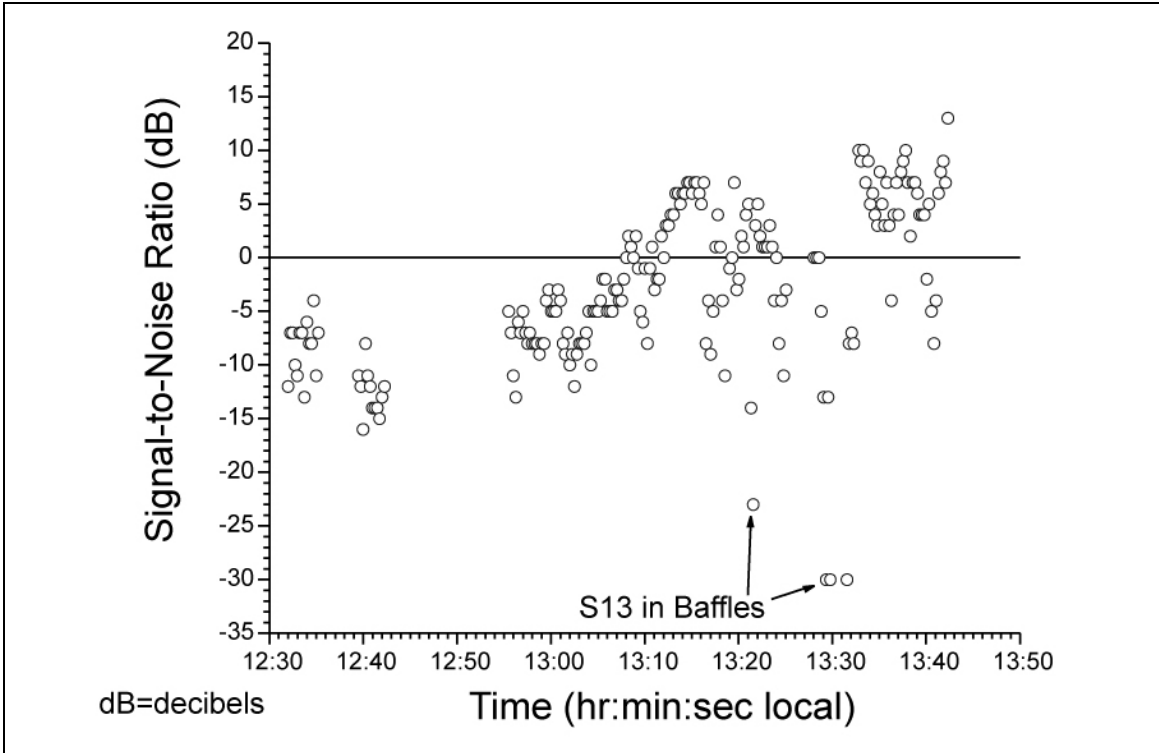
Signal-to-Noise Ratio Increase. Meanwhile, in the sonar room, the broadband stack operator noted that while the submarine was in the middle of the high-speed maneuvers, the SNR for S-13 was "relatively high." Figure 9 shows the SNR data for S-13 (the *Ehime Maru*) that were captured by the *Greeneville*'s sonar system computers on the day of the collision, as plotted by Safety Board engineers.

Figure 9. An increase in the SNR for a contact can be an indication that the target is getting closer. In this plot, each circle represents an S-13 signal captured by the *Greeneville*’s sonar system. As indicated in the plot, the SNR for the *Ehime Maru* increased over time except for when the fishing vessel was briefly in the baffle area. Note: The plot developed by Safety Board engineers is not representative of the display on the sonar monitors.

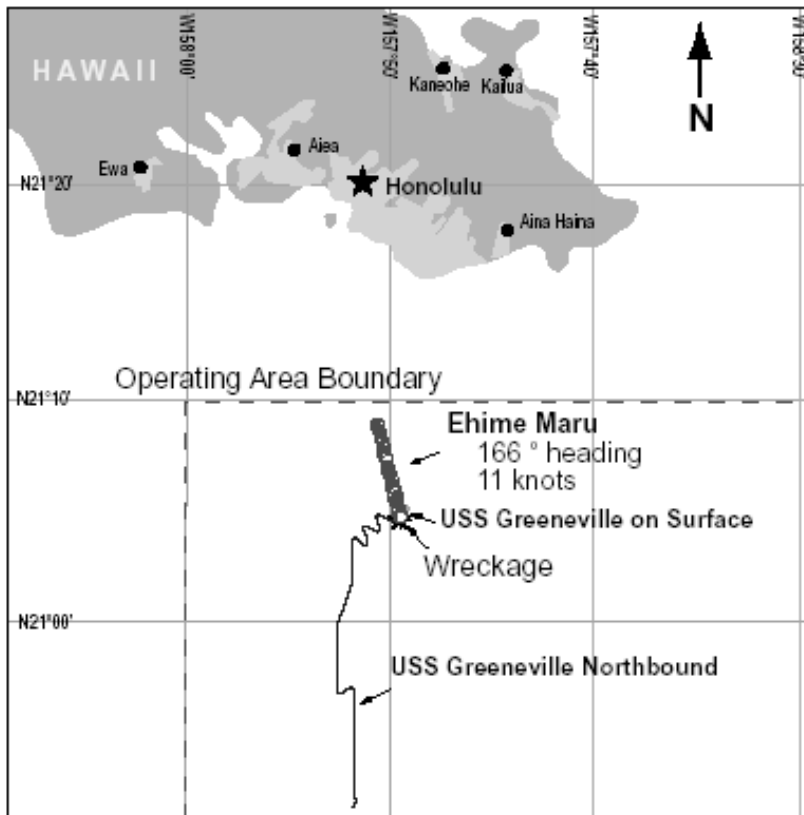
The sounding of the alarm was the signal to begin the emergency blow maneuver. At this time, witnesses reported, the guest at the high-pressure air controls operated the levers under close supervision of Navy personnel, and the submarine started to rise at a sharp angle. The guests recalled that, shortly afterward, there was a loud noise, and the submarine shuddered. The guests quoted the CO as saying, "What the hell was that?" After the submarine slowed and the periscope could be raised, the CO looked into the periscope and announced that the submarine had struck another ship. (See figure 10.)

Figure 10. The collision between the *Greeneville* and the *Ehime Maru* occurred about 9 miles south of Oahu, Hawaii, at position 21°05.5' N, 157°49.1' W. Dotted line indicates the edge of the submarine's assigned submerged operating area.

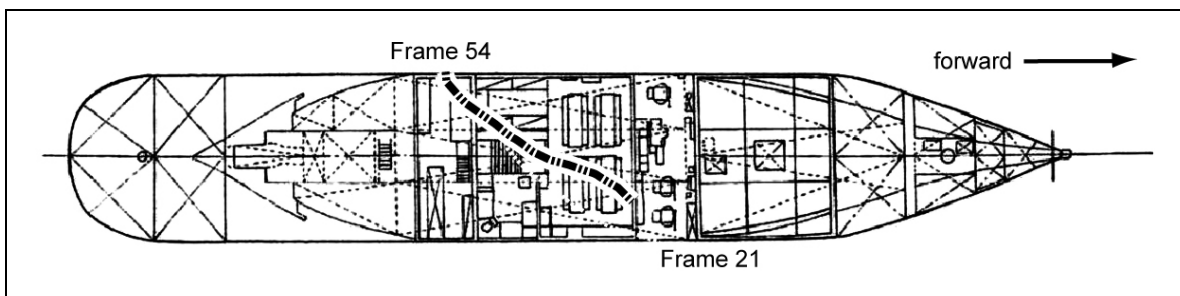
Ehime Maru. An underwater survey of the vessel's bottom revealed a cut in the hull that began on the starboard side inboard of the bottom near the deckhouse front. (See figure 12.) The cut, between 2 to 3 feet wide, ended on the port side shell in the vessel's engine room, where it extended vertically from the vessel's bottom to 11.5 feet (3.5 meters) above it (the design waterline mark).

Figure 12. According to diver reports, the line of cut in the *Ehime Maru* extended from frame 21 to frame 54 through both the bottom and the innerbottom of the doublebottom vessel. The cut, therefore, resulted in breaches in the student lounge, the access stairwell to the student lounge, the engine control room, and the engine room.

The cut proceeded from forward to aft of the vessel and breached the vessel's innerbottom³² in the student mess, the stairwell, and the engine control room. The cut then proceeded through the bulkhead between the control room and the engine room, leaving a vertical cutout in the bulkhead that was the approximate shape and size of the *Greenville's* upper rudder. The vertical outline of the rudder was also visible on the port side shell of the *Ehime Maru's* engine room, through which the submarine's upper rudder had exited the fishing vessel's hull. The line of cut had breached several doublebottom (DB) tanks; going forward to aft these tanks included No. 2 fuel oil DB tank (starboard), No. 3 fuel oil DB tanks (starboard and center), and No. 4 fuel oil DB tank (port) in the engine room. Both the outer and innerbottoms had been cut through. Damage to the control room and to the interior of the student mess and vertical stairtower on the port side of the computer room was visible during the survey. The open vertical stairtower allowed water to immediately flood upward to the upper deck levels of the vessel.

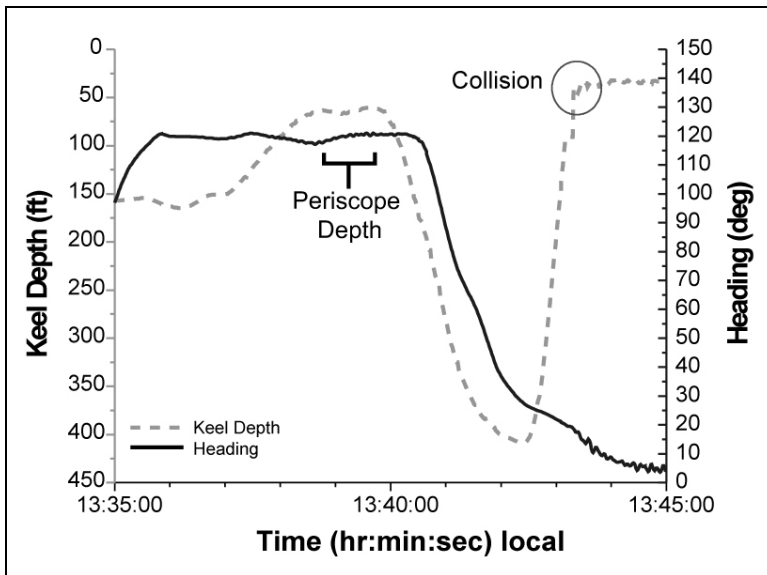
³⁴ The keel depth data held 90.84 feet for 7 seconds immediately before the collision. The Safety Board worked with the Navy to determine the cause of this false reading, but nothing conclusive was determined.

Figure 13. Keel depth and heading of the *Greenville* between the ascent to periscope depth and the collision.

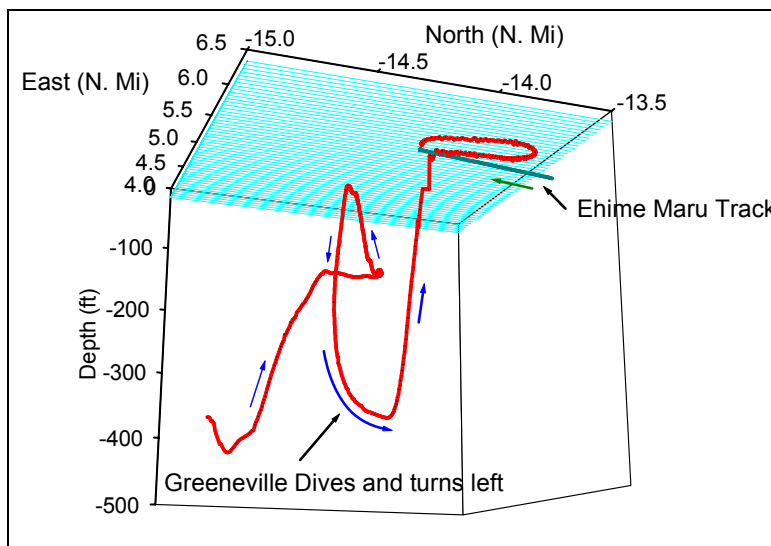
Figure 14. Three-dimensional representation of the *Greenville* and *Ehime Maru* tracks, showing the submarine's ascent to periscope depth, the diving left turn, the collision with the *Ehime Maru*, and the return to the wreckage site. Note that depth is not to scale with east and north position.

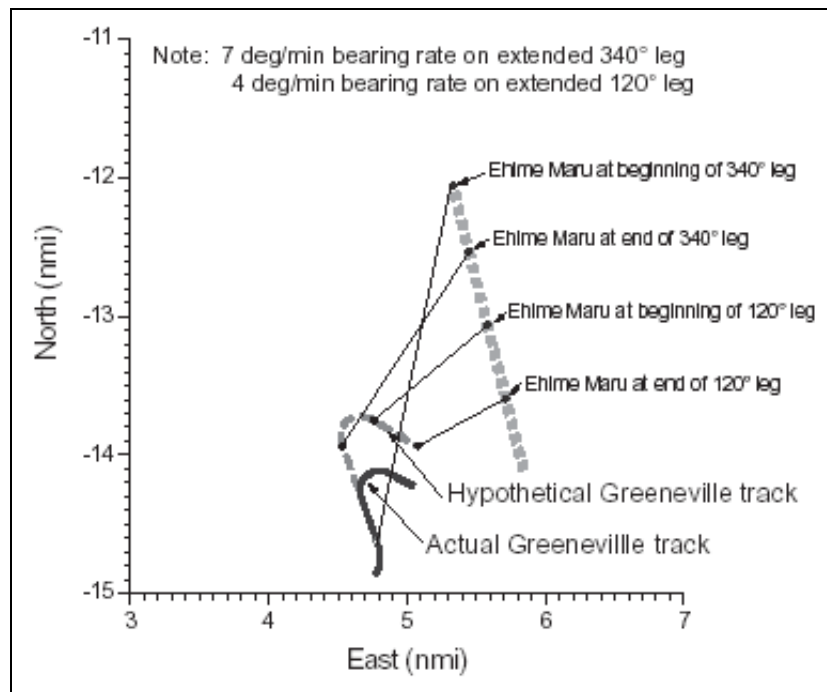
The CO's order to change course meant that he allowed the *Greeneville* to remain on the 340° leg less than 2 minutes (1331:36 to 1333:03), rather than the 3 minutes stipulated for TMA in Navy operating procedures. More important, the submarine was on a steady speed and course (to 340°) less than 25 seconds before the course change to 120° began. The baffle clear turn was complete about 1335; however, the CO then ordered the submarine to proceed to periscope depth at 1336:45. Consequently, he did not hold course long enough on either the 340° leg or the 120° leg to permit good TMA, a serious error.

The Safety Board constructed a hypothetical *Greeneville* track, extending the 340° and the 120° legs to 3 minutes each to allow for proper TMA. Figure 15 superimposes the hypothetical track over the actual *Greeneville* track. As shown in the chart, the too-rapid course changes on the actual track resulted in no bearing rate change, which is necessary for accurate identification of the contact's course.

Figure 15. Comparison of *Ehime Maru* bearings with *Greeneville*'s actual track and with hypothetical track calculated for 3-minute legs.

The hypothetical track using 3-minute legs produced bearing rate changes that would have readily revealed the course of S-13 to both the sonar crew and the FTOW. The *Greeneville*'s bearing to the *Ehime Maru* on the hypothetical 3-minute legs would have been as follows:
