RS/6000 SP

Maintenance Information Volume 2, Maintenance Analysis Procedures

Second Edition (February 1999)

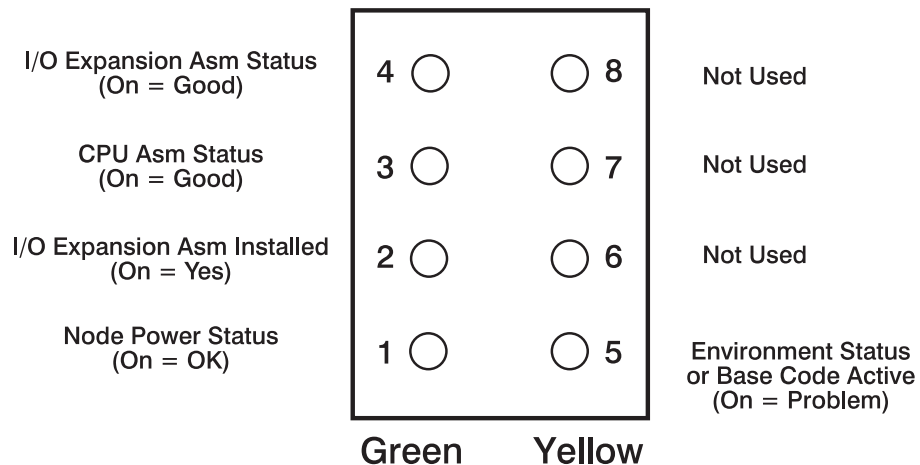
Figure 1-5. 332 MHz SMP Node Supervisor Card LEDs

Note: LEDs 6, 7, and 8 are unused.

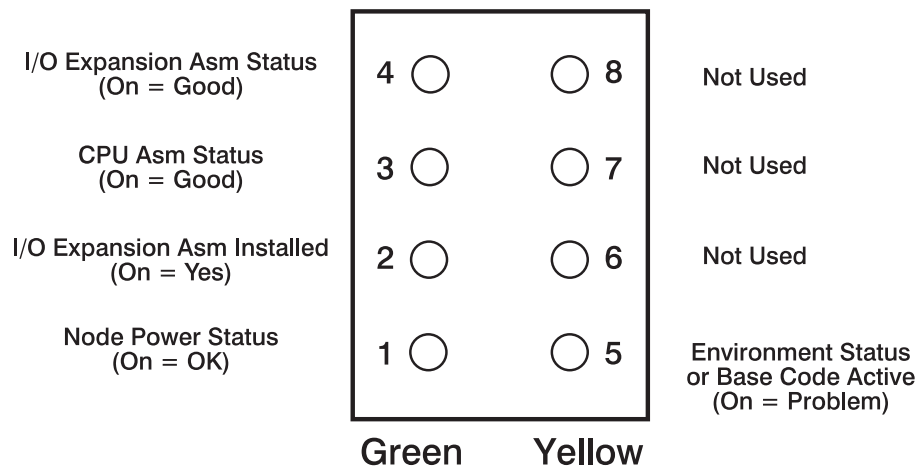
Figure 1-6. POWER3 SMP Node Supervisor Card LEDs

Table 1-5. POWER3 SMP Node LED Definitions		
LED #	Color	Signifies
8		Not used
7		Not used
6		Not used
5	Yellow	Environment status (On = Problem)
4	Green	I/O expansion power (On = Good)
3	Green	CPU assembly (On = Good)
2	Green	I/O expansion assembly installed (On = Yes)
1	Green	Node power status (On = OK)

Note: LEDs 6, 7, and 8 are unused.

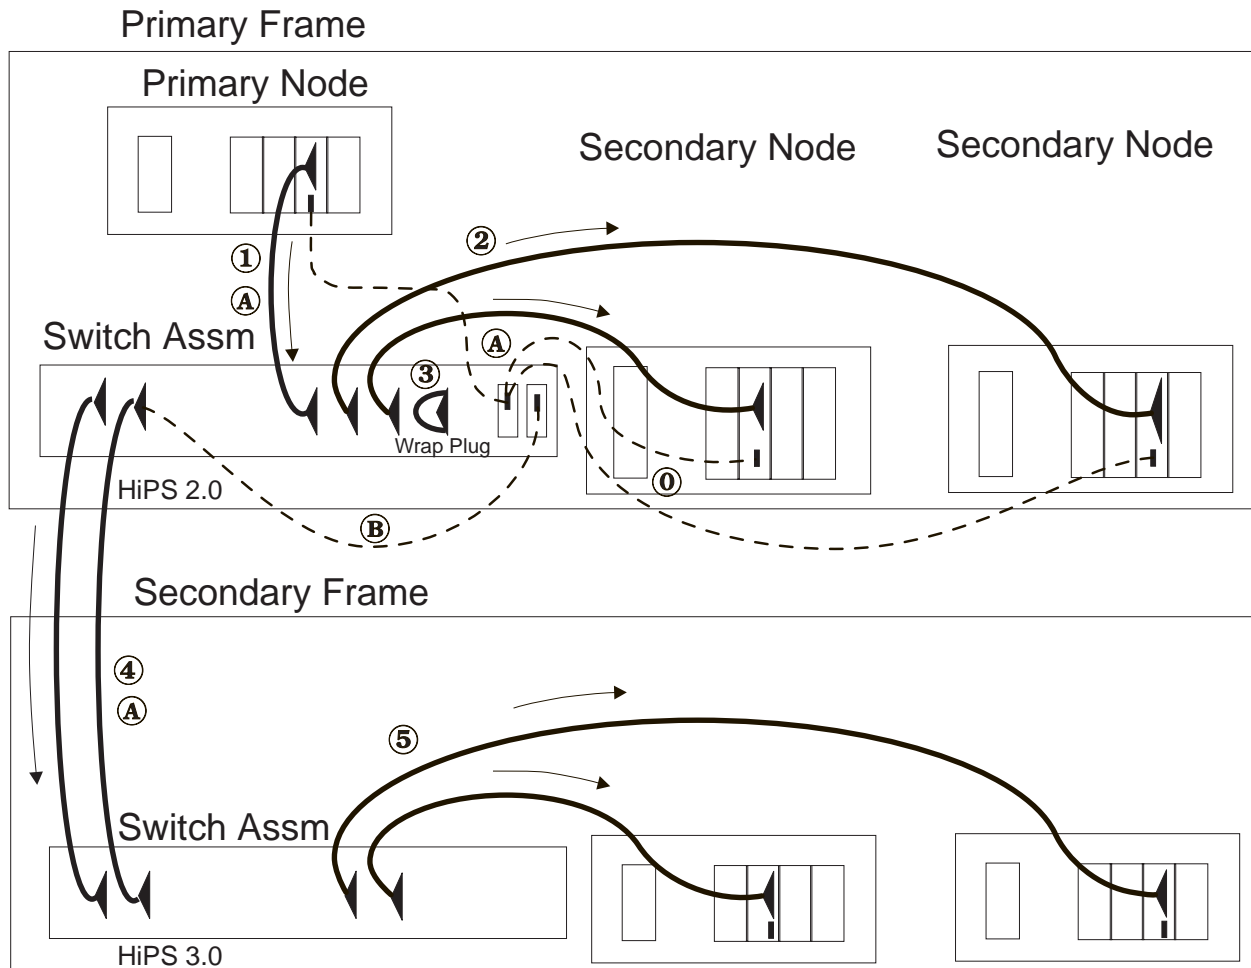
Figure 1-35. Switch Connectivity Diagram

Label A in diagram: Switch clocks may be distributed through discrete clock cables or within the switch data cables.

Label B in diagram: Clock interposer (P/N 93G1097) is used on HiPS 2.0 switch assemblies only. See Figure 1-36.
