NATIONAL TRANSPORTATION SAFETY BOARD
OFFICE OF AVIATION SAFETY
WASHINGTON, D.C.

SURVIVAL FACTORS GROUP FACTUAL REPORT OF INVESTIGATION

A. ACCIDENT : **DCA97MA058**

LOCATION Nimitz Hill, Guam, Mariana Islands
DATE August 6, 1997
TIME 0142 Local Time
AIRPLANE/OPERATOR : Boeing 747-3B5B (300), S/N 22487,
Flight 801, Operated by Korean Air

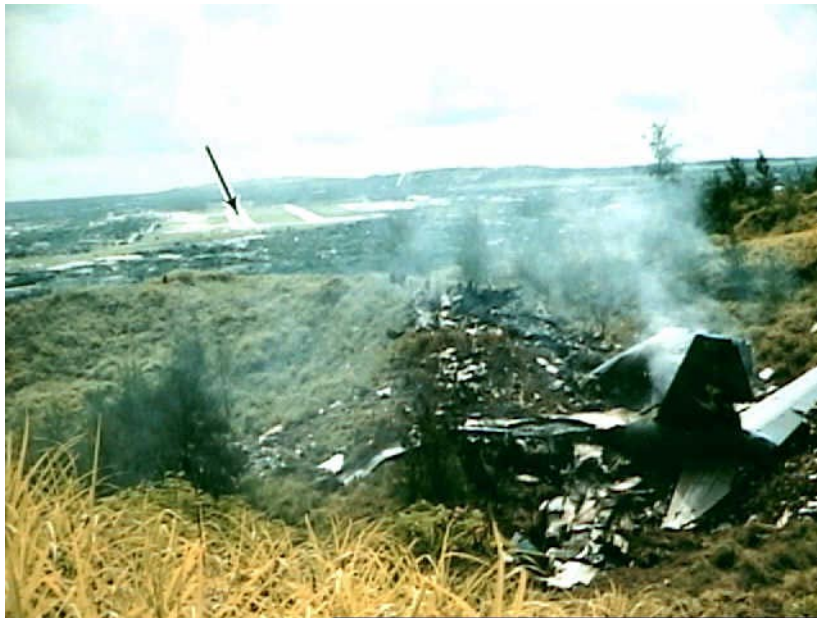
Survival Factors 6 - Photo 1. View of accident site looking North-East toward Guam International Airport (GIA) (Note: Arrow points to GIA runway 06)

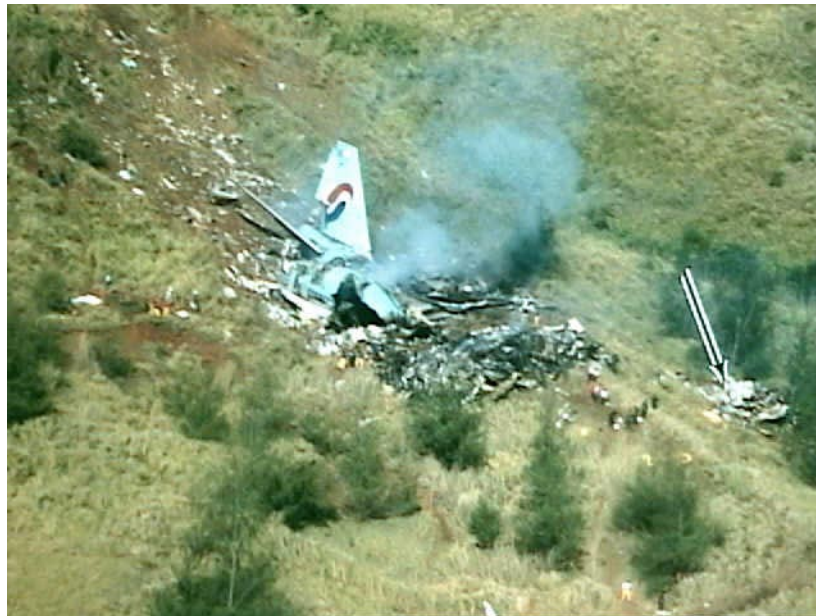
Survival Factors 6 - Photo 2. Aerial view of accident site (The arrow points to the nose of the airplane)

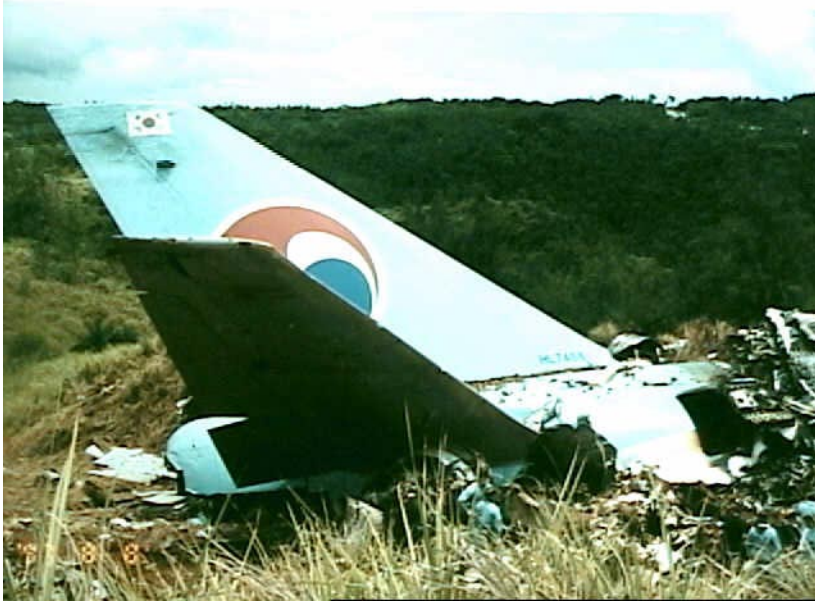
Survival Factors 6 - Photo 3. View of the separated tail section of KAL Flight 801

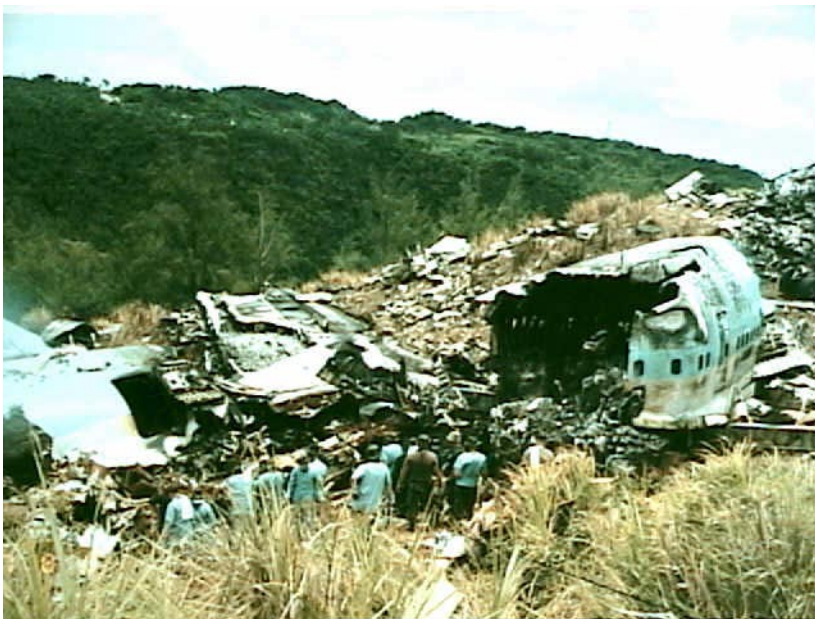
Survival Factors 6 - Photo 4. View of center fuselage section (Note: the interior cabin is destroyed by fire)

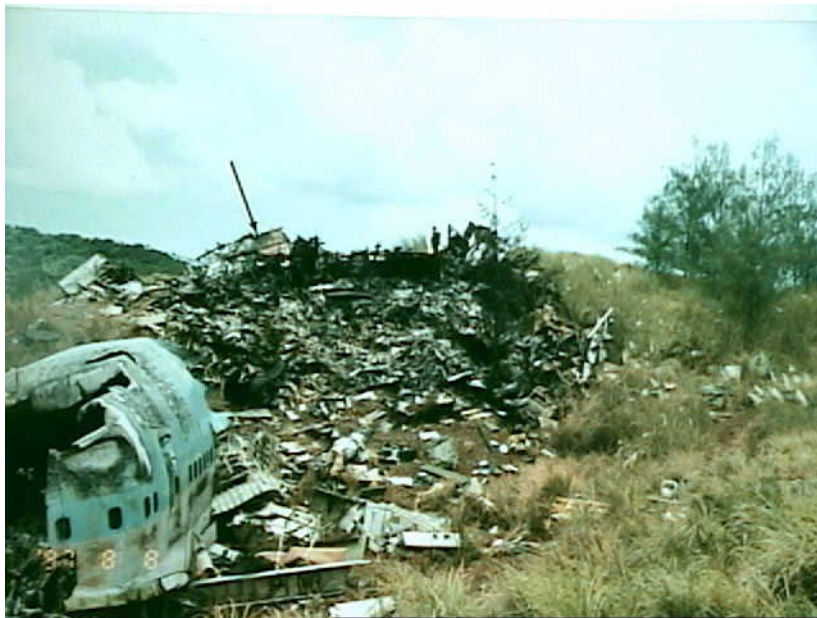
Survival Factors 6 - Photo 5. View of the destroyed forward fuselage
(Note: arrow points to one of the airplanes forward galley partitions)

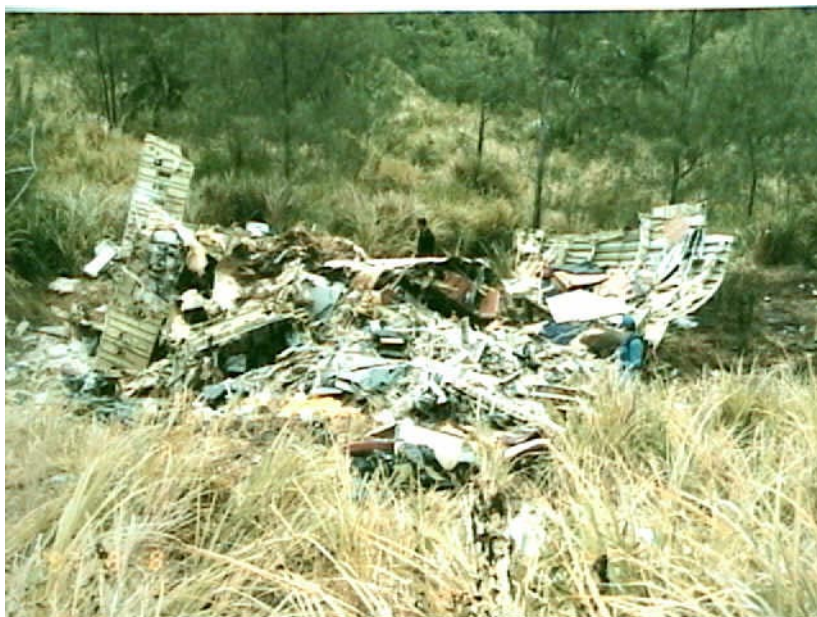
Survival Factors 6 - Photo 6. View of the cockpit and First class
section of the airplane.

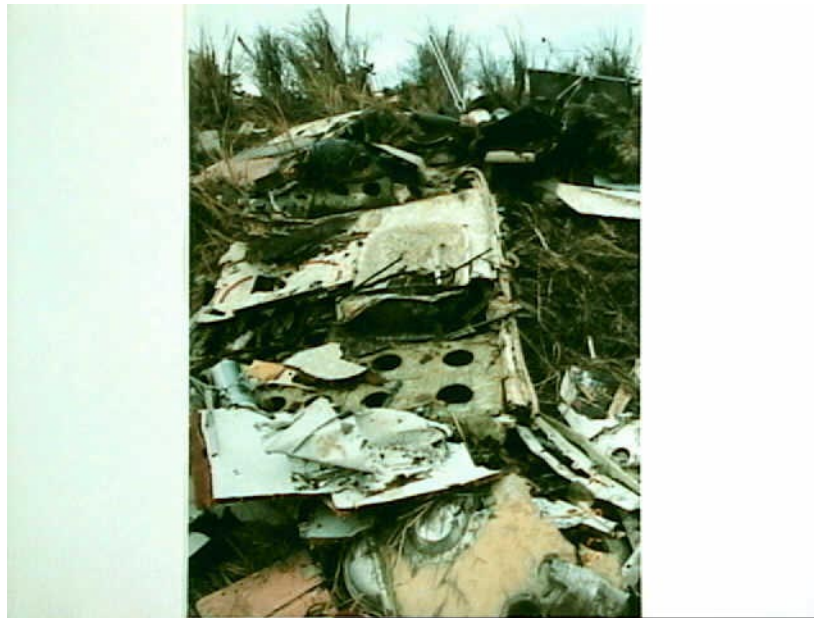
Survival Factors 6 - Photo 7. View of the R1 door Note: double flight attendant seats in background

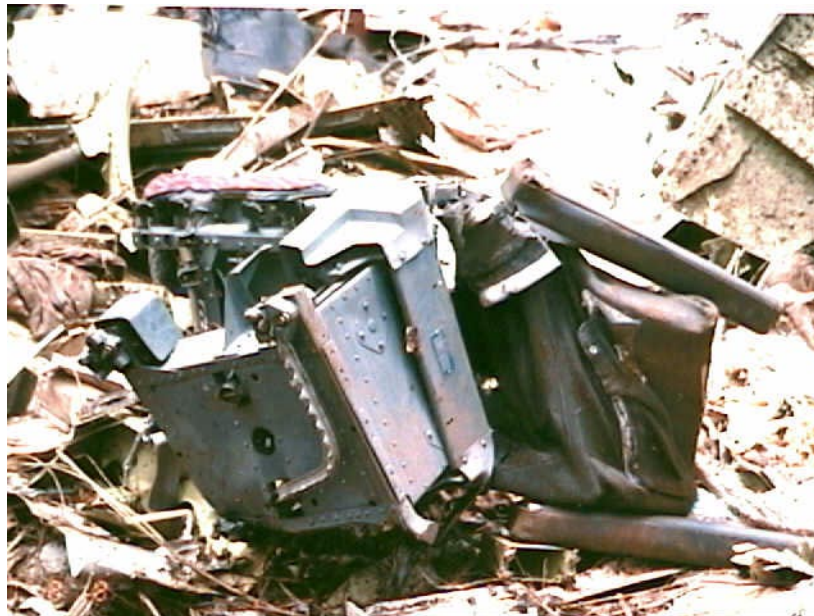
Survival Factors 6 - Photo 8. View of the First Officer's Seat
