## Examples of fractures, failures and rejections in engineering materials and components

**C.Dasarathy**  
**May 2011**

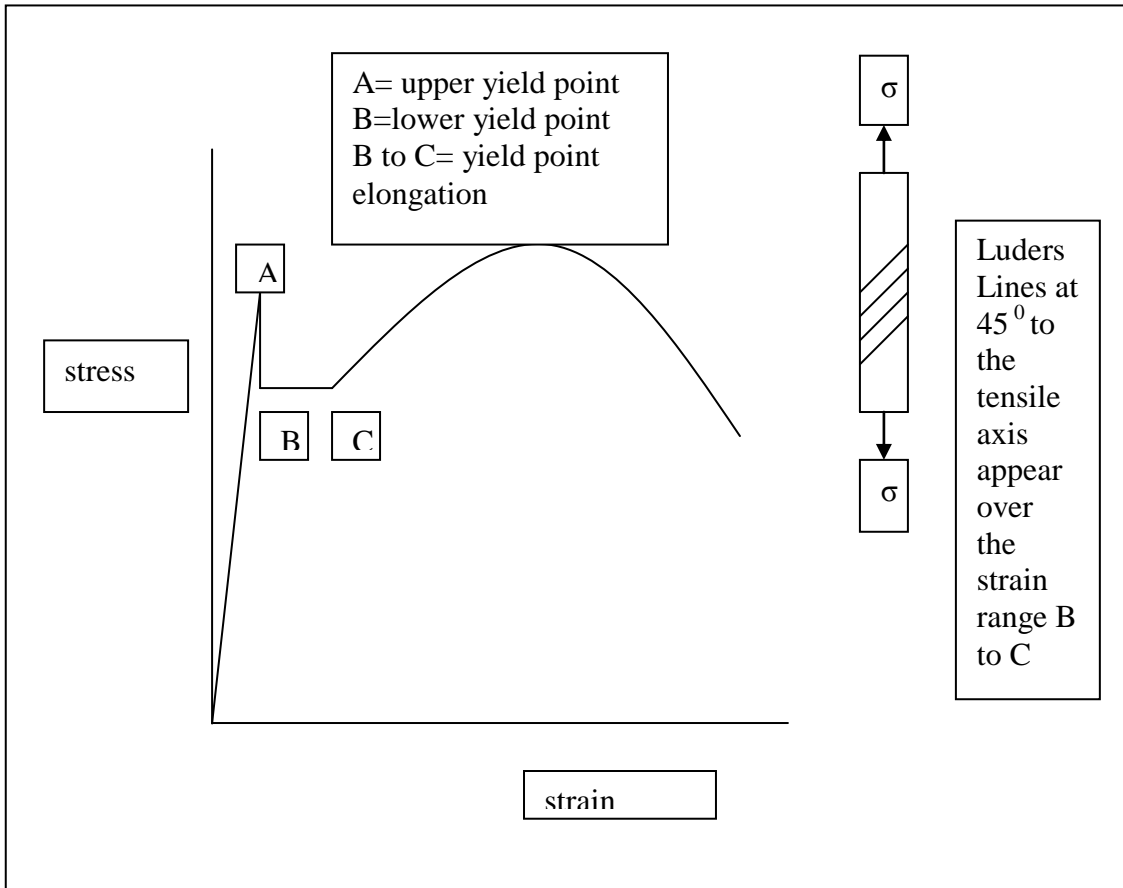
Fig 2 Stress-strain curve for steels

(Stress in  $\text{N/mm}^2$ )

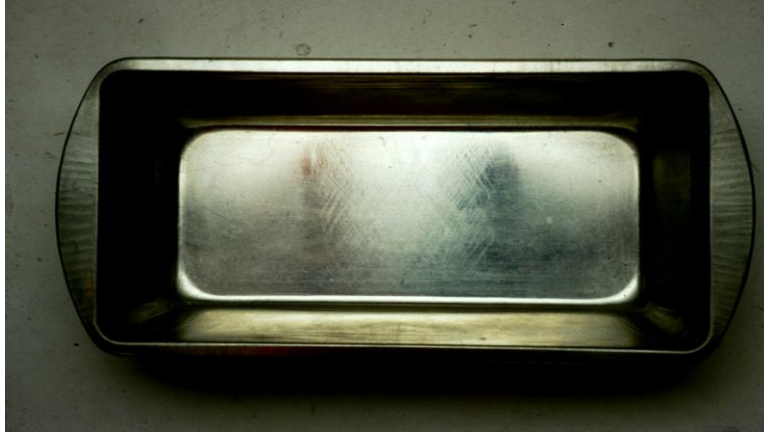
Fig 4

In commercial pressings where the stress system is not merely uniaxial tension but, in fact , more complex, Luders lines are replaced by Stretcher Strain marks (Figs 4&5) . When sheet steels are used in the manufacture of external autobody components , door ,

roof, bonnet panels, etc, these Stretcher Strain marks are highly undesirable. In fact, they often lead to the rejection of otherwise sound materials on the grounds of the surface quality being unacceptable.

How is 'discontinuous yielding' replaced by 'continuous yielding' in order to avoid the formation of 'Stretcher Strain marks on exterior autobody panels ?

- Skin passing/Temper rolling, a very small amount (~0.8%) cold rolling of annealed sheet steels is the practice normally employed .
- By adding Ti or Nb to the steel; these tie the C and N up as TiCN or NbCN ; the steel thus becomes free of interstitials, C or N.

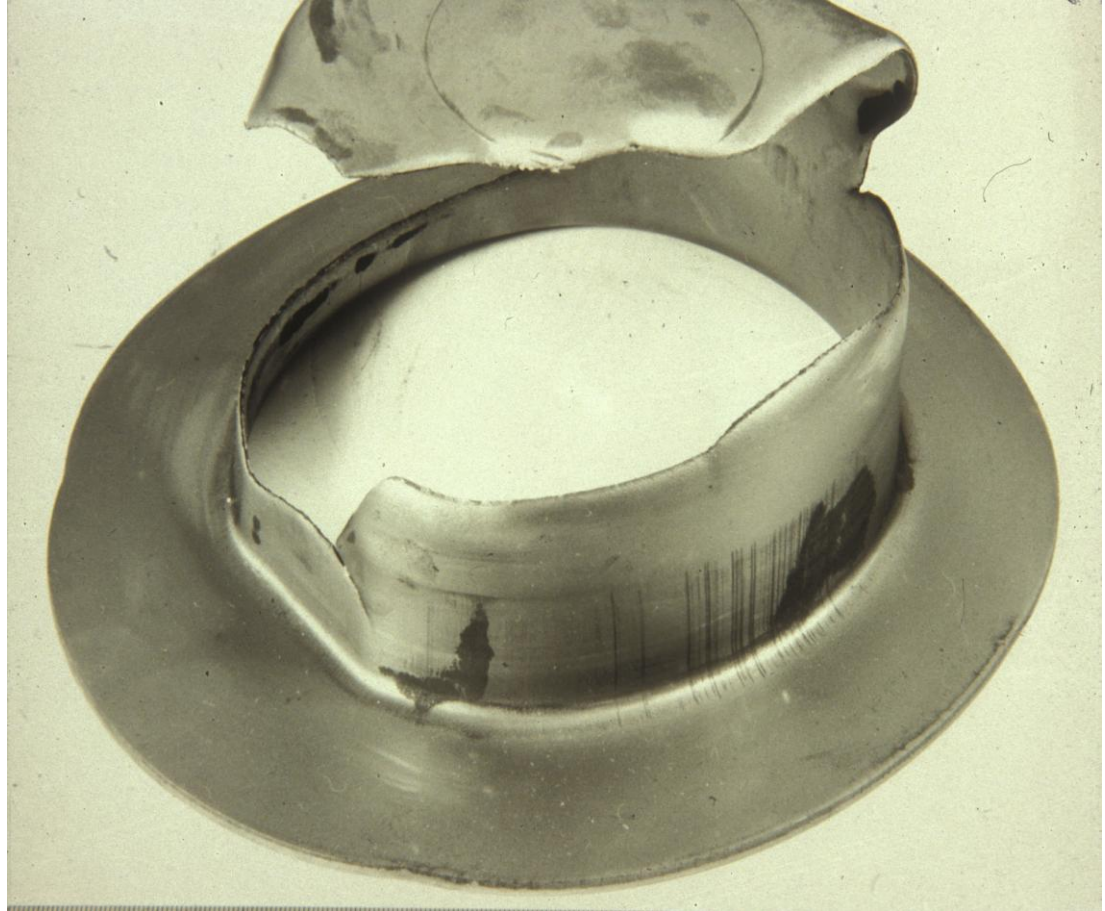
- This is from a sheet steel about 1.4-1.6mm thick
- This is an example of a failed draw
- The mean plastic strain ratio,  $R_m$ , calculated from the  $0^\circ$ ,  $90^\circ$  and at  $45^\circ$  to the rolling direction was relatively low
- Significant thinning is evident as the wall thickness strain rose to a high level. Also evident are the score marks on the wall; this may suggest that the tooling was not set correctly or that the level of lubrication was poor .

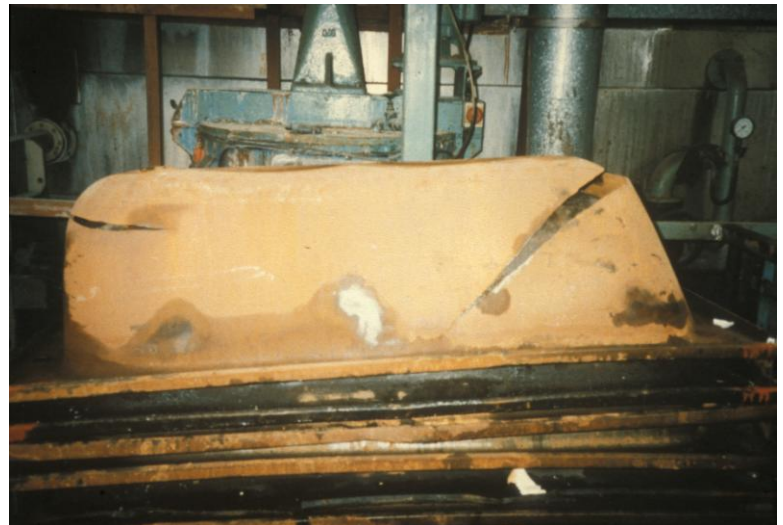
- Fig 12 shows a successful pressing based on a steel with good stretchability ie. a high 'n' value
- Fig 13 shows the failure around the radii of the component in a steel with a poor 'n' value
- Other than this difference in the 'n' values, both materials showed comparable deep drawability ie. their  $R_m$  values were similar
- Also to be noticed in both figures is the pronounced earing arising from anisotropy
- Clear evidence of wrinkling can be seen on the ears; this arises from inadequate blank holder pressure exerted during forming

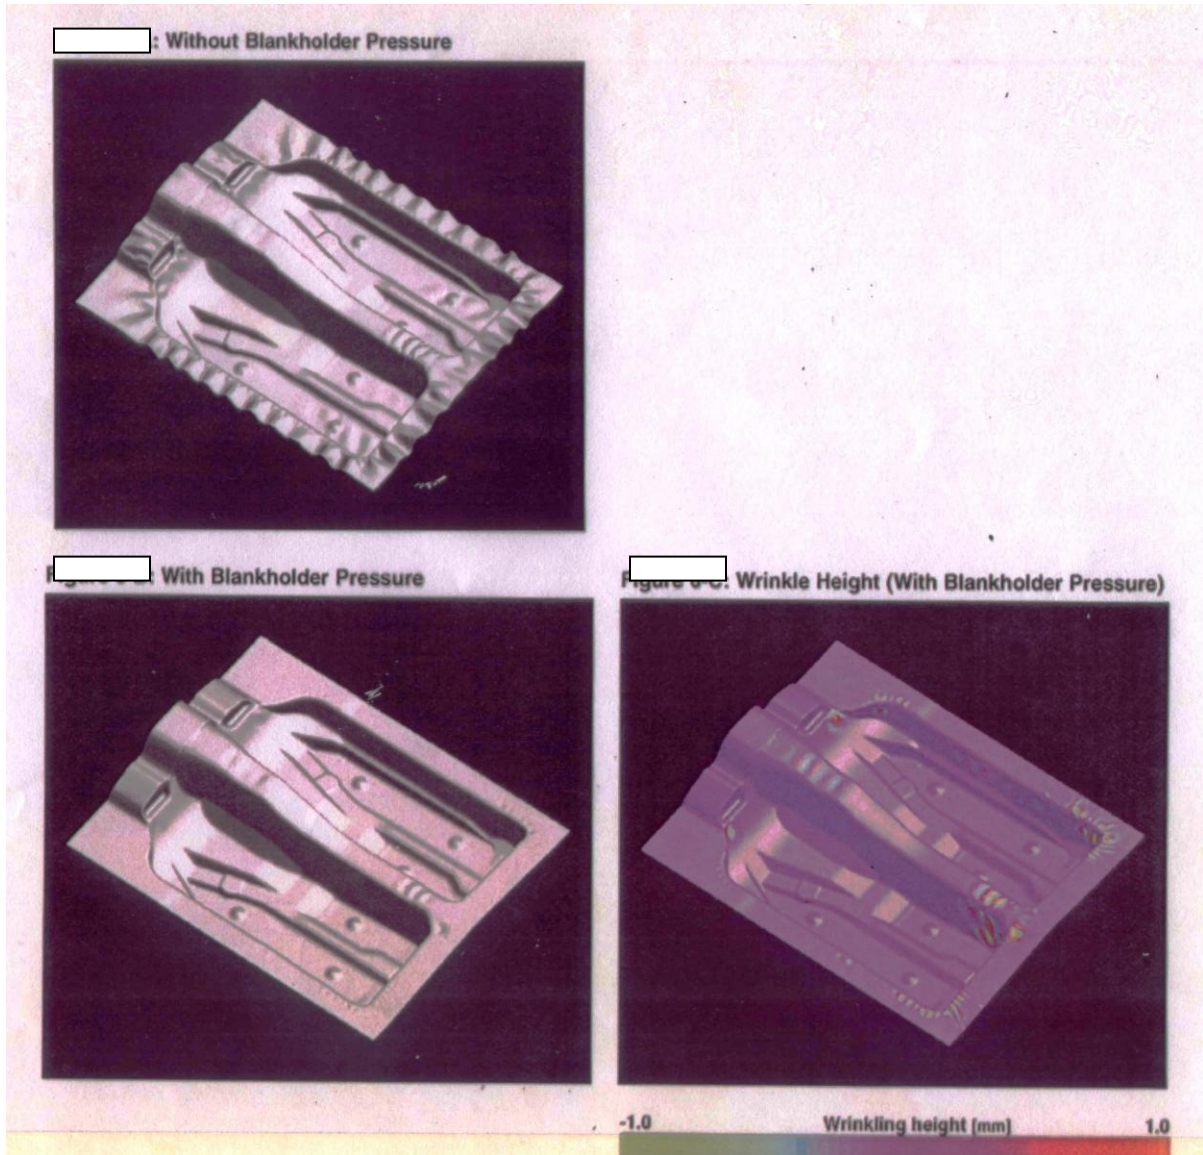
Fig 15 shows the importance of the optimum blank holder pressure to be applied.( see also Figs 7 &10)

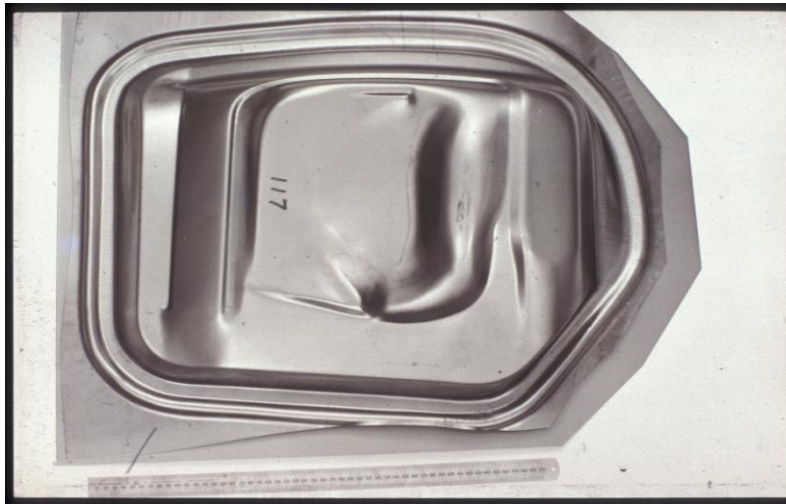
Fig17

The settings in the press can have very significant effects on the operation. Material that is entirely satisfactory can be rendered useless by incorrect press parameters, such as the rate of punch travel, force applied on the punch, blank holder pressure, die clearance , level of lubrication, etc. (Fig17).

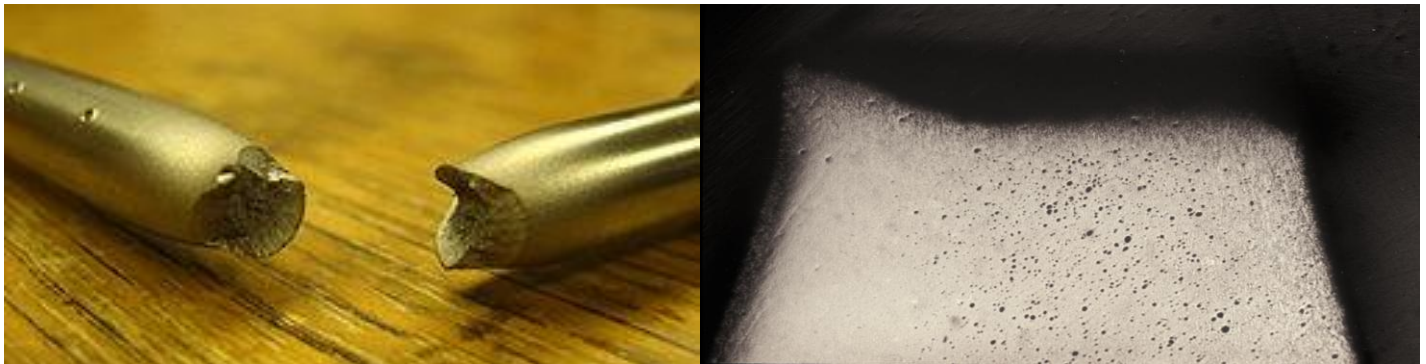
Fig 19 Ductile fracture in a rod sample    Fig 20 Ductile fracture in a sheet sample

Ductile materials exhibit significant total elongation prior to fracture. Typically, with a well annealed sheet steel ( mild steel), the total elongation over a 50mm gauge length can exceed about 40%. Fig 21 shows a scanning electron micrograph of a typical ductile fracture; the fibrous nature of the fracture is clearly evident.

As the level of strain increases, we approach the point of plastic instability; in ductile samples, a typical necking failure is the outcome ( Figs 19 &20).]

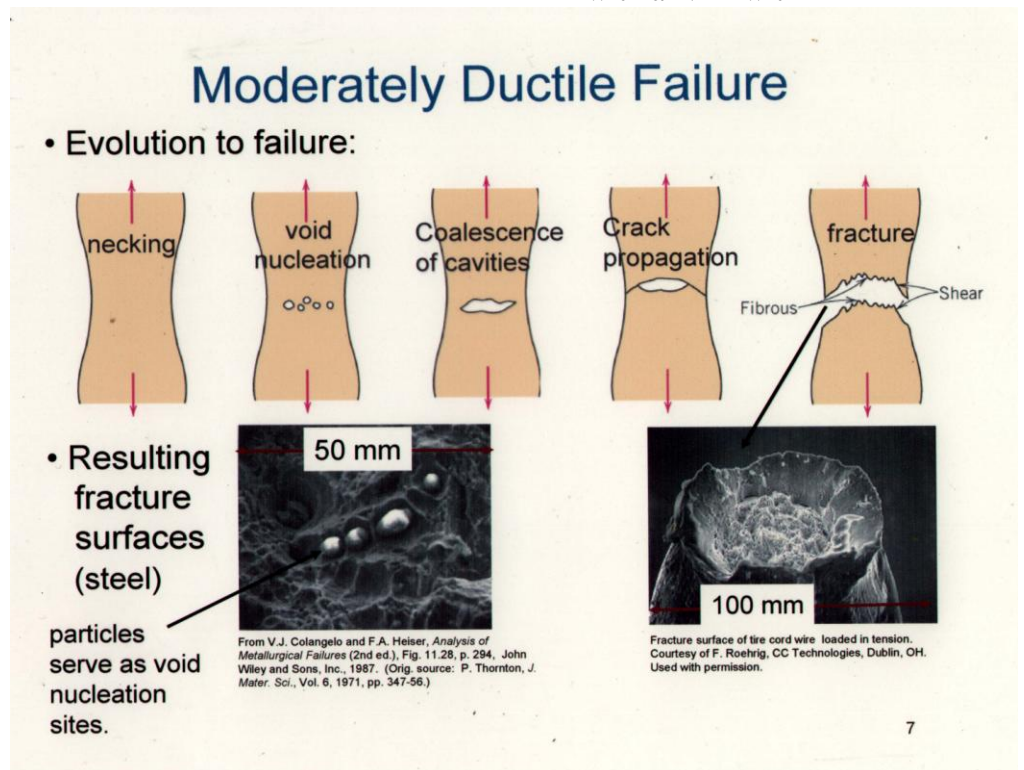
Fig25

Due to poor production practices, commercial materials can, at times, suffer from a higher than normal level of contamination from NMIs. Fig 25 is an example. Components produced from such a material will fail either during the production stage or after a very short time in service.

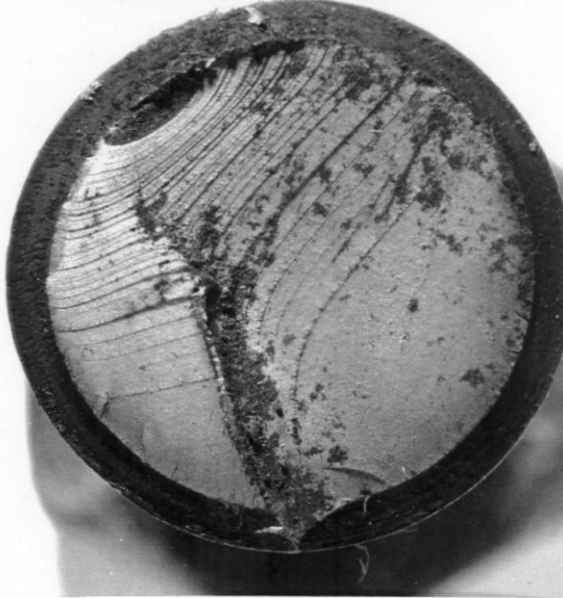
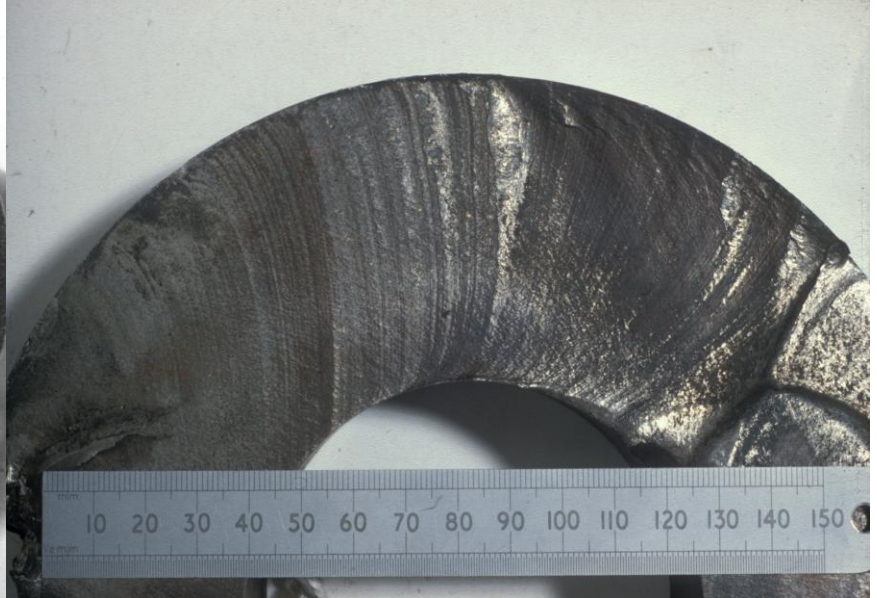
Fig 33

Fatigue fractures similar to those in Figs 33 ( a bolt ) & 34 ( a pulley ) show features, often described in books as clam shell markings or beach markings.

striation spacing increases with the stress range

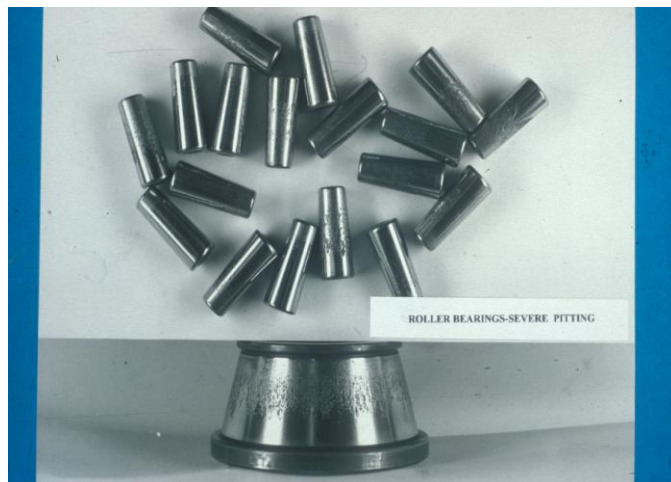
Fig 40

Other issues in this context are examples of abrasion of components subjected to fatigue loading . Fig.40 shows the pitting/ abrasion and wear on the roller bearings and the cage.

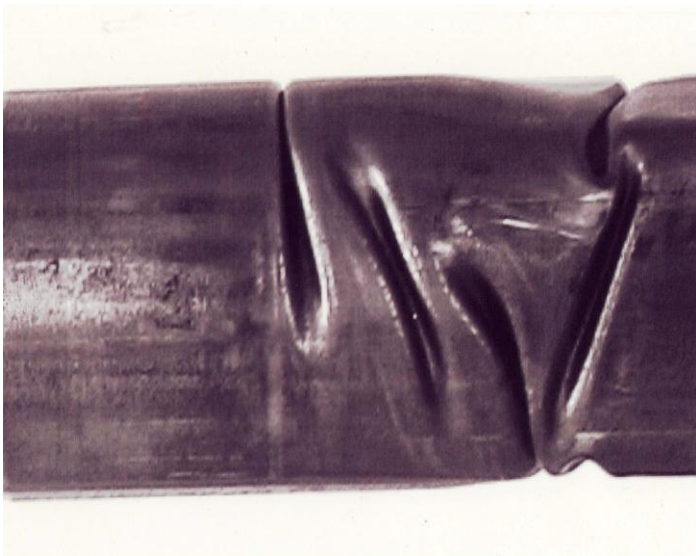
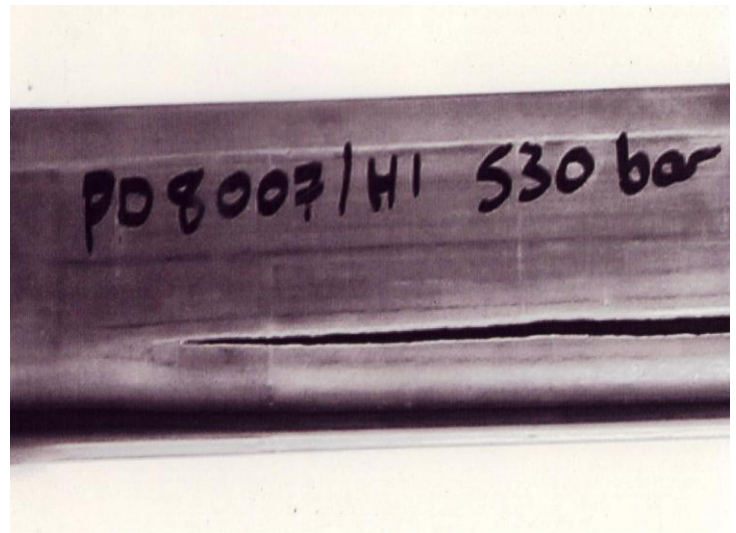
Trial and error help to optimise the pressure and the axial force applied during forming. Fig 65 illustrates how critical it is to avoid failures such as those shown in Figs 66 & 67.

Fig 66 / Buckling

Fig 67/ A split due to high pressure &/ incorrect tooling

Conventional forming systems discussed with reference to Figs.6-17 and Figs.63-67, have high tooling costs, involve high strain rates, leave the components with problems such as 'spring back' and are used for high volume, mass produced parts. In contrast, SPF entails minimal tooling costs and slow strain rates; it is, hence, not ideal for high volume, mass produced parts and leaves the components in a relatively strain-free condition. However, SPF involves operating at relatively high temperatures ie. when the materials behave superplastically. The aerospace industry has benefitted significantly from the SPF methods.

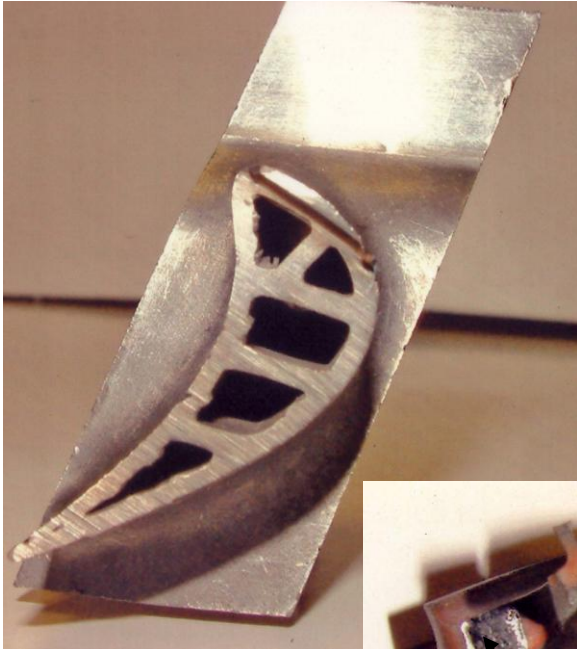
crystals, from which the blades are machined out. Fig 78 shows a blade cut at the base to reveal the channels within to provide air cooling. The examples shown below have been given to me during visit to the Turbine Blade Division of R-R at Bristol.

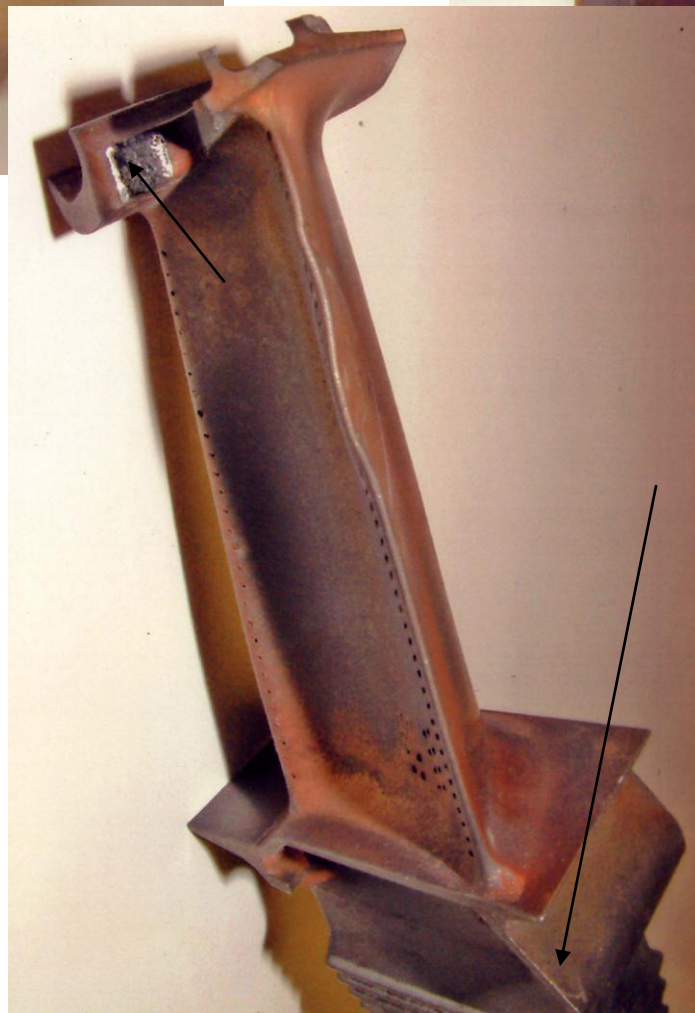
Fig 80

The root of the blade is shaped like a fir tree and slots within the turbine disc

Fig 79 & 80 are examples of damage to the high pressure turbine blades. Continued exposure to a combination of high stress levels and temperatures has led to the shape distortion to the blade as well as to the breakage at the tips . Fig 81 is an example of failure within the vents in the intermediate section of the engine . This is primary damage; secondary damage occurs as the broken fragment spins away with a high centrifugal velocity and force and impacts and ricochets elsewhere within the engine .

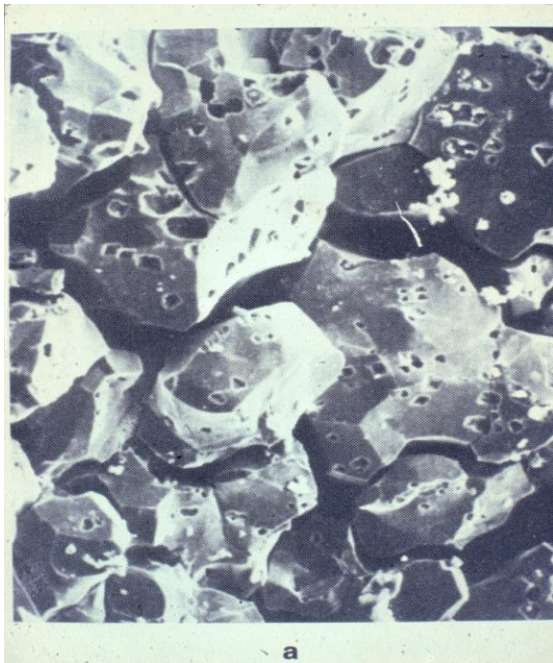
Fig 85 Failure at the grainboundaries & severe pitting on the grain surfaces.

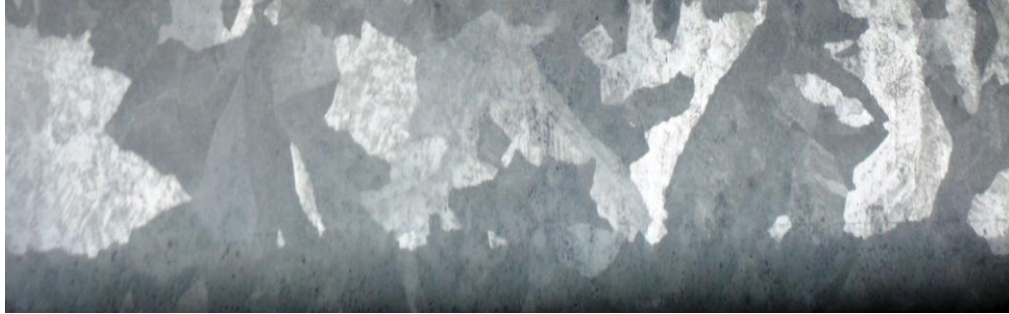
Fig 88

many variations) or by electrodeposition involving a soluble zinc anode , an electrolytic cell and the sheet steel being the cathode). The most widely used hot dip galvanised product can be seen on the guard rails of roadside bridges, motorway crash barriers, farm buildings, grain silos, new metal dustbins, etc. The characteristic 'spangle' appearance of the zinc crystals on such products can be seen with the naked eye ( Fig.88).

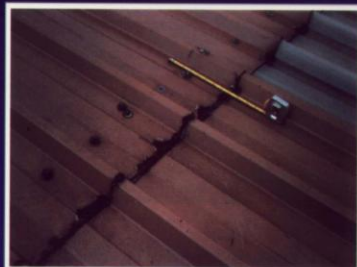
Fig 90a

A product that is widely used in the roofs and interiors of buildings, office furniture and similar applications is known as COLORCOAT. Cut edges of sheets of this product often suffer from corrosion. An example is shown in Figs 90a&b

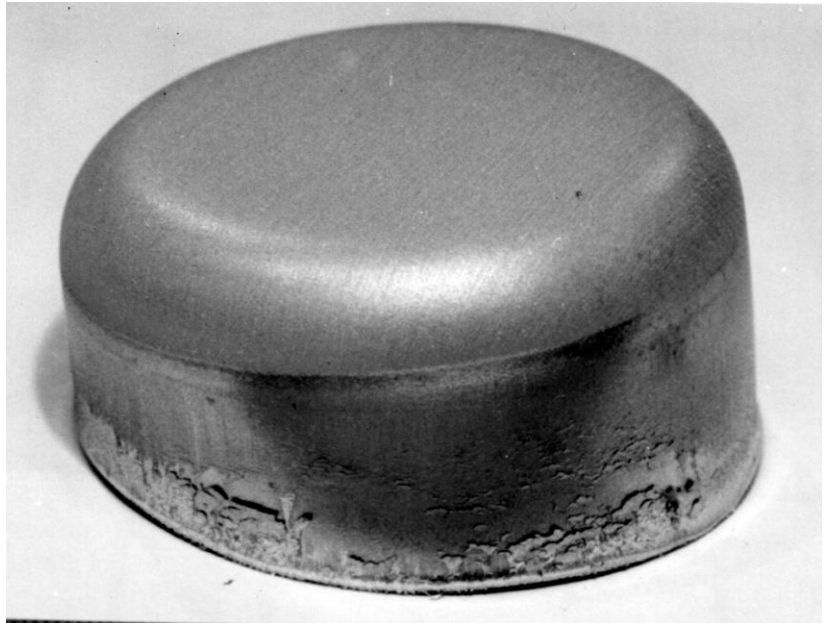
Fig 91

Sheet steels used in the manufacture of autobodies need to meet exacting demands since cars are exposed to a range of severe conditions. The coating must have a good bond with the steel substrate; this is especially important during the forming of door, wing, bonnet and roof panels in the press shops. At times, the adhesion of the coating is poor and defects such as those in Fig 91&92 appear on the surface . The reasons for such failures can be seen from Fig 93.

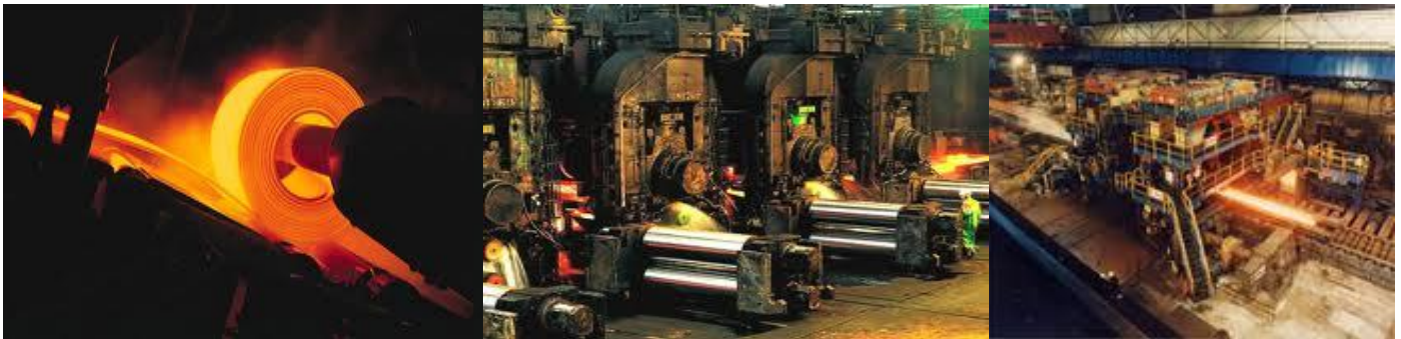
Fig 100

Temperature control at all stages of processing is crucial. One of the best examples to illustrate this point is the case of hot rolling of steel strip. Typically, the slabs (~250 mm thick) enter the hot mill at ~1200 °C and leave it , for example, at 900 °C ( ~1.4mm thick). At an intermediate stage, the steel is ~ 100 mm thick and is coiled in the unit known as the coil box. Fig100. Further hot rolling down to the final gauge is carried out

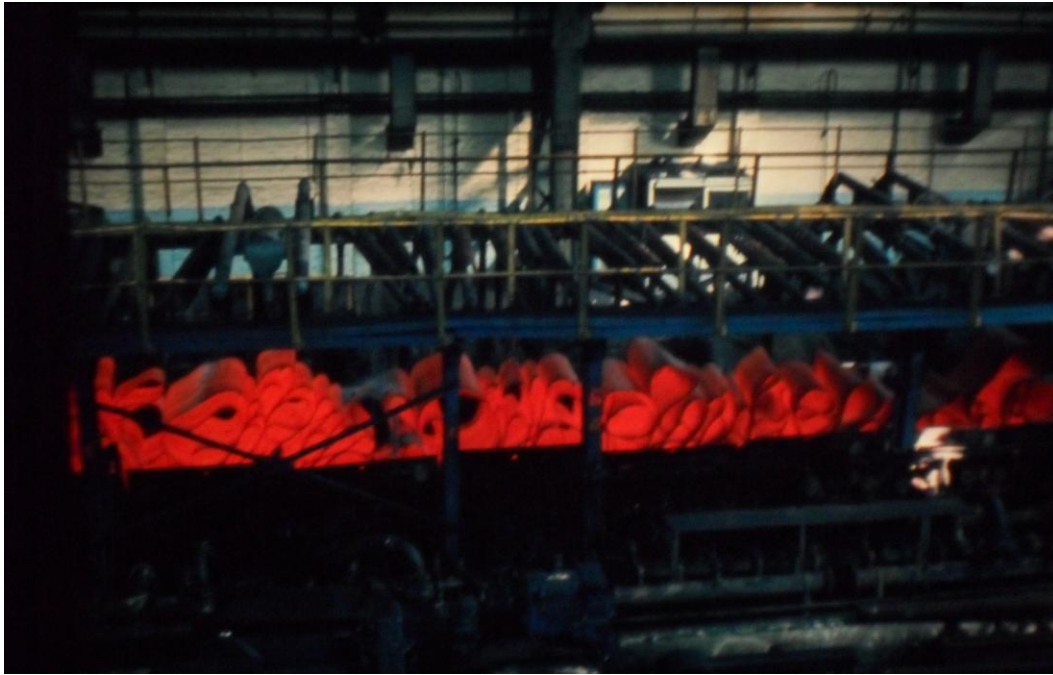
Fig 104

If the slab or bar or strip temperature is not high enough, hot rolling ceases since the steel is too hard to be rolled. This results in a pile up of sheet steel of different thicknesses jammed between the work rolls of the mill Fig 104. This is known as
