*This document is an English translation of the Final Report on the accident on 10 April 2010, on Smolensk "Severny" airdrome, to the Tupolev Tu-154M tail number 101 of the Republic of Poland.*

**INTERSTATE AVIATION COMMITTEE  
AIR ACCIDENT INVESTIGATION COMMISSION**

**FINAL REPORT**

Type of occurrence	Accident
Type of aircraft	Airplane, Tu-154M
Registration	Tail number 101, Republic of Poland
Owner	Republic of Poland
Operator	Ministry of Defense, Republic of Poland
Site of occurrence	Between the middle marker and runway 26 threshold, Smolensk "Severny" Airdrome, N 54°49.450' and E 32°03.041'
Date and time	10.04.2010, 06:41 UTC, 10:41 local time, daytime

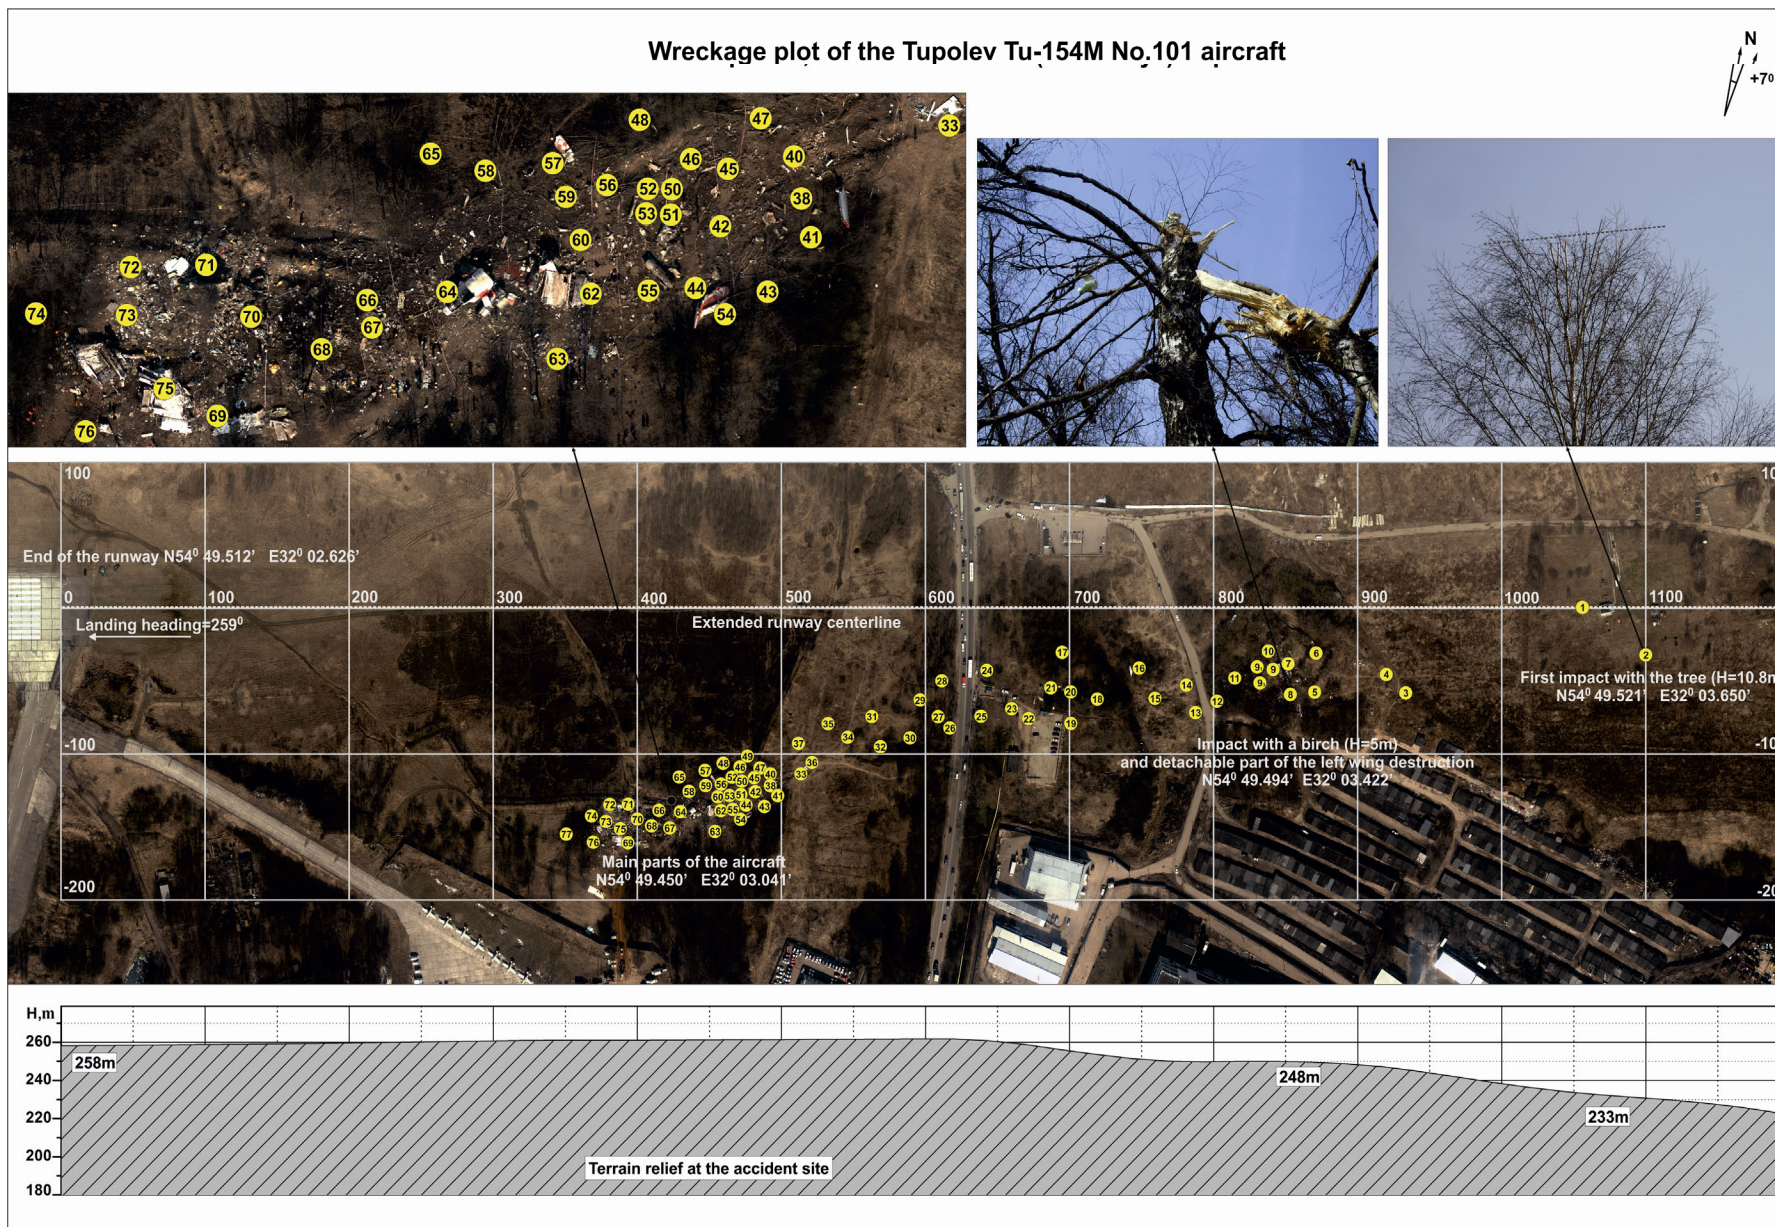
Figure 35

The following table contains the complete list of the aircraft fragments on the wreckage plot (Figure 35).

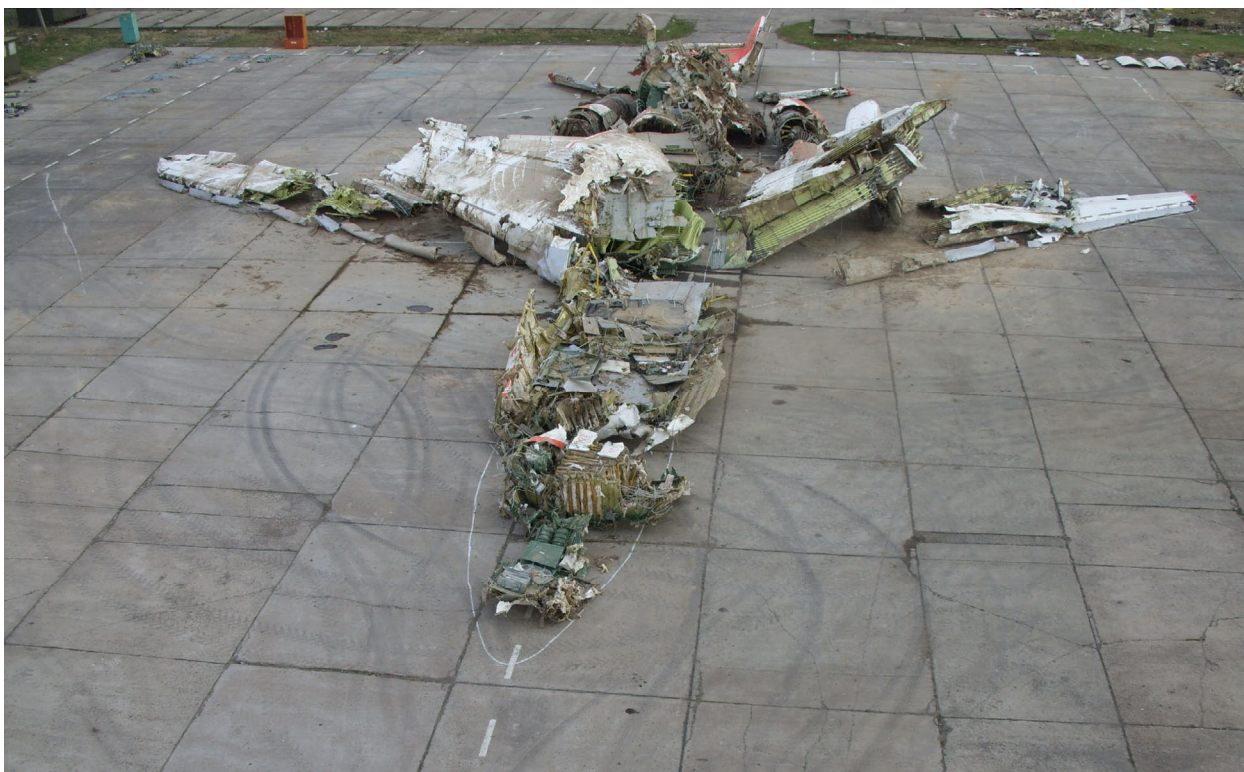
**Figure 37**

From 13.04.2010 to 16.04.2010 the aircraft fragments were evacuated to the secured site and the aircraft airframe (Figure 37), avionics and flight control systems were laid out.

As the aircraft impacted the ground inverted the radome, cockpit light and upper part of the fuselage from frame 4 to frame 67A were totally destroyed into small fragments difficult to identify.

On the basis of the layout analysis it can be definitely concluded that the destruction of the aircraft structures and systems was caused by the unexpected impact forces, no traces of the in-flight fire were detected.

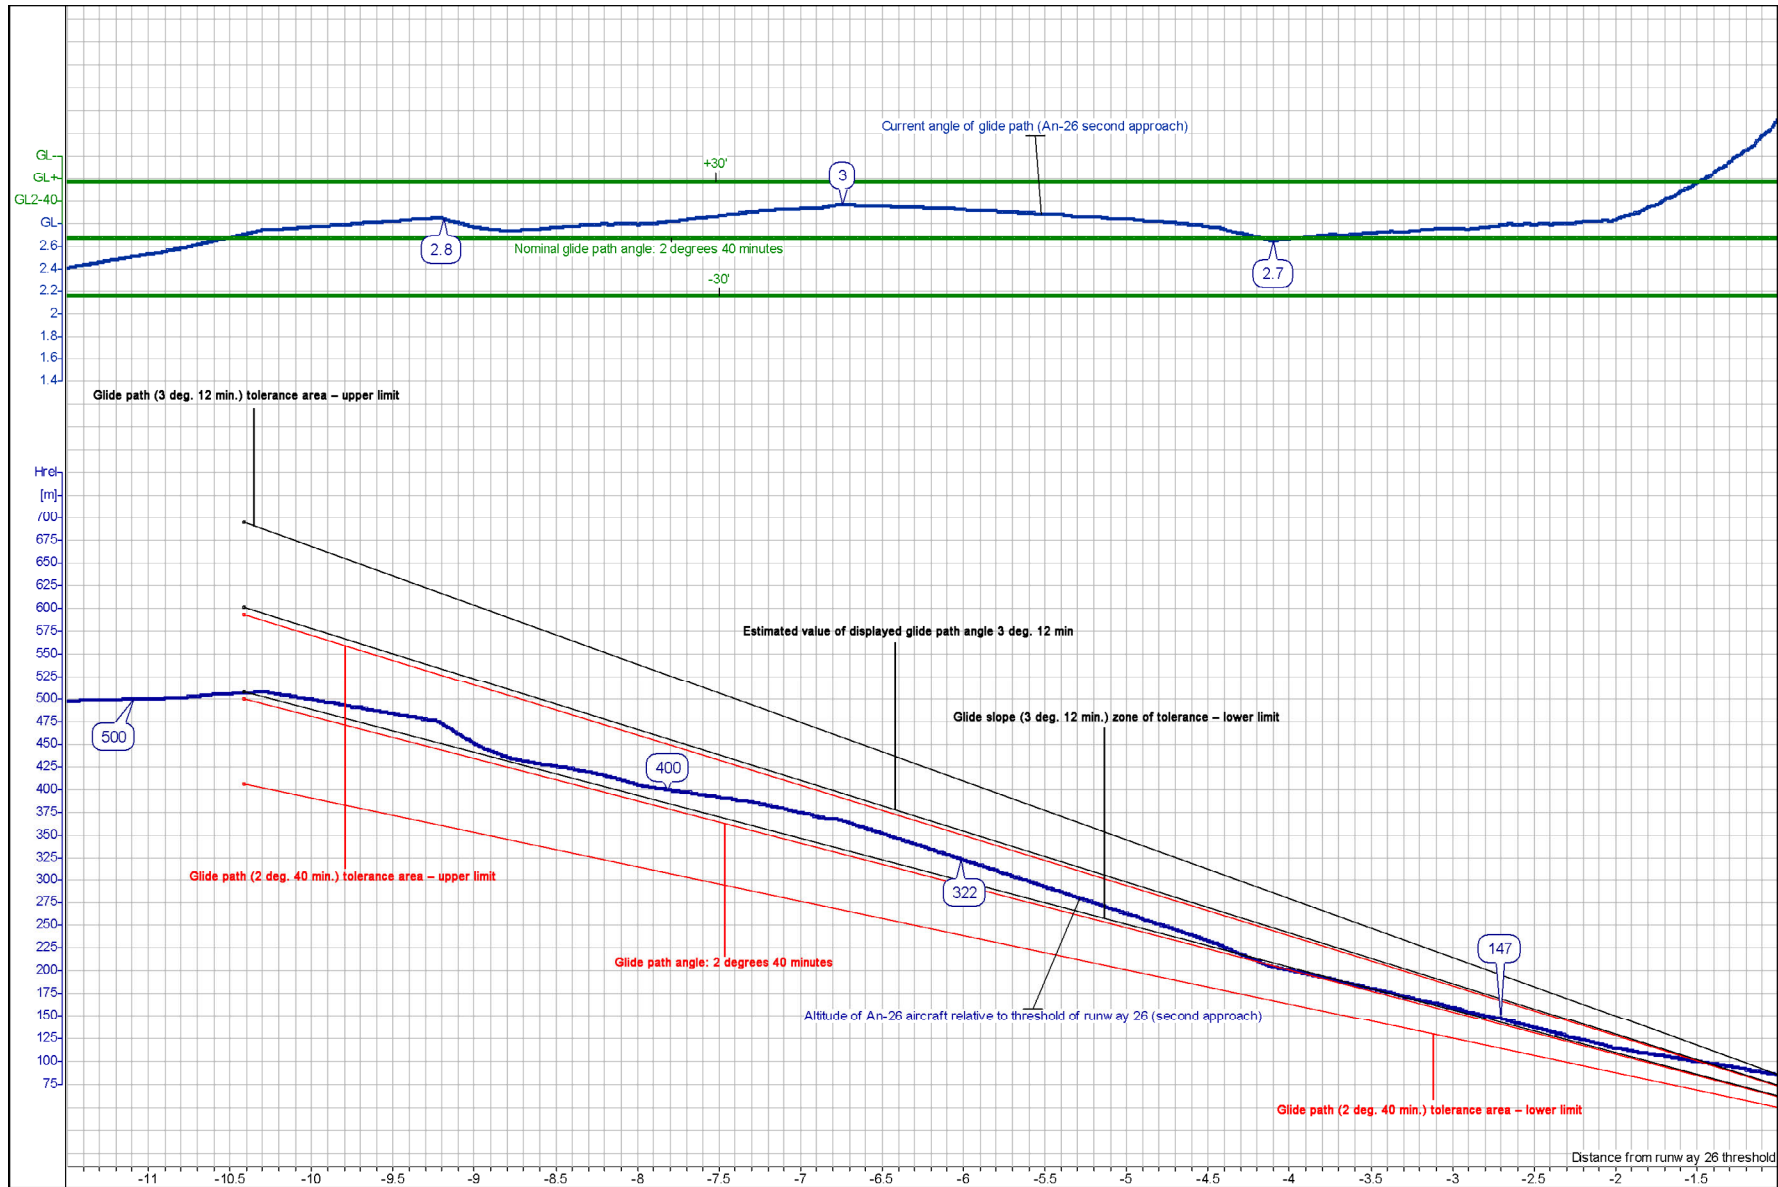
The analysis findings are shown on Figure 40 and Figure 41. The first chart shows the changes in altitude in the test flight as a function of the distance from RWY 26 threshold. The chart also shows the nominal glide path, the area of tolerable deviations and the so-called momentary glide path angles. These angles are calculated as arctangent of the quotient from dividing the current altitude by distance to the touchdown point when following the nominal glide path (the touchdown point is 320 m after the runway threshold).

- 1 The landing radar screen mounted for the experiment (and during the accident flight) had lines approximately designating the following angles (shown in black on the chart):
  - Lower line -  $2^{\circ}42.3'$ ;
  - Central line -  $3^{\circ}12.3'$ ;
  - Upper line -  $3^{\circ}42.3'$ ;
- 2 The landing radar underrates the indications of the aircraft distance from the runway threshold by about  $90 \div 150$  m (depending on the distance of the aircraft from the runway threshold).

Thus, in the accident flight the landing zone controller saw the aircraft blip on the radar as being referenced to glide path of  $\sim 3^{\circ}10'$ . The inaccuracy was about  $0.5^{\circ}$ , which is equal to the tolerance area range.

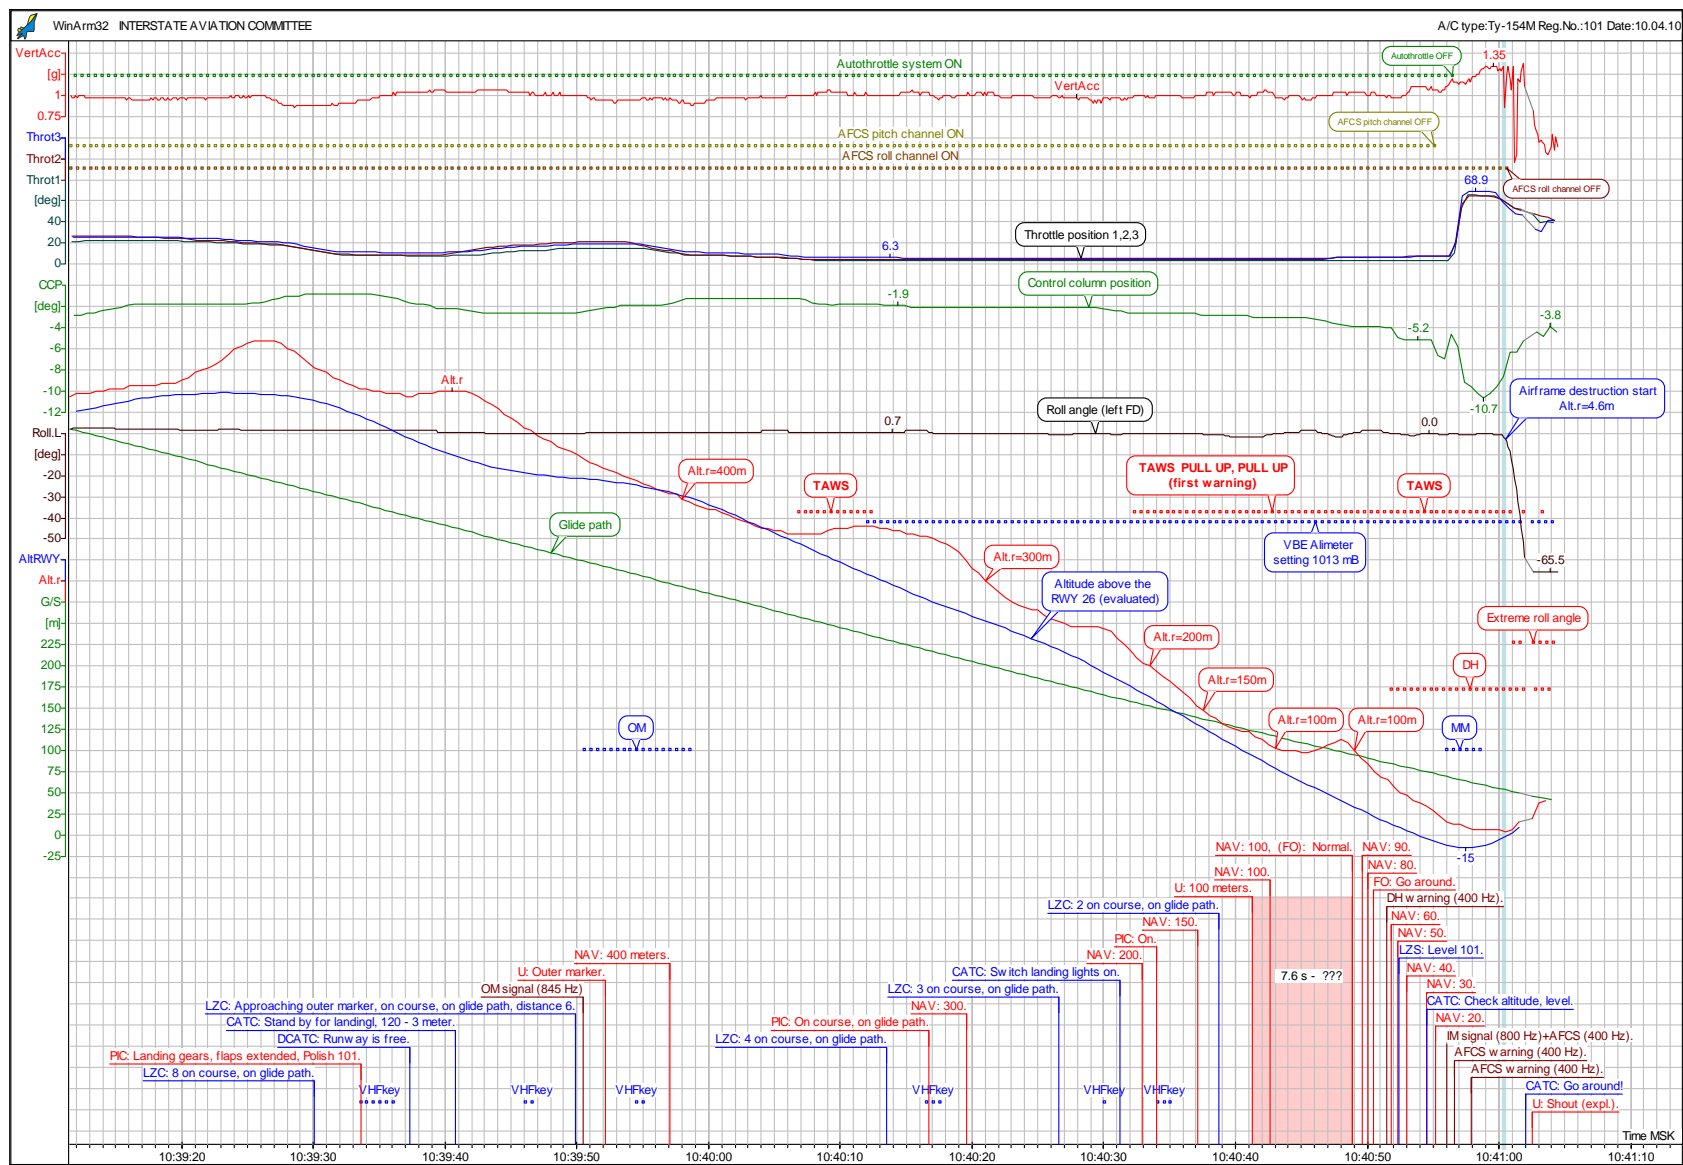
The actual descent path of the aircraft is shown in Figure 45 and Figure 46.

At 10:40:20 the navigator reported the height: “300”. The comparison of this and further navigator’s reports on the flight height (250 m, 200 m, 150 m, 100 m) with the actual pressure altitude and radio height especially in the time interval from 10:40:41 – 10:40:49 indicated in color on Figure 45 reveals that at least from that moment the altitude was monitored by the radio altimeter<sup>50</sup>. It should be noted that the navigator had not conducted flights on Tu-154M flying as a co-pilot of Yak-40 for the last 2.5 months. The interview of the Yak-40 PIC who was flying to Smolensk "Severny" Airdrome on April 7 and 10 showed that for the crews of Yak-40 in the regiment “there is a procedure of monitoring altitude by the radio altimeter from the height of 250 m”. The actual terrain along the flight path is shown on Figure 46. It is clear from the picture that after the outer marker the terrain level was much lower than RWY 26 threshold (up to 80 m).

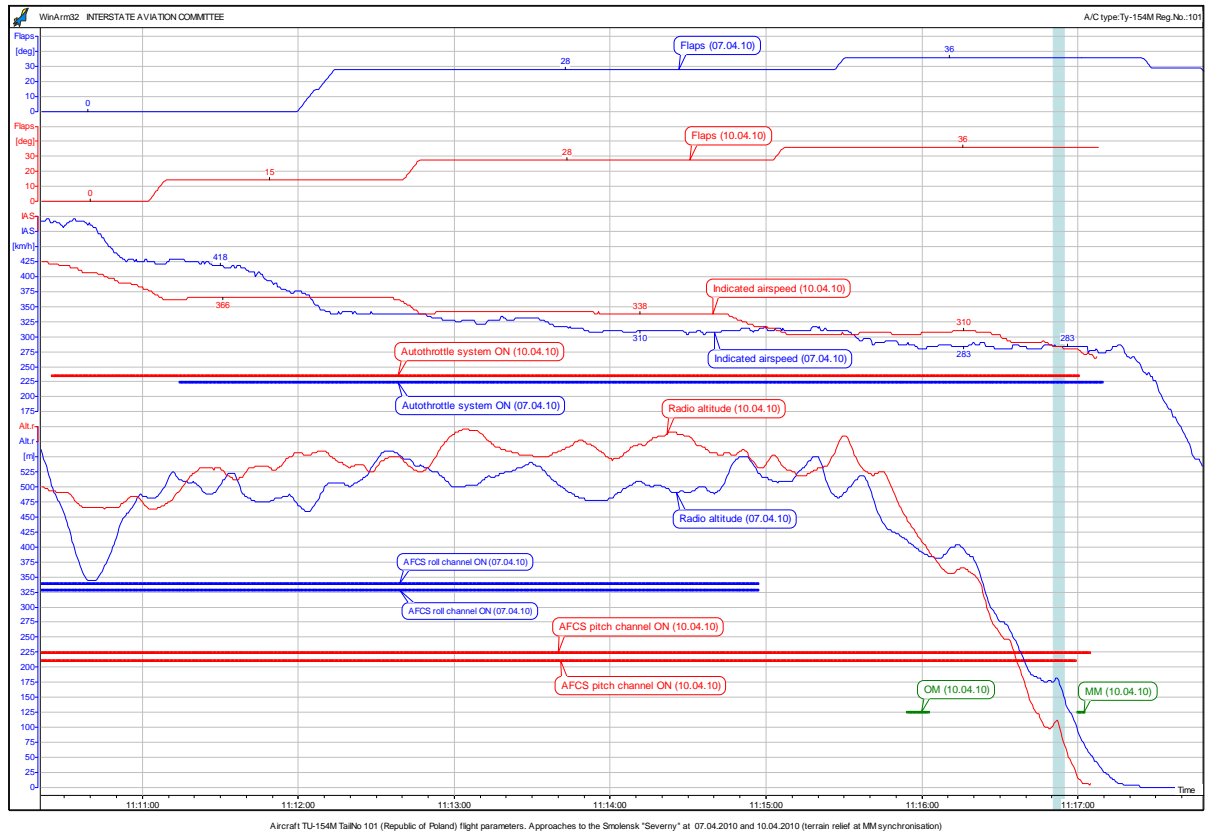
**Figure 47**

**Note:** *The analysis of the flight made to Smolensk "Severny" Airdrome on this aircraft on April 7, 2010 reveals that the crew switched to manual control column steering before starting the glide path descent (Figure 47).*

The use of autopilot by the PIC which was not stipulated by the FCOM at an airdrome with no precision instrument landing systems confirms the uncertainty of the PIC that he could maintain the selected descent parameters controlling the aircraft manually as well as his psychological stress due to the incompliance of the actual weather conditions with his training level provided he had had breaks in approaches in the established weather minima.

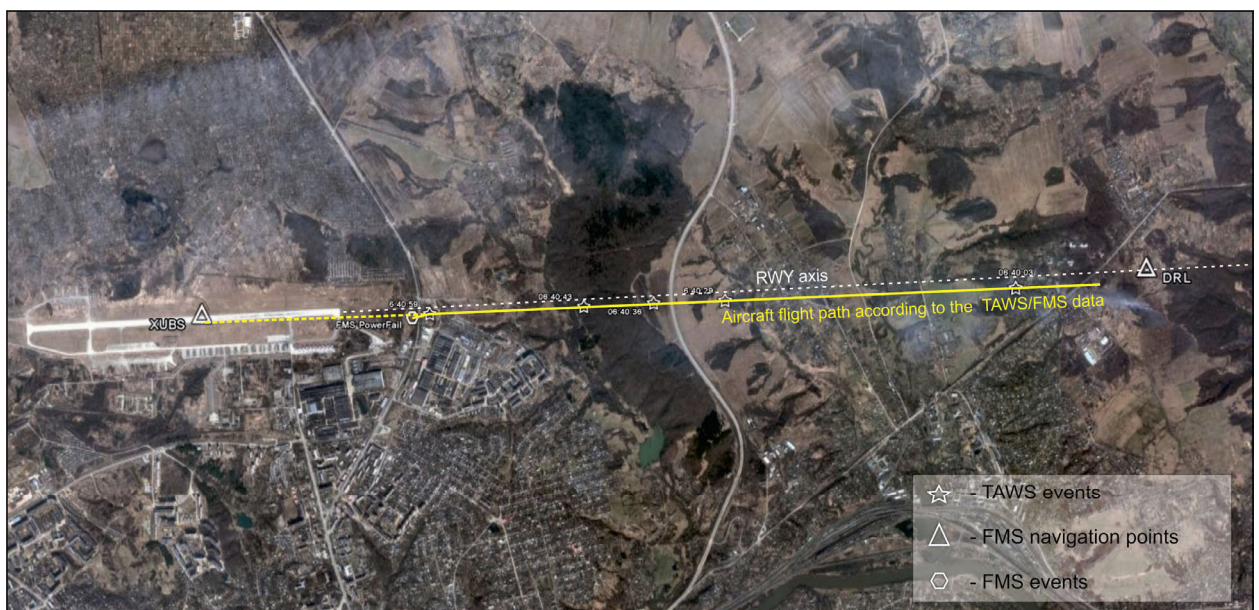
**Figure 48**

From the outer marker to XUBS (the last waypoint in the active flight plan), the flight path calculations (Figure 48) suggested two possible methods as to how the flight crew was controlling the airplane - either by the FMS, or by the use of the TURN (HEADING) knob. The flight path calculations revealed that, after passing the outer marker, the airplane was to the left of the extended runway centerline (within the course tolerance area) heading directly to the XUBS waypoint. It is possible the FMS could have provided the course adjustment for the airplane to track directly to XUBS and, therefore, converge on the line between the waypoints. In addition, the flight crew could have used the autopilot TURN (HEADING) knob to adjust the airplane's track.
