IBM Maintenance Library

Magnetic Tape Subsystem Maintenance Manual

3803-2/3420

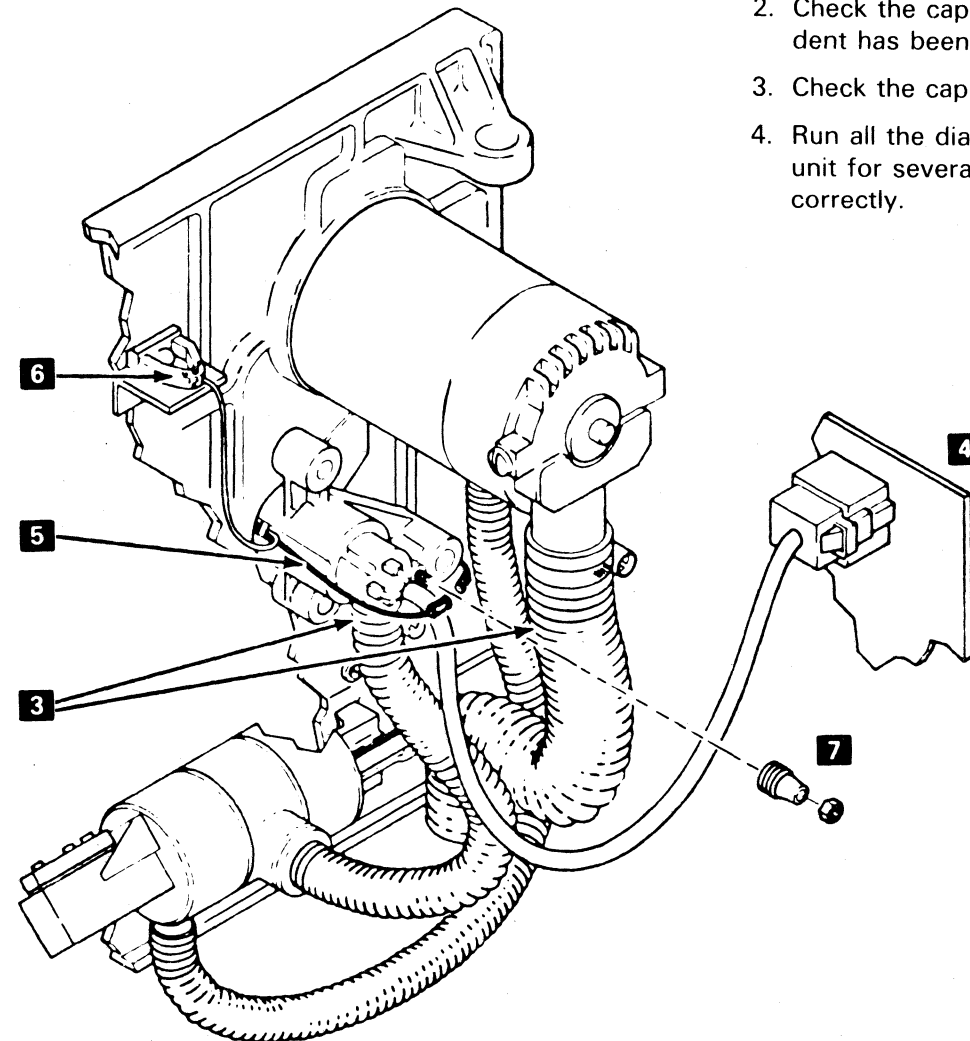
To remove the assembly:

1. Unload the tape unit and turn off tape unit power.
 2. Loosen the two upper stubby bar mounting screws and slide the bar down and to the right to increase capstan clearance. Tighten the screws temporarily.
 3. Disconnect the air hose(s) from the capstan motor and the left reel motor.
- Note:** The two wires inside the motor cooling port were used in manufacturing and should be ignored. Slip them back into the port so they do not interfere with your work.
4. Unplug the power cable from the capstan motor control board.
 5. Disconnect the tachometer cable.
 6. Remove the wedge holding the capstan fiber optic bundle in the light manifold and pull out the bundle.
 7. Remove the spring cluster load nut and spring cluster.
 8. Remove the capstan assembly from the rear, being careful not to snag any wires or damage the capstan or reference plate.

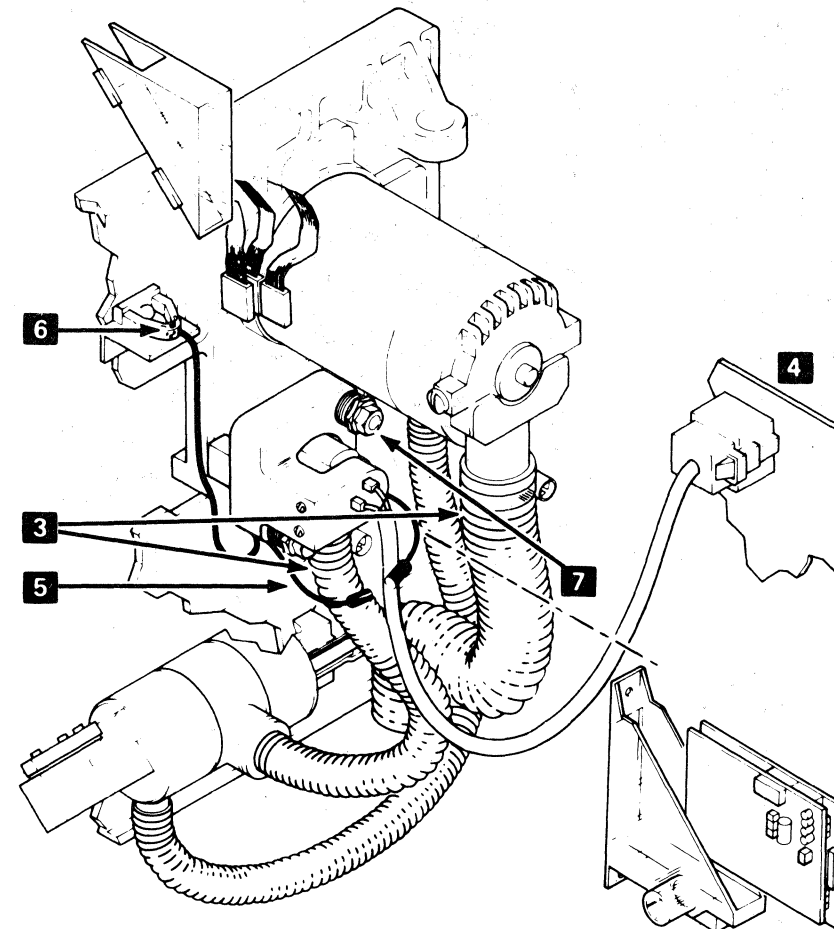
Note: If a slotted stud is accidentally removed, replace it before proceeding. The studs act as guides and help prevent capstan and tachometer damage.

8. Remove the capstan assembly from the rear, being careful not to snag any wires or damage the capstan or reference plate.

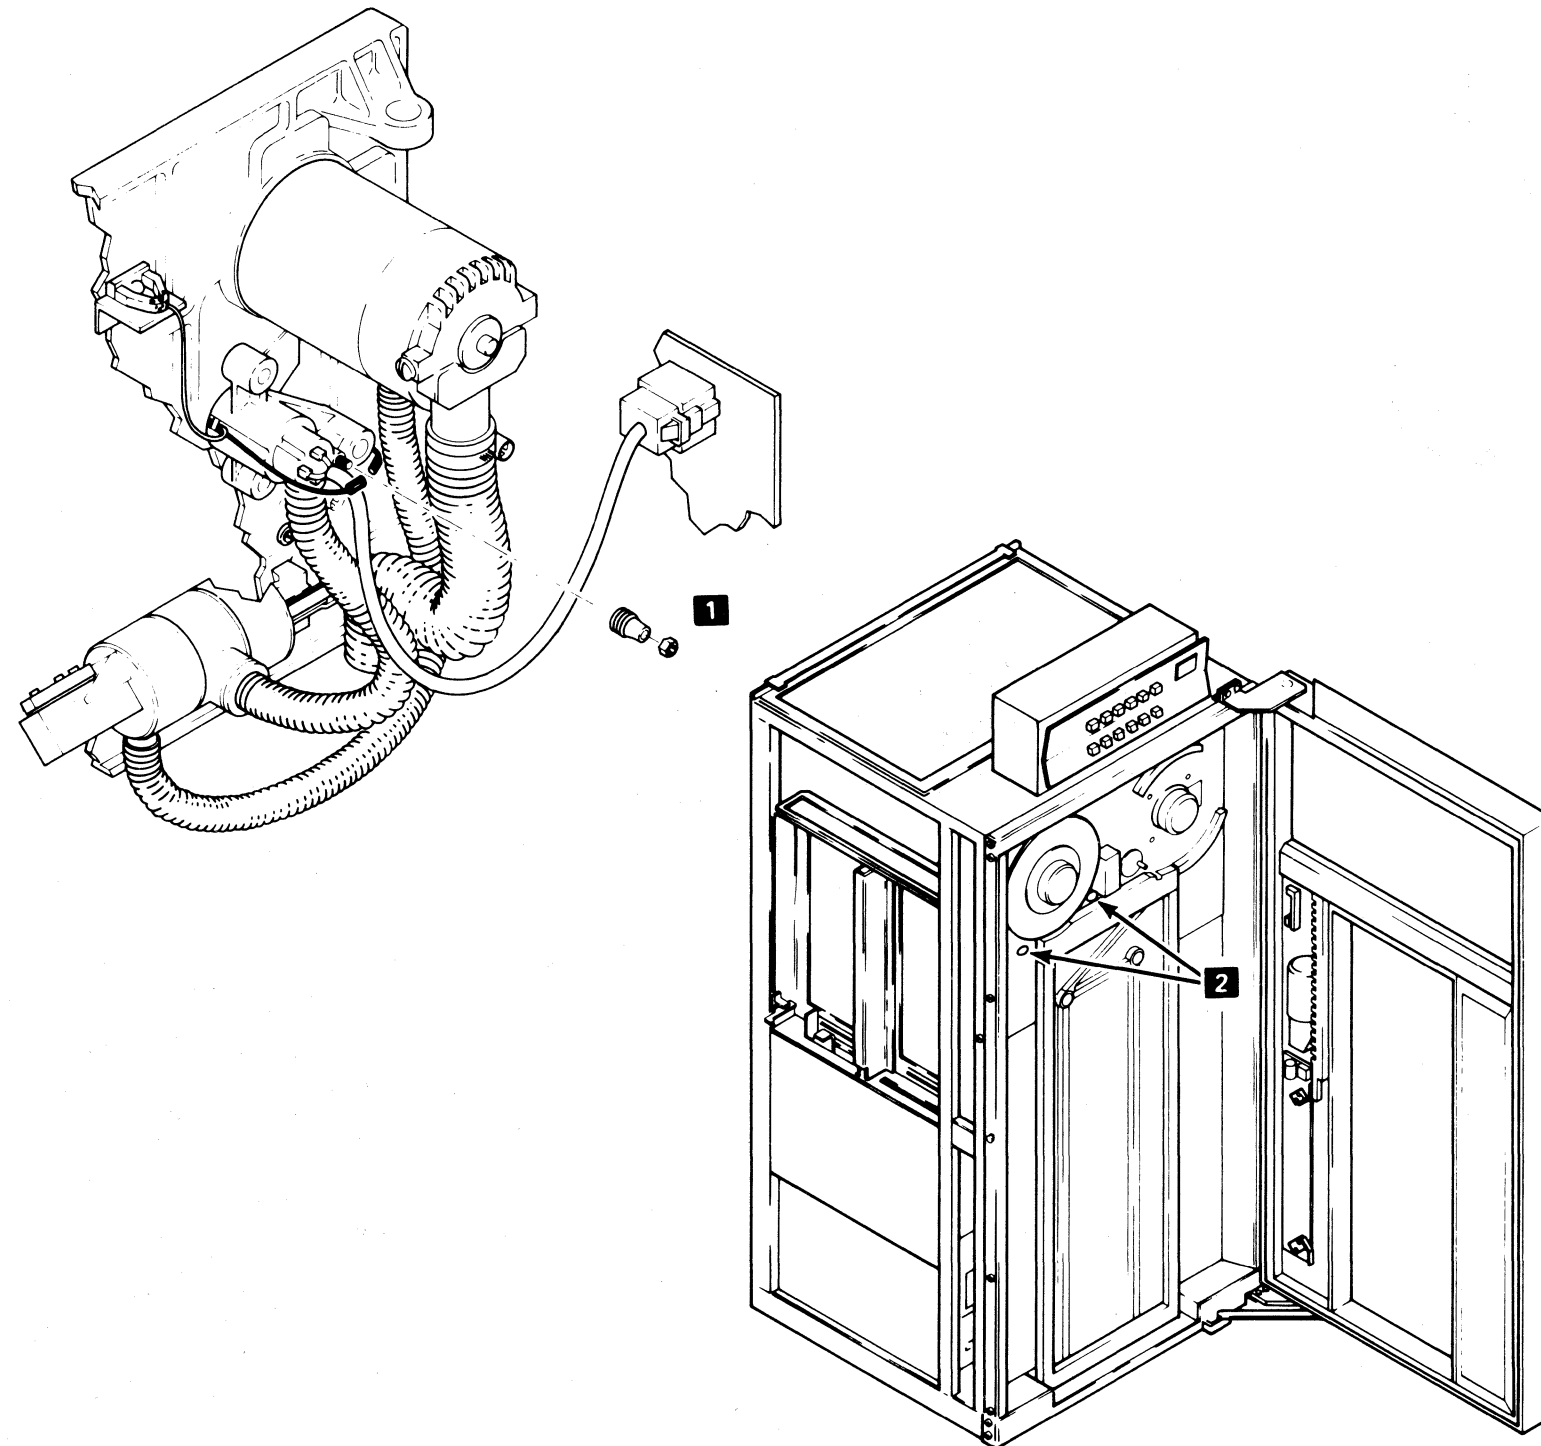
Non-90,000 Series Tape Units

- 1 Loosen the spring cluster load nut three turns.
- 2 From the front, turn both adjusters counterclockwise until they touch the bottom in the threaded sleeve. Access is made through holes in the faceplate.
- 3 Turn each adjuster two full turns clockwise.
- 4 Tighten the spring cluster load nut until slack is removed; then tighten 4 to 4-1/4 turns more. If no slack is present, loosen the cluster load nut 1 until the slack is just noticeable, then retighten 4 to 4-1/4 turns.
- 5 Perform the Capstan-To-Stubby Bar Clearance Adjustment procedure on 08-080.
- 6 Check for $17/32 \pm 1/64$ inch (13.5 ± 0.4 mm) from the reference plate to the front edge of the capstan wheel.

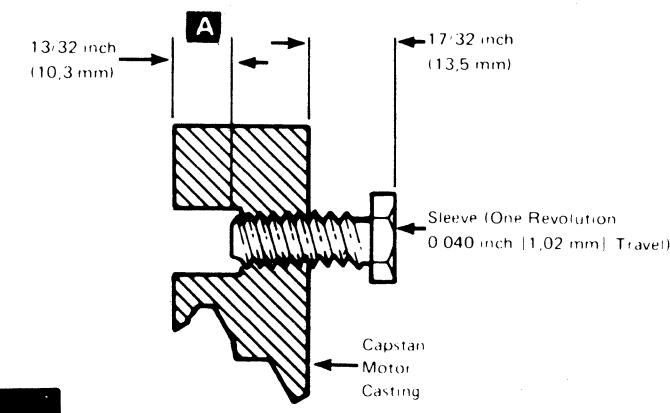
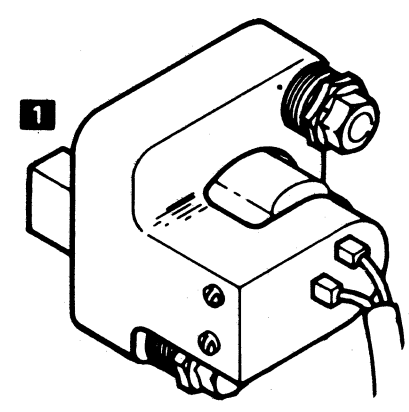
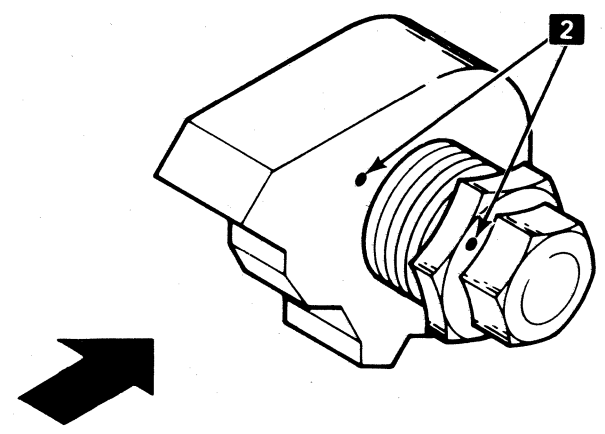
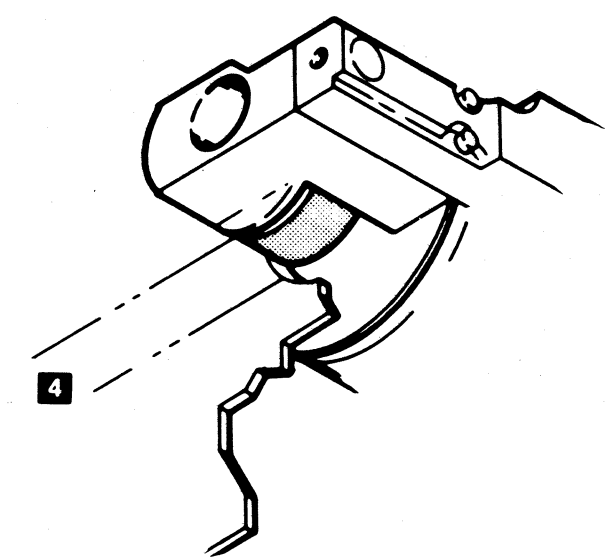
If the capstan alignment tool, P/N 2515376, is available, use the procedure on 08-062. If the tool is not available, proceed as follows:

- 1 Remove the capstan assembly. See 08-030, "Capstan Assembly Removal."
 - 2 If necessary, rotate each sleeve until the zero marks align, and the sleeve tips are $13/32$ inch (10.3 mm) **A** from the end of the capstan motor casting. Use a steel scale, P/N 450158 or equivalent, to make this measurement.
 - 3 Replace the capstan assembly. See 08-050, "Capstan Assembly Replacement."
- Caution:** Be very careful not to damage the capstan wheel, reference plate, fiber optic bundle, or tachometer cable when installing the capstan assembly.
- 4 The front edge of the capstan should be $17/32 \pm 1/64$ inch (13.5 ± 0.4 mm) from the reference plate. If not, rotate all sleeves until this condition is met.

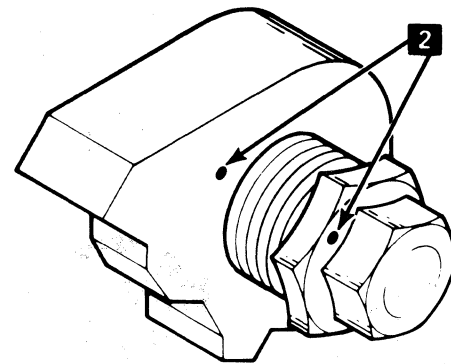
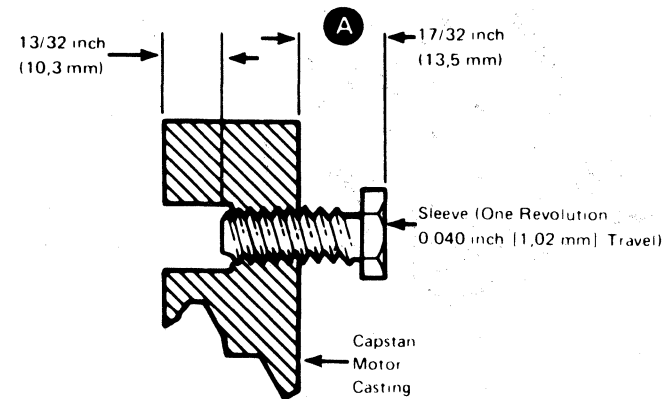
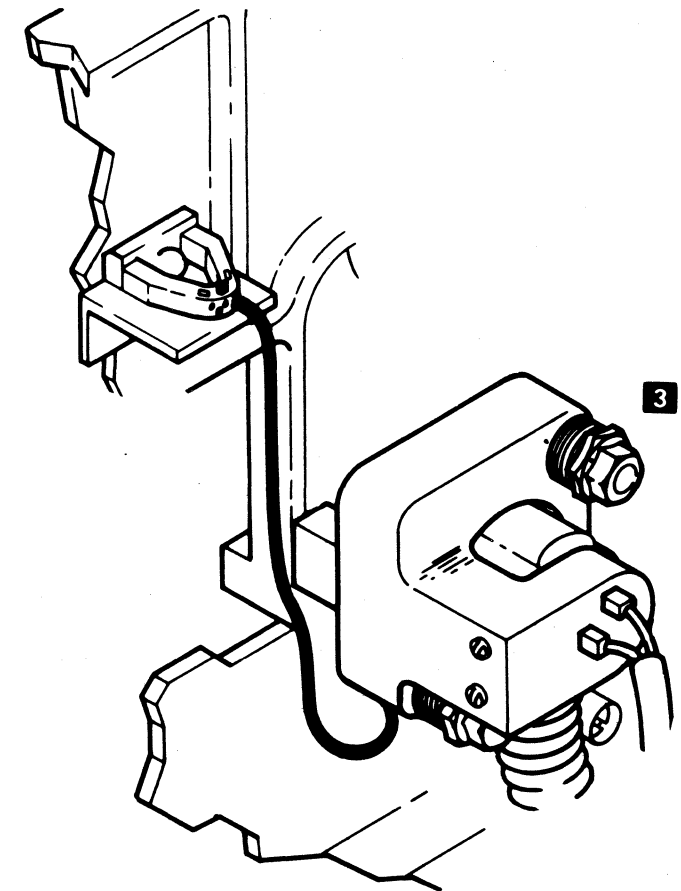
Note: If any sleeve requires more than 135 degrees of rotation, remove the capstan assembly and follow the procedure on 08-062 or 08-064.

3. When all the sleeves are aligned with their casting marks, measure from outside edge of each sleeve to the edge of the capstan casting. Each should measure $17/32 \pm 1/32$ inch (13.5 ± 0.8 mm) **A**; all should be within $1/32$ inch (0.8 mm) of each other. Use a steel scale, P/N 450158 or equivalent to make this measurement.
4. If the previous check is not within specifications, rotate each sleeve, where necessary, to meet this condition.

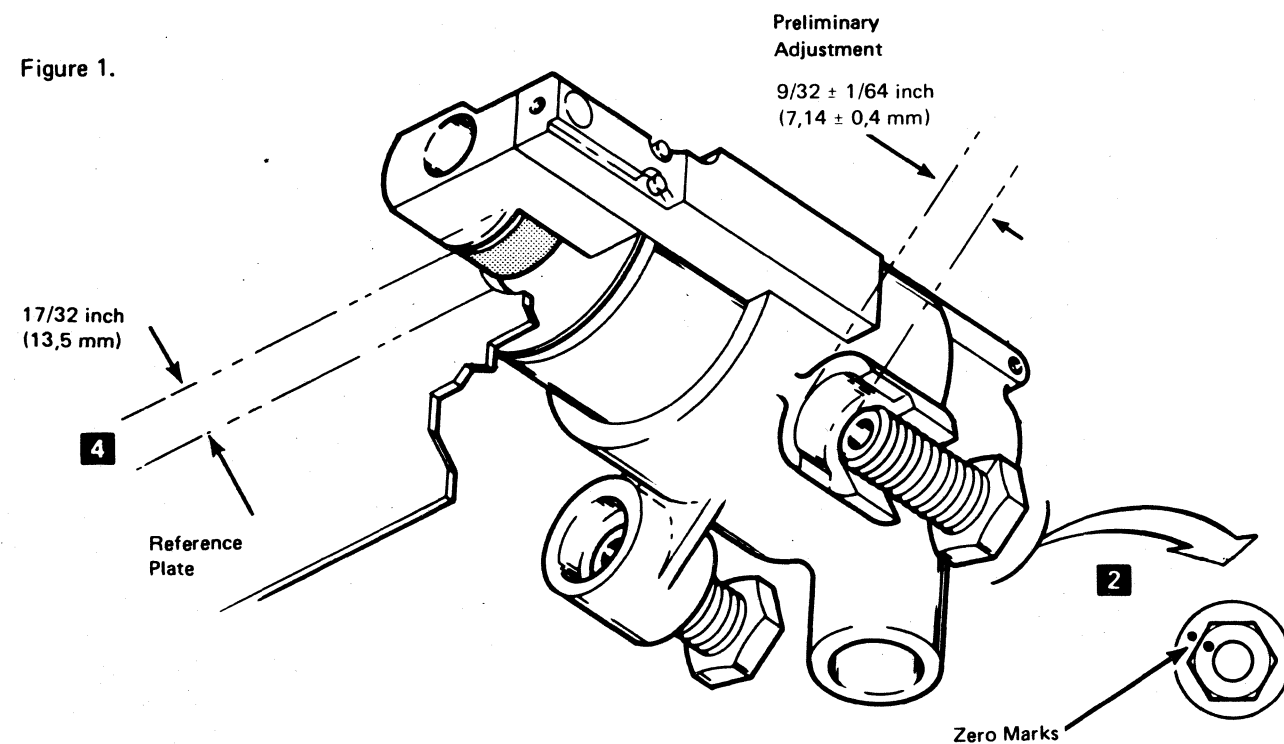
Figure 1.

1. Remove the capstan assembly. See 08-020 or 08-030, "Capstan Assembly Removal."
2. Turn each sleeve until all sleeves measure $3/32 \pm 1/64$ inch (2.38 ± 0.4 mm) from the sleeve tip to the end of the capstan motor casting. Use a steel scale, P/N 450158 or equivalent, to make this measurement.
3. Replace the capstan assembly. See 08-040 or 08-050, "Capstan Assembly Replacement."
4. The front edge of the capstan should be $17/32 \pm 1/64$ inch (13.5 ± 0.4 mm) from the reference plate. If not, rotate all the sleeves until this condition is met.

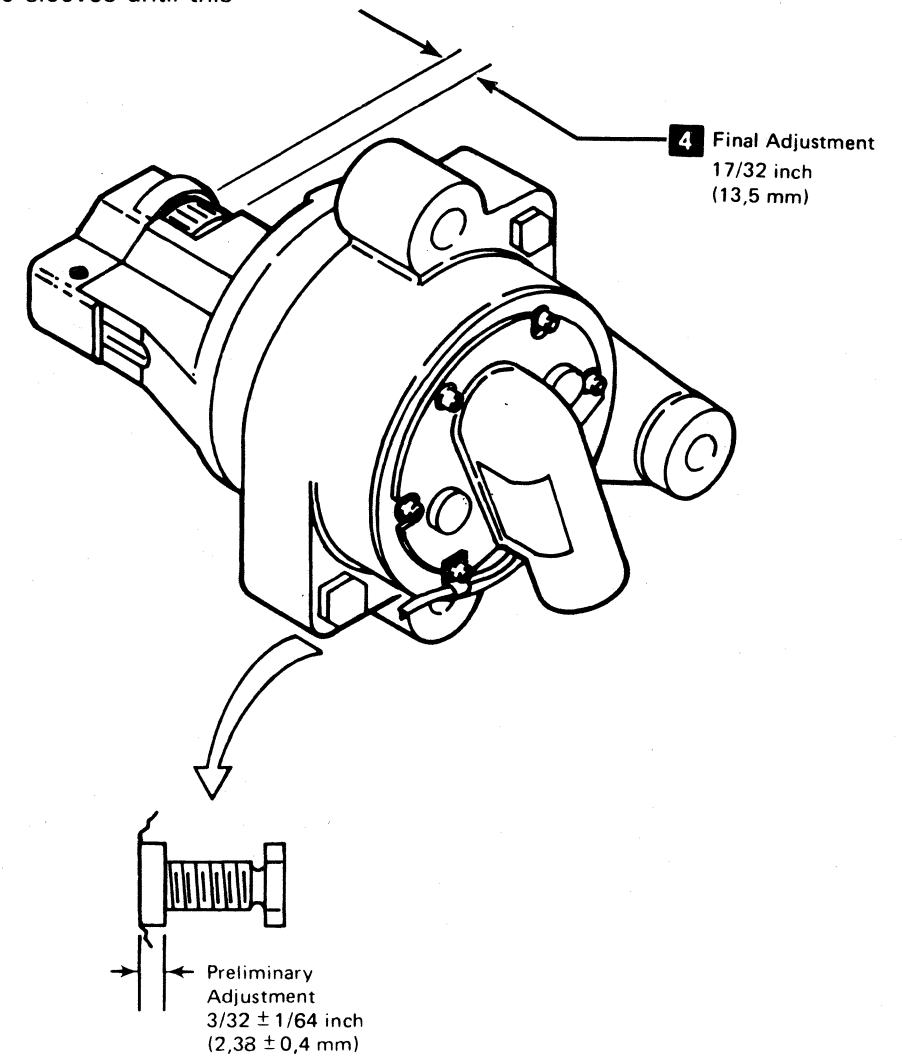
Figure 2.

Model 8 (with Zero Marks, See Figure 2)

Model 8 (without Zero Marks, See Note on Figure 2)

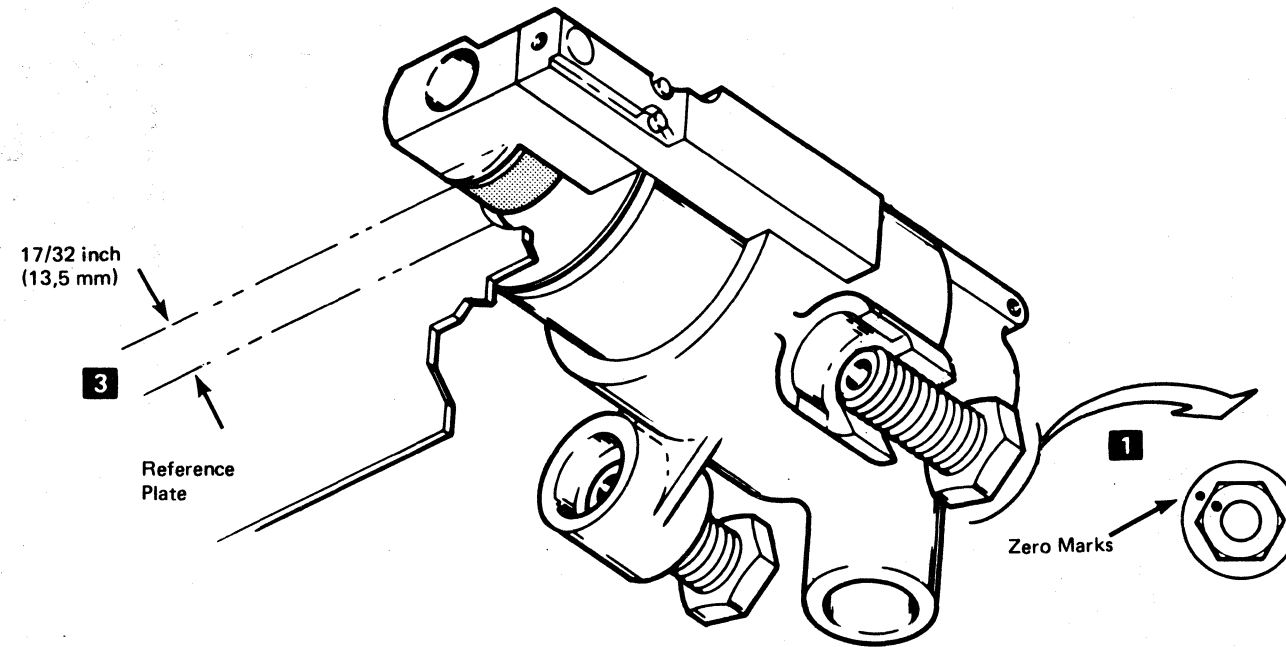
Note: This procedure does not apply to tape unit Model 8 without the zero marks. For tape unit Model 8 without zero marks, use the procedure on 08-068.

- 1 Check the zero mark on each sleeve for alignment with its corresponding casting mark (loosen and partially unscrew the sleeve locking nut if a sleeve mark is obscured).
2. If the zero marks are not aligned, loosen the locking nut and turn the sleeve in the direction that requires the least rotation to align the sleeve and casting marks. **Note:** If any sleeve requires more than 135 degrees of rotation, remove the capstan assembly and follow the procedure on 08-068.
- 3 Check for $17/32 \pm 1/64$ inch (13.5 ± 0.4 mm) from the front surface of the reference plate to the front edge of the capstan. If this dimension is not met or you cannot see seven exposed threads on each sleeve, remove the capstan assembly and follow the procedure on 08-068.

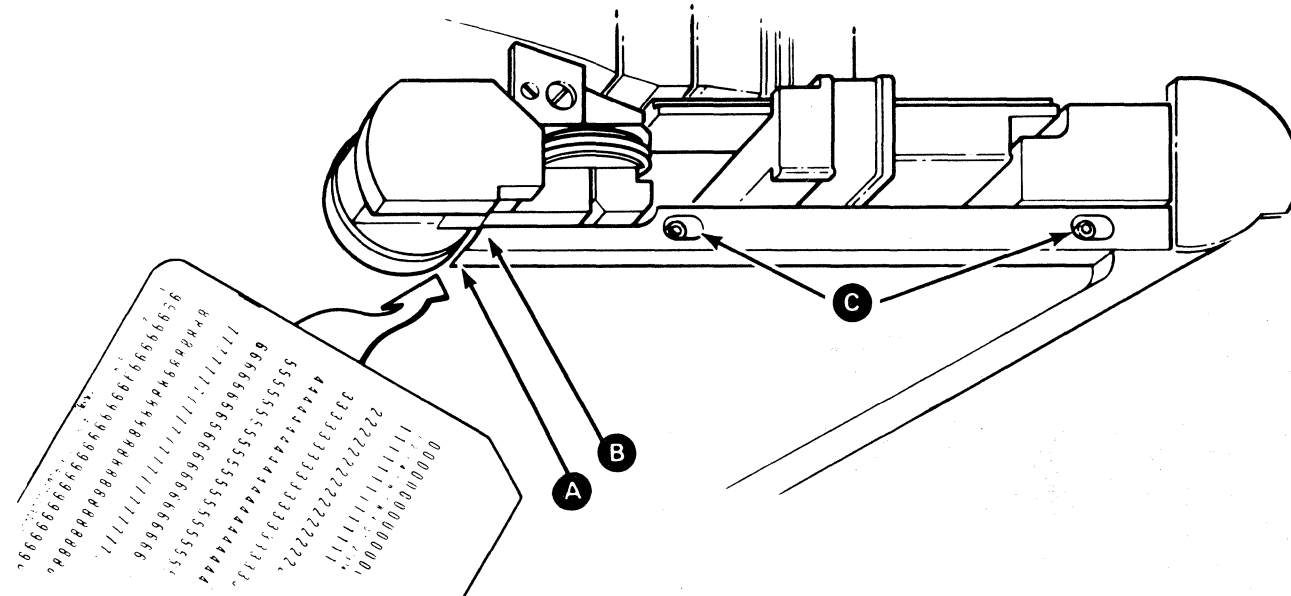
The capstan-to-upper stubby bar clearance must be 0.006 to 0.010 inch (0.15 to 0.25 mm) at both reference points **A** and **B** on the stubby bar, as shown. To adjust, loosen the two screws **C** in the upper stubby bar, position the bar to correct clearance and horizontal, then tighten the screws.

Note: Moving the stubby bar can affect the autocleaner adjustments. See 08-382.

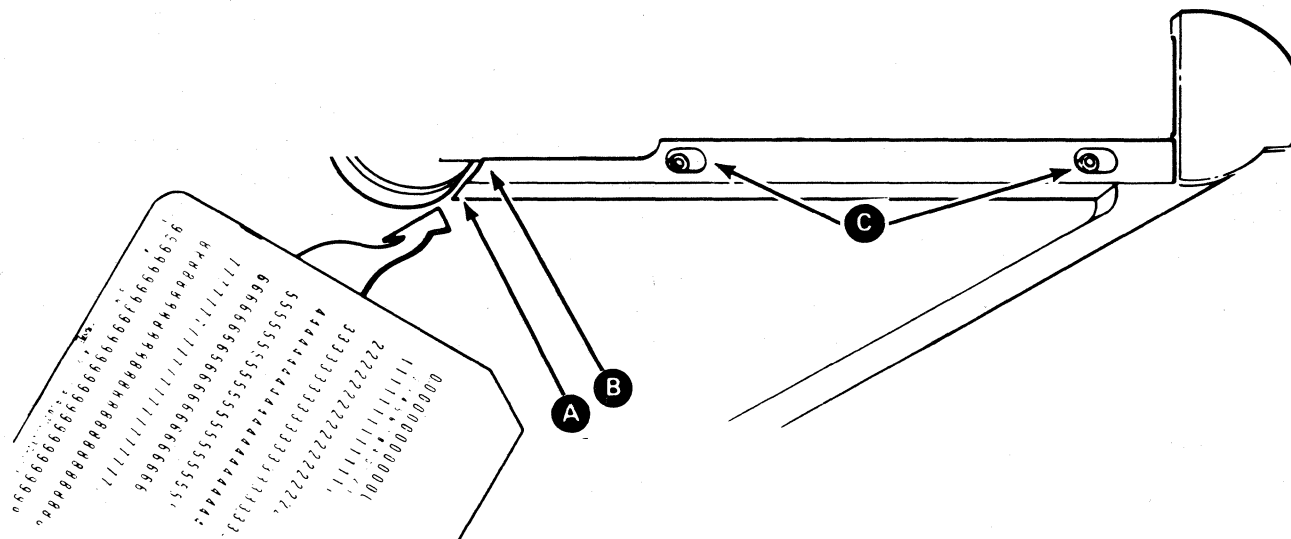
**CAPSTAN-TO-STUBBY BAR CLEARANCE
ADJUSTMENT (TAPE UNIT MODELS
3, 5, 7)**

Caution: To avoid damaging the smooth surface of the tape path, do not use a metal feeler gauge or any other hard object to measure the clearance. One data-processing card, approximately 0.0065 inch (0.165 mm) thick, can be used.

Check that the outside capstan diameter clears the radius of the upper stubby bar by 0.006 to 0.010 inch (0.15 to 0.25 mm) at **A** and **B**. The flip-down mirror must be centered between the capstan and the EOT/BOT block. Loosen the screws **C** on the stubby bar to adjust it.

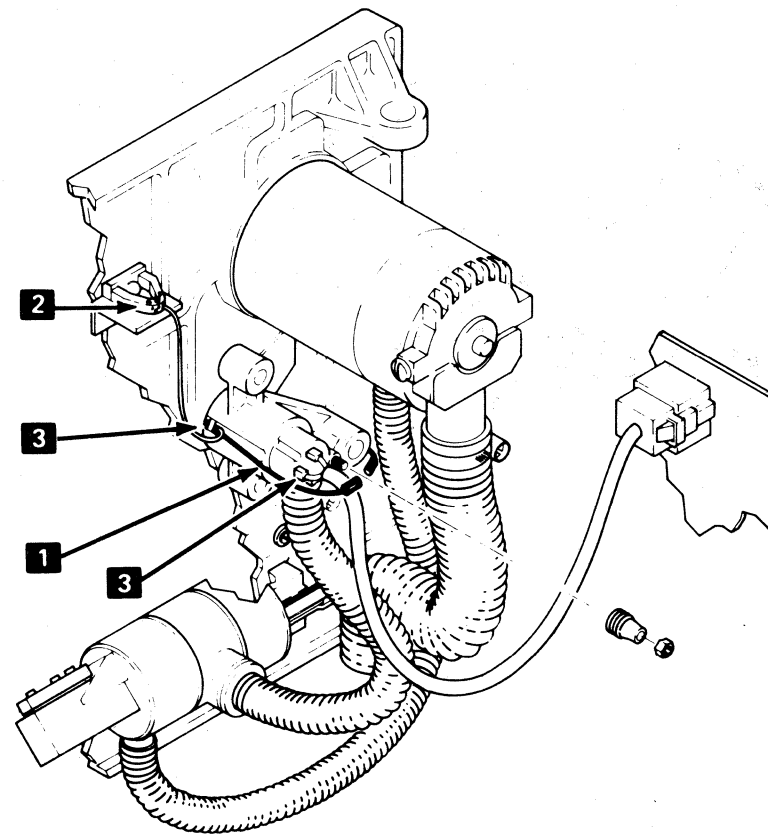
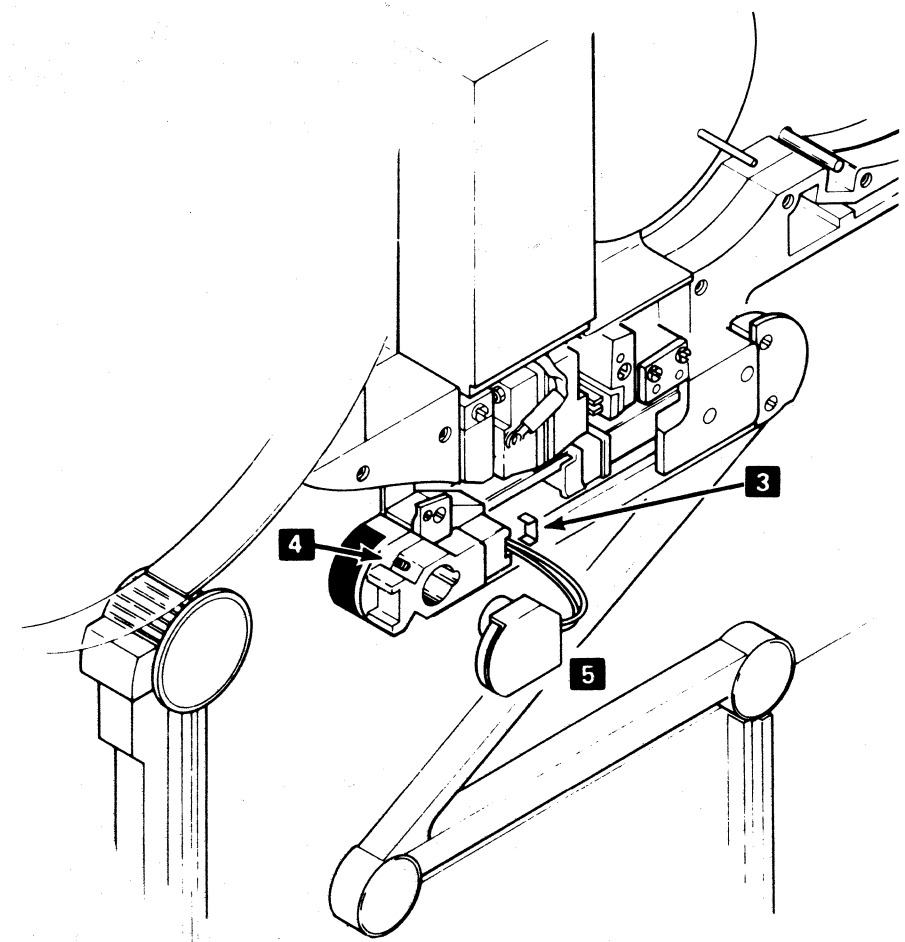
**CAPSTAN TACHOMETER
REMOVAL/REPLACEMENT
(TAPE UNIT MODELS 4 AND 6)**

1. Unplug the tachometer cable.
2. Remove the wedge and disconnect the fiber optic bundle from the light manifold.
3. Loosen the cable clamps at the front and rear of the capstan.
4. Loosen the protruding setscrew on top of the front motor support.
5. Carefully pull the tachometer and fiber optic bundle out of the supporting block.
6. Reverse the procedure to install the tachometer.
7. After installing the tachometer, perform the Capstan Tachometer Check/Adjustment procedure on 08-120.

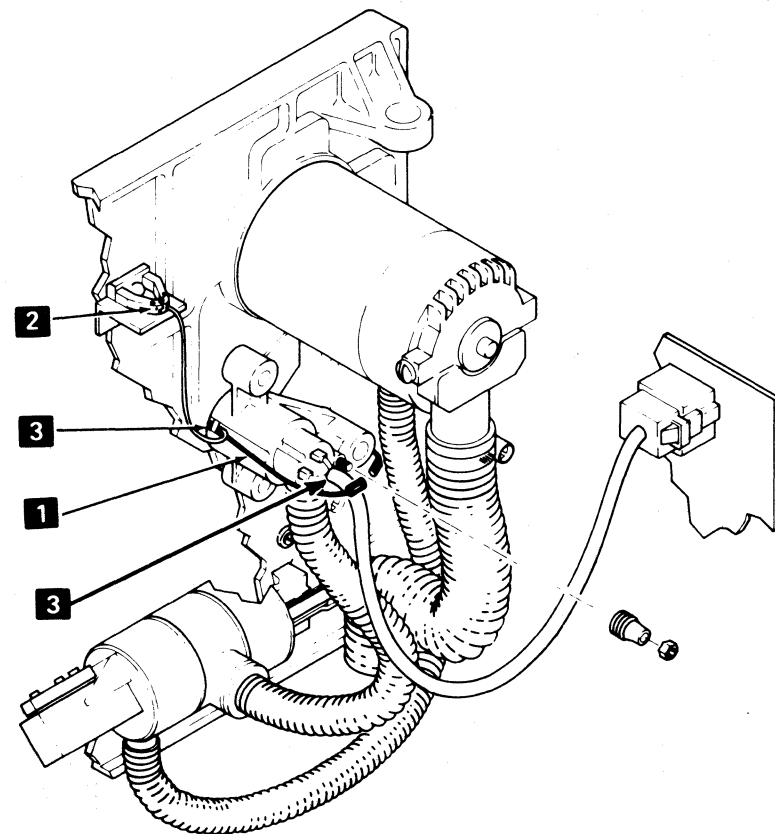
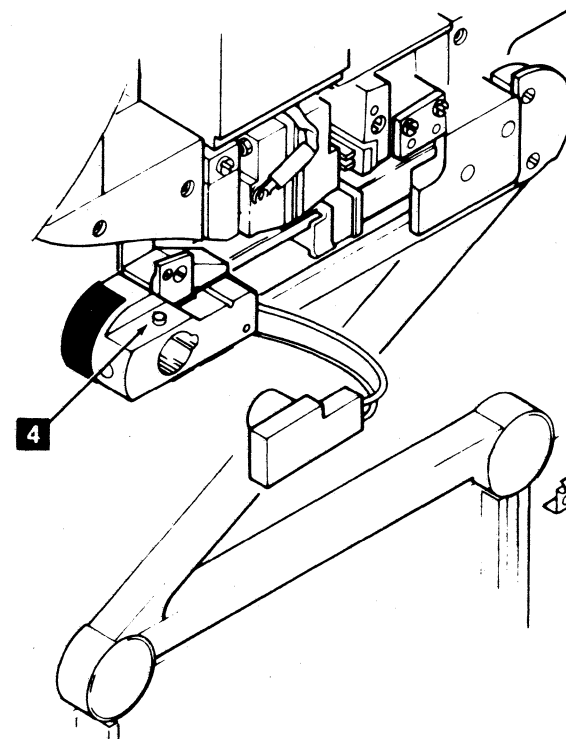
**CAPSTAN TACHOMETER
REMOVAL/REPLACEMENT
(TAPE UNIT MODELS 3, 5, 7)**

- 1 Unplug the tachometer cable.
- 2 Remove the wedge securing the tachometer fiber optic bundle to the light manifold; then remove the fiber optic bundle.
- 3 Loosen the cable clamps at the front and rear of the capstan. Remove the cable strap on the side of the motor.
- 4 Loosen the protruding set screw above the front motor support.
- 5 Carefully pull the tachometer and fiber optic bundle out of the supporting block.
- 6 Reverse the procedure to install the tachometer.
- 7 After installing the tachometer, perform the Capstan Tachometer Check/Adjustment procedure on 08-130.

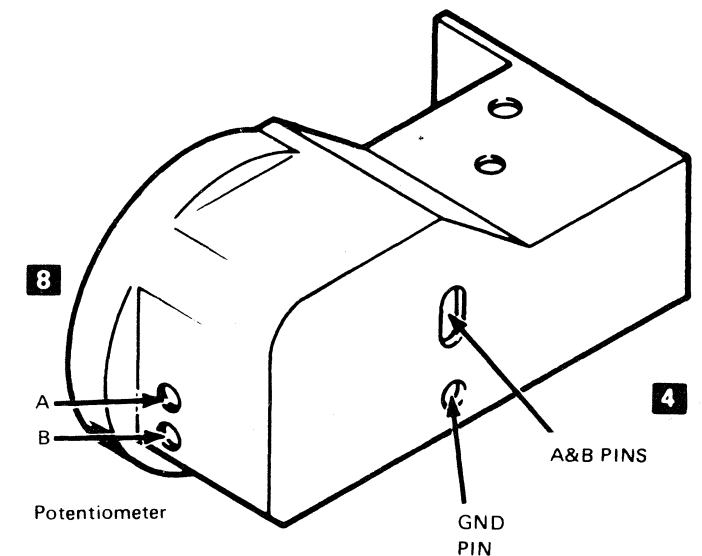
Model 8 Capstan

Note: If the waterfall is greater than 10%, remove the capstan tach and clean as instructed on 08-140.

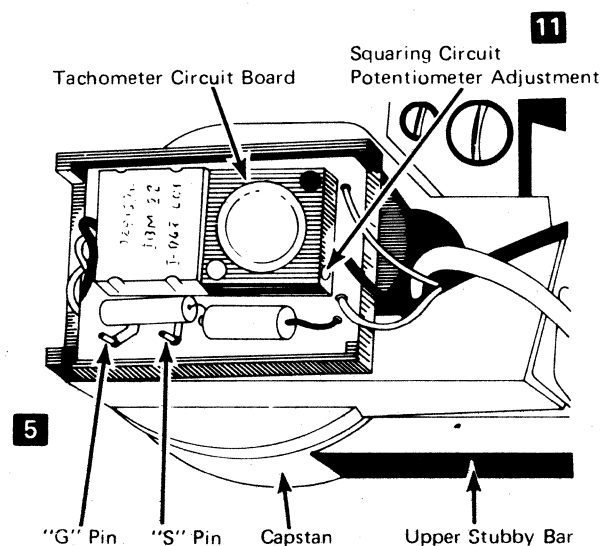
Note: If waterfall **A** is excessive, 10% of a full cycle or greater, remove the capstan tachometer and clean the tachometer disk and interrupter mask, following the procedure on 08-140.

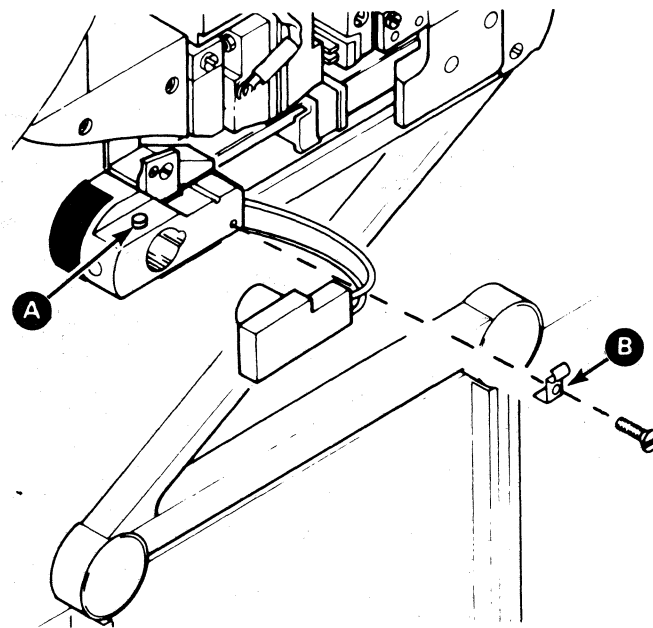
Model 3,5,7

4. Replace the tachometer by reversing the procedure in step 1.
5. Repeat the Capstan Tachometer Check/Adjustment procedure on 08-120 or 08-130.

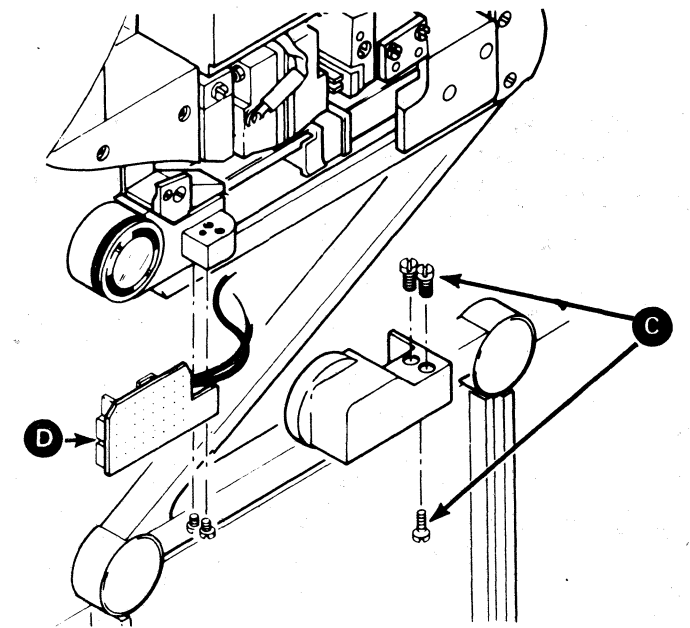
Model 8

Note: Tach block shown removed **D** for illustration only.

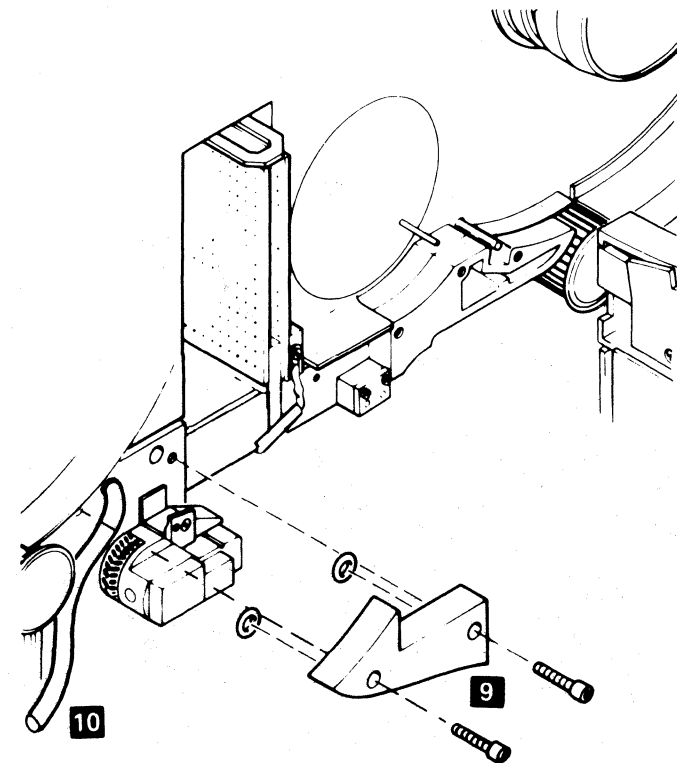
Caution: Do not lose the two O-rings located behind the threading channel.

10. On NRZI-featured tape units, remove the small hose attached to the threading channel. Allow 3 to 5 inches (76 to 127 mm) of hose to extend beyond the reference plate. If the hose falls out of the reference plate, it may be necessary to remove the capstan motor to reinstall it.

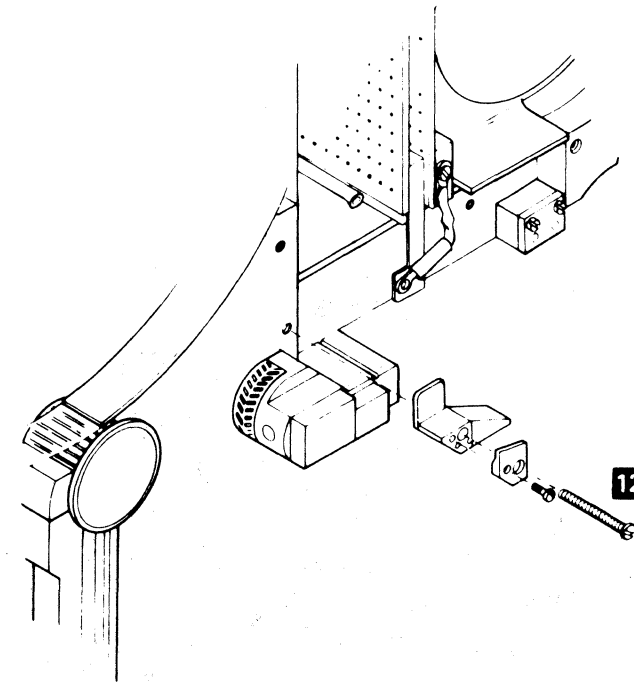
12. Remove the screws holding the front guide to the ramp and the large screw that holds the ramp to the reference plate. Remove the front guide.

Caution: Do not lose the spring behind the rear guide. (in NRZI-featured tape units only.)

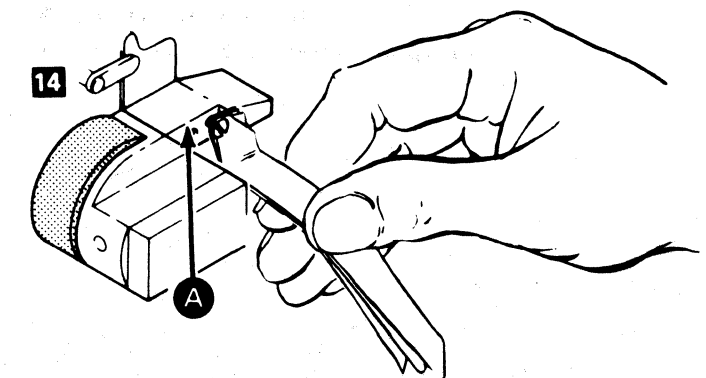
14. On NRZI-featured tape units, retract the rear movable guide, using the retracting clip on the tape unit, P/N 2522983.

Note: The guide must retract completely behind the reference plate. Shape the retracting clip if necessary.

Caution: Do not allow the screw head to touch the tape. If necessary, fold a tab card several times and place it next to the screw head as shown (A) to prevent screw-head-to-ramp contact and damage to the reference plate.

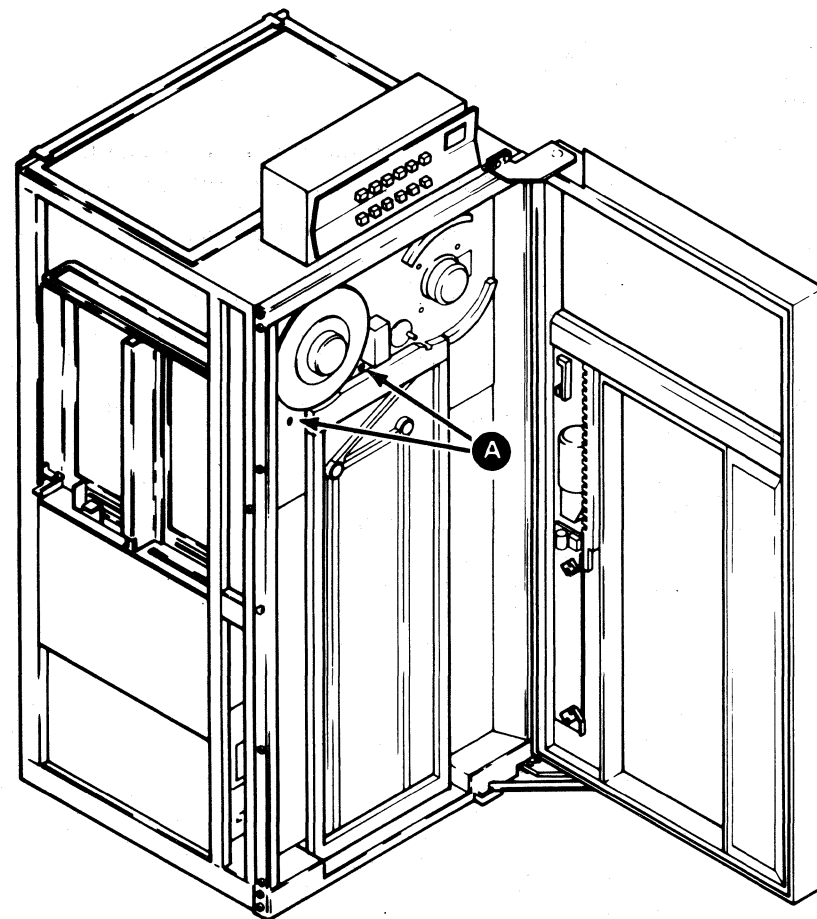
To check dynamic tracking at the left carbide guide:

18. Set the field tester to read forward.
19. With tape moving forward, turn the left adjuster **A** until the ramp surface **B** is just visible. Turn the adjuster clockwise to cause the tape to track toward the rear of the machine, or counterclockwise to cause the tape to track toward the front of the machine.

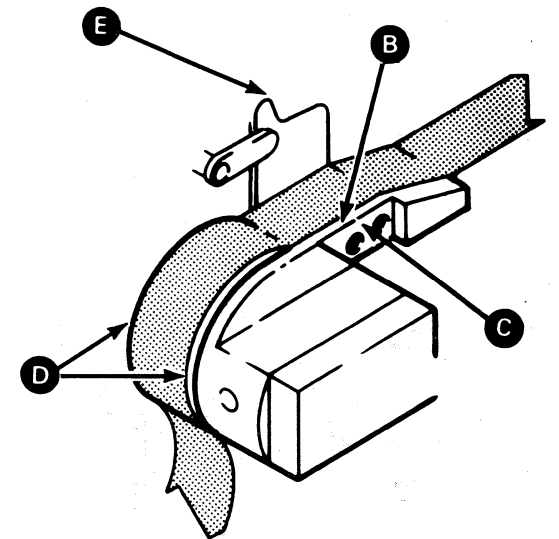
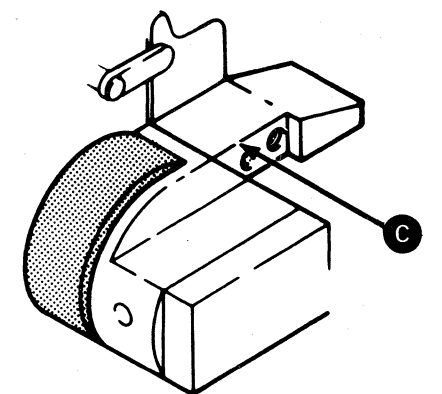
20. Set the field tester to read backward.
21. With tape moving backward, turn the upper adjuster to obtain a slight clearance **B**.
22. Set the field tester to read forward.
23. With tape moving forward, turn the left adjuster counterclockwise until the front edge of the tape rides exactly on the front edge of the ramp **C**.
24. Set the field tester to read backward.
25. With tape moving backward, turn the upper adjuster clockwise until the front edge of the tape rides exactly on the front edge of the ramp **C**.
26. Repeat steps 22 through 25 until the tape rides evenly on the ramp edge **C** when the tape is moving in either direction.
27. Turn both adjusters clockwise until the tape has a slight clearance **B** with the tape moving in either direction.

Note: A slight clearance at the reference plate and front of ramp **B** and no front-to-back movement indicates correct tracking. Verify that some capstan rubber is visible **D** at each edge of the tape.

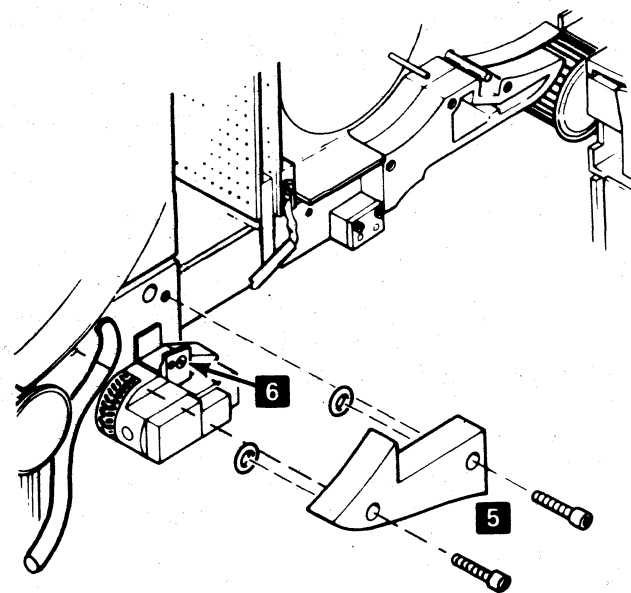
1. Switch tape unit offline.
2. Attach the 3420 field tester.
3. Load an undamaged CE work tape, set the field tester to read forward, and move the tape forward until the load-point sticker is past the BOT/EOT block.
4. Turn tape unit power off.
5. Remove the left threading channel and left threading plate on the vacuum column door so that you can observe the tape while making adjustments. Remove the rubber door spacer behind the threading plate, if necessary.

Caution: Do not lose the two O-rings located behind the threading channel.

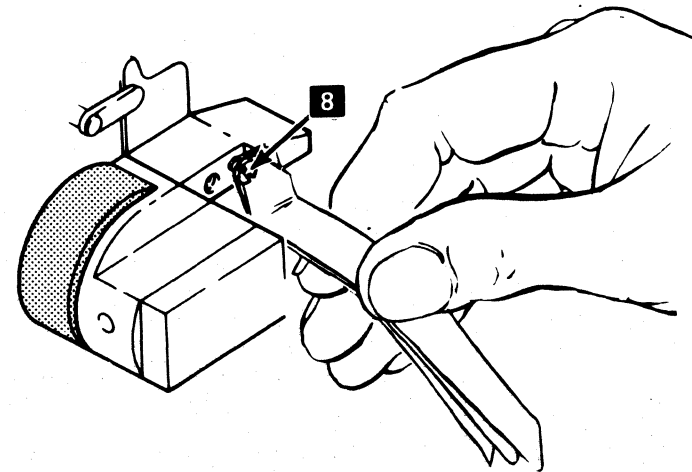
6. Remove one short and one long screw from the front of the carbide guide.
7. Remove the front carbide guide and threading ramp.
8. Use the long screw to fasten the threading ramp to the reference plate. Press down on the right side of the ramp for correct positioning. If a binder head screw is used, replace it with a flat-head screw to eliminate interference while setting the tracking, or place a folded tab card between the existing binder head screw and the ramp. A size 6 nut can also be used.

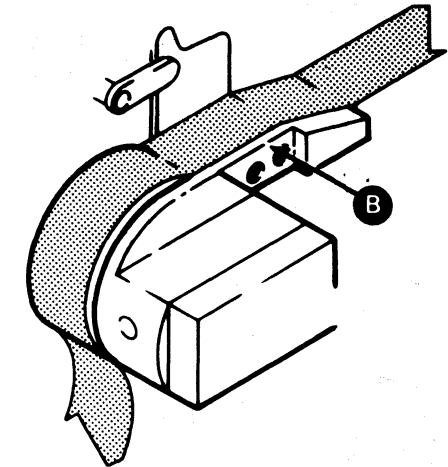
Note: A slight clearance at the reference plate and front of ramp B and no front-to-back movement indicates correct tracking.

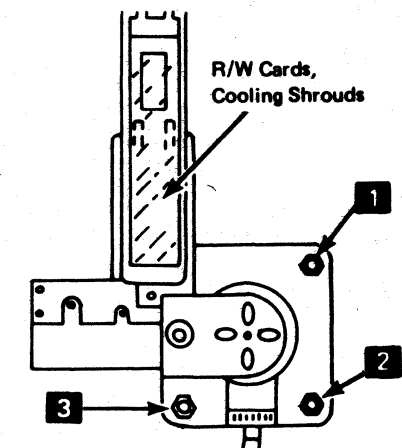
24. After adjustment, lightly tighten the three locking nuts and check the capstan for binds. When the capstan is free of binds, tighten all three locking nuts.

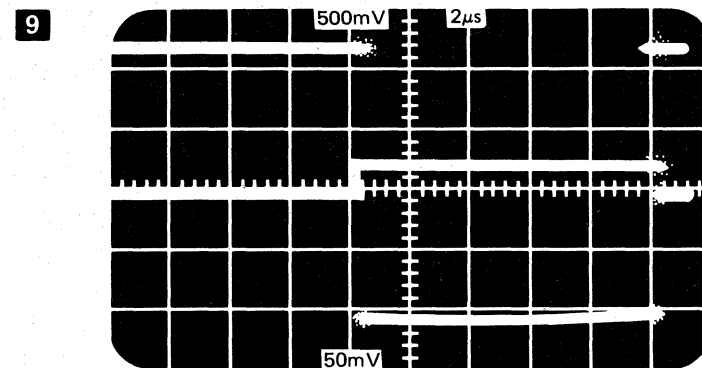
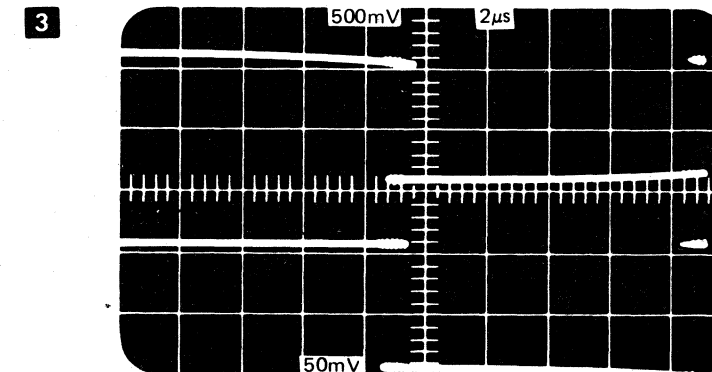
11. Repeat steps 8 through 10 until the specification in step 10 is met.
12. Perform the Capstan-to-Stubby Bar Clearance Adjustment procedure on 08-080.

Caution: Attach the cooling hose to the read/write card shroud and remove the jumper installed.

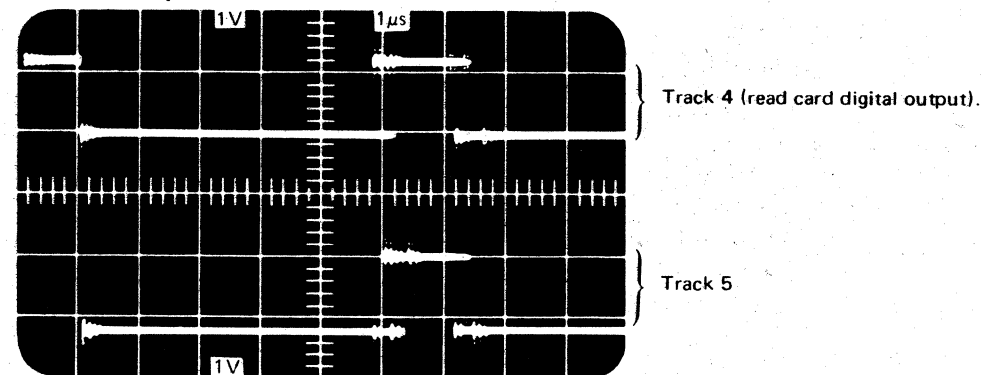
Typical Scope Presentation of Skew

11. If the skew exceeds the limits, repeat the Capstan Dynamic Alignment procedure on 08-150.
12. If the skew is within the limits, adjust the head skew plate until the outside track signal either leads or lags the inside track signal by the same amount when going forward or backward. Track 4 is inside, track 5 is outside, on 9-track tape units. Track P is inside, track 7 is outside, on 7-track tape units.
13. At the completion of the mechanical skew adjustment in NRZI mode, ensure that the analog sine waves for all tracks coincide at the read-card test points (left side).
14. Check the capstan-to-stubby bar clearance. See 08-080, "Capstan To Stubby Bar Clearance Adjustment."
15. Check the read and write electrical skew. See 08-190, "Read Electrical Skew Adjustment" and 08-200, "Write Electrical Skew Adjustment."

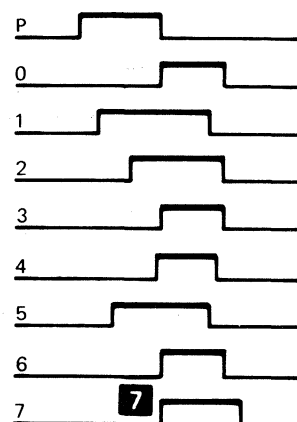
BEFORE

9. Adjust each remaining track's pulse width until the negative transition (trailing edge) lines up with the trailing edge of the pulse adjusted in step 8.
10. Set the tester to read backward continuously.
11. Change the scope sync to negative.
12. Repeat steps 5 through 9 adjusting the backward potentiometer.
13. Check the write electrical skew. See 08-200, "Write Electrical Skew Adjustment."

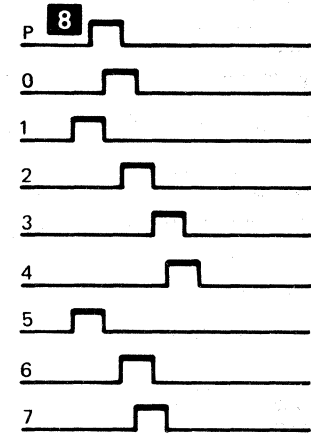
BEFORE

9. Adjust each track's write deskew potentiometer until the negative transition (trailing edge) lines up with the negative transition of the most lagging track (step 8.)
