IBM Maintenance Library

Magnetic Tape Subsystem Maintenance Manual

3803-2/3420

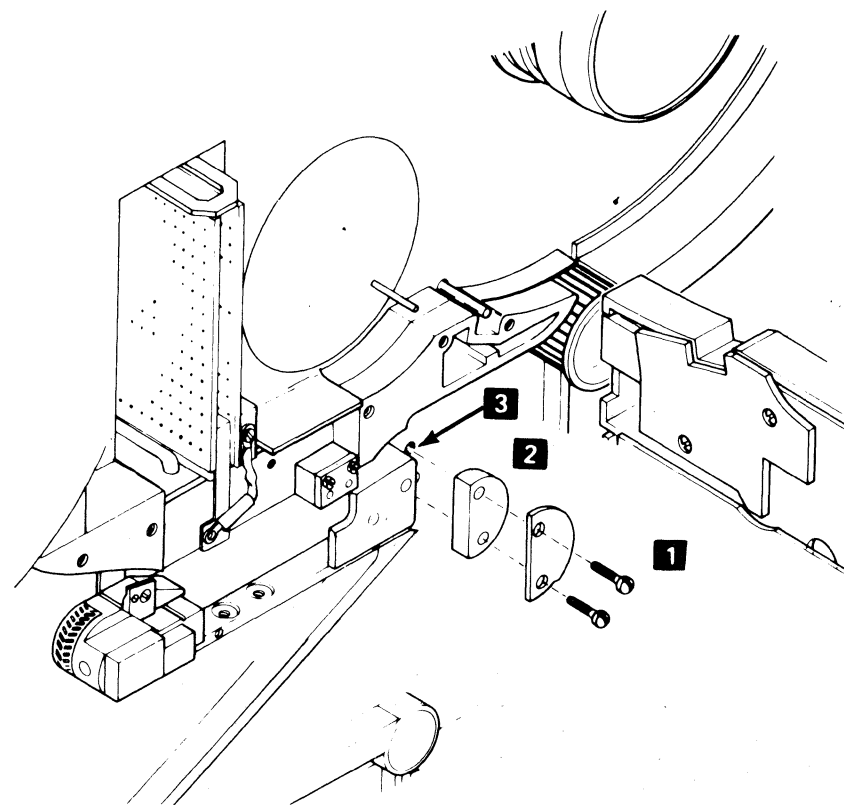
**D-BEARING, RIGHT REAR MOVABLE
GUIDE
AND RETRACTOR
REMOVAL/REPLACEMENT —
(NRZI-FEATURED TAPE UNITS)**

4. Disconnect the air-pressure hose from the retractor.
5. From the rear, remove the three screws that hold the retractor to the plenum cover and take out the retractor.
6. Reverse the procedure to replace the retractor and right rear movable guide.

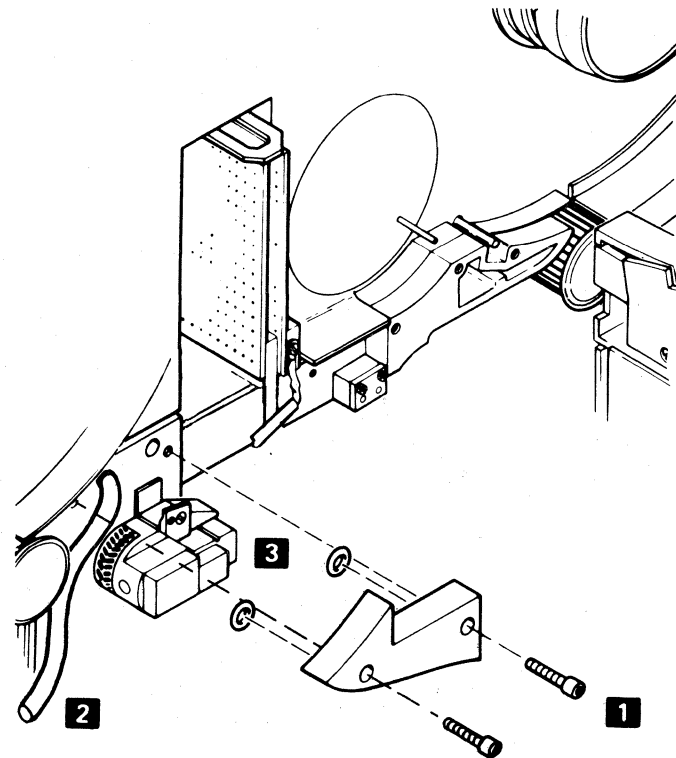
**LEFT MOVABLE GUIDE AND RETRACTOR
REMOVAL/REPLACEMENT
(NRZI-FEATURED TAPE UNITS)**

1 Remove the two screws that hold the left threading channel to the reference plate.

4. Remove the solid guide, movable rear guide, and spring.

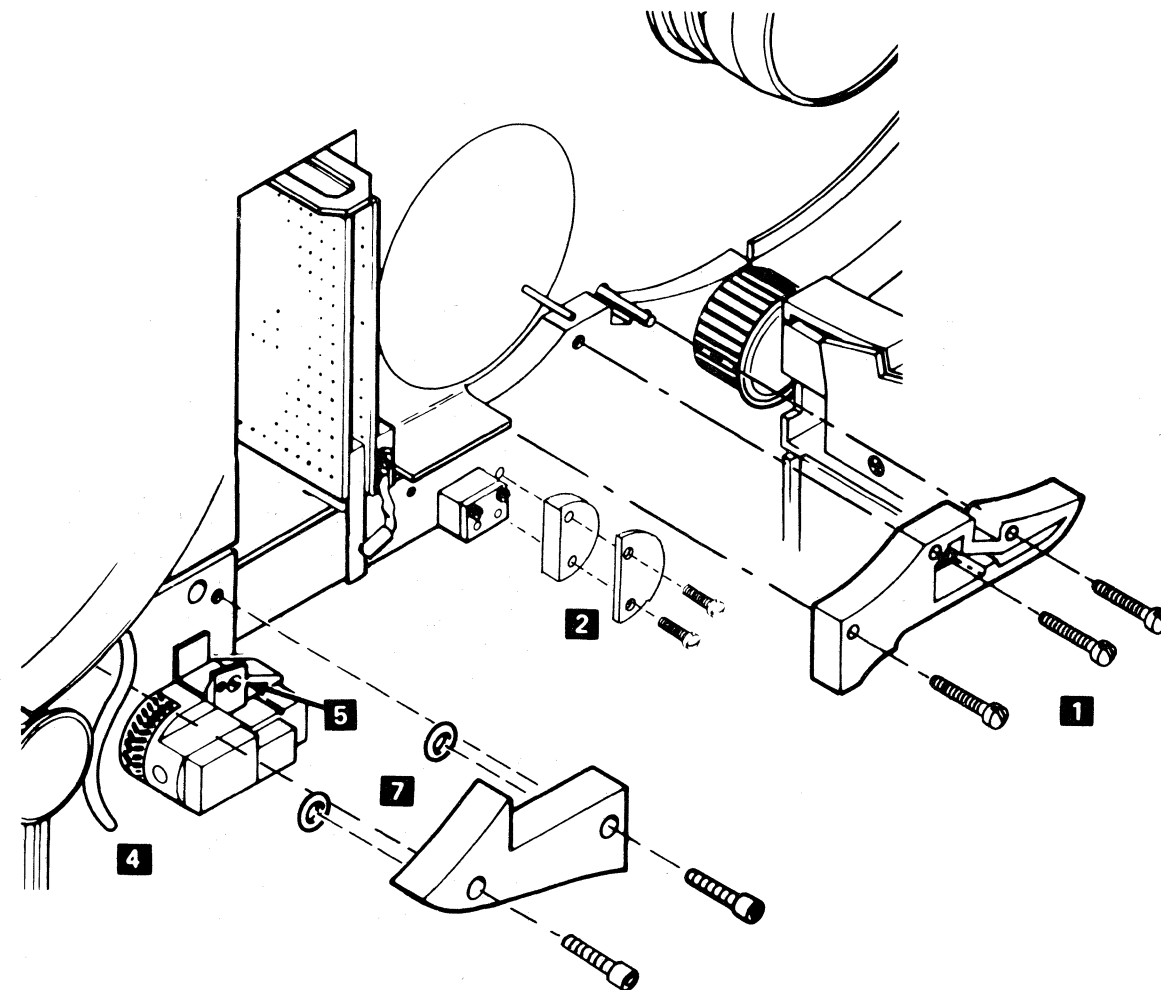
- 1** Remove the three screws that hold the right threading channel to the reference plate.
- 2** Clean the oxide deposits from the D-bearing, front flange, rear movable guide, and recessed area around the rear guide.
3. Inspect the flange and guide for wear and replace if the grooves are visible on their surfaces.
- 4** **Caution: Do not lose the two O-rings located behind the threading channel.**

- 5** Clean the oxide deposits from the left front guide, left rear movable guide, and the recessed area around the rear guide.
6. Check that the right and left rear guides move freely.
- 7** Reinstall the threading channels. Ensure that the two O-rings are in position behind the left threading channel.

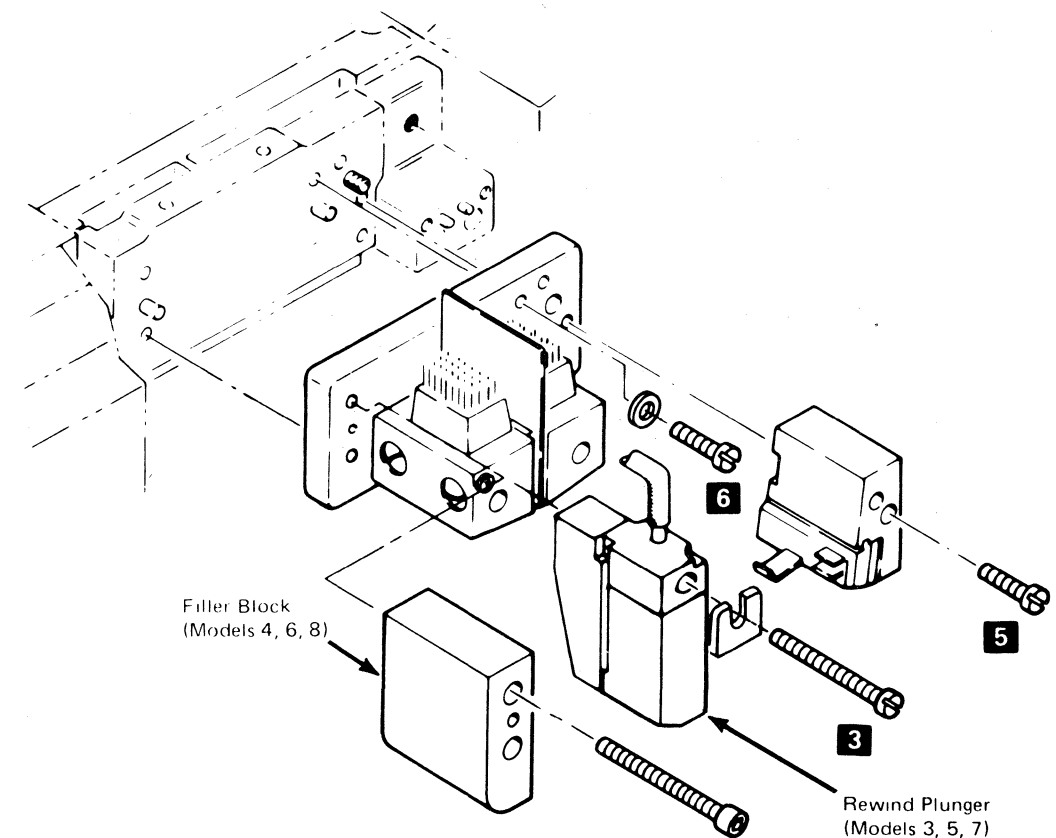
1. Turn off tape unit power.
2. Remove the front read/write card cover by pulling it straight out.
3. Remove the two mounting screws, disconnect the hose, and remove the filler block (Models 4, 6, and 8), or the rewind plunger (Models 3, 5, and 7).
4. Unplug the read/write cards from the head. See 08-260, "Read/Write Head Card Removal/Replacement."
5. Remove the nylon screw that holds the erase head to the mounting plate. Carefully pull out the erase head without damaging the wires. Care must be taken not to damage the cable while unsoldering the leads.

7. Carefully pull the head and mounting-plate assembly straight out. (If the locating pins bind, rock the assembly to loosen.)

Caution: Do not loosen or remove the eight skew-plate screws, as this causes the factory-set read/write head wrap angle to be changed.

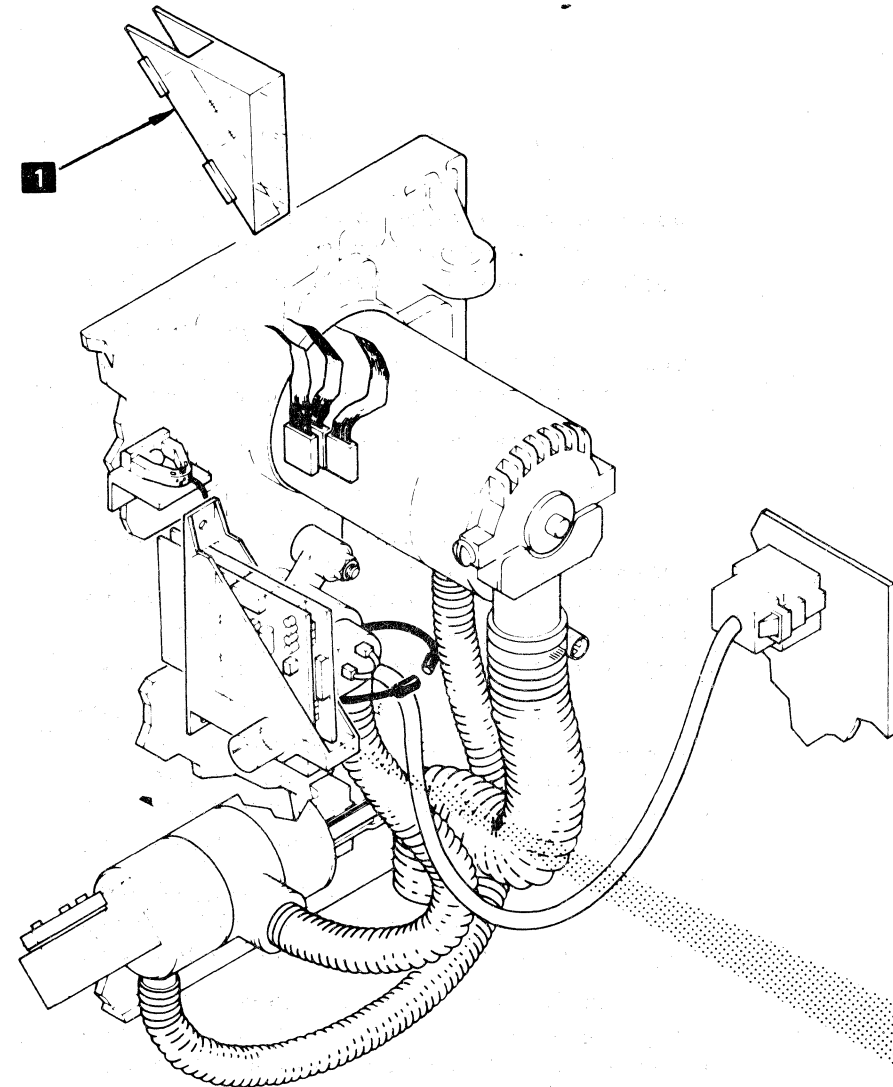
- 1 From the rear of the unit, unsnap the upper half of the read/write card cooling shroud.
- 2 From the rear of the unit, unplug the cable(s) from the top of the card being replaced. (Models 4, 6, and 8 have two cable plugs on the read card, Y and Z, and one on the write card J-3.) (Models 3, 5, and 7 have J3 and J1 cables only.)
- 3 From the front of the unit, remove the decorative head cover.
- 4 Disconnect the write card ground strap from the front of the read/write head.
- 5 Unplug the card while holding the socket with one hand, pull the front edge of the card straight up with your other hand, rocking gently to loosen.

- 8 Before installing a new write head card on Model 4, 6, or 8, perform the Write Head Driver Card Plugging procedure on 08-270.
- 9 After installing a new read head card on Model 3, 5, or 7, perform the Amp Sensor Adjustment procedure on 08-290 or 08-300.
- 10 After installing a new read head card on Model 4, 6, or 8, perform the Read Amplitude Adjustment procedure on 08-310.
- 11 After installing a new write head card in any model, the verify amplitude or amp sensor adjustments on 08-290, 08-300, and 08-310.

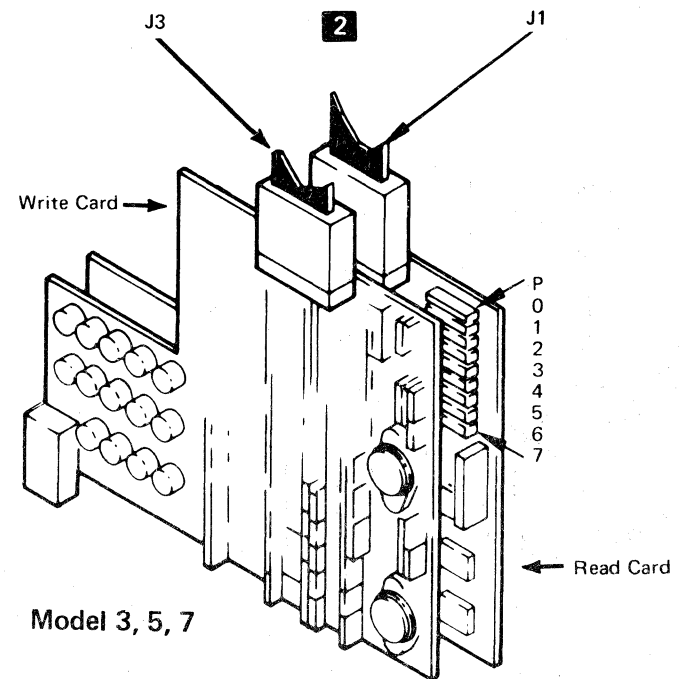
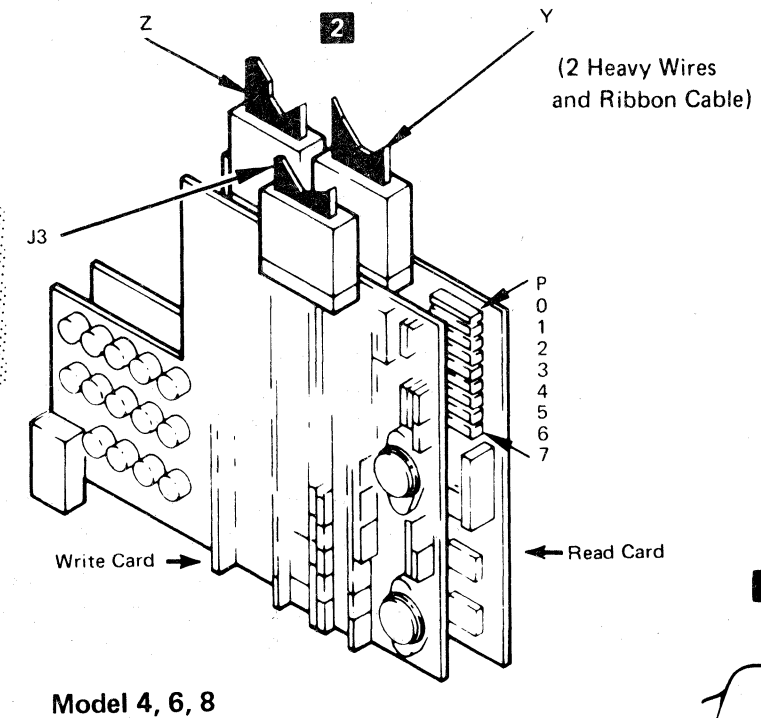
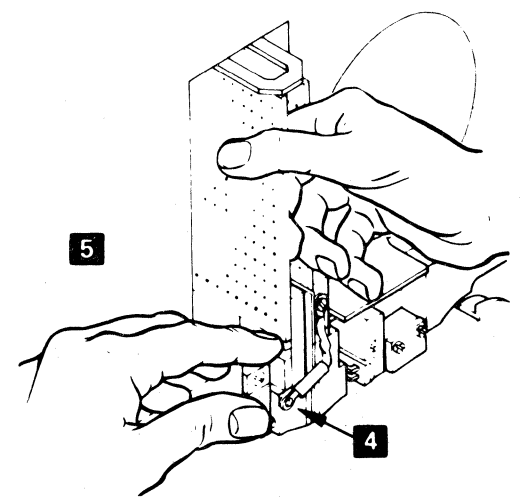
- 12 After replacing the write card, shape the ground strap in such a manner that the resultant forces are in a downward direction 4.
- 13 The cooling shroud reduces overheating of the read and write head cards. Ensure that the cooling shroud is reinstalled after working in this area.

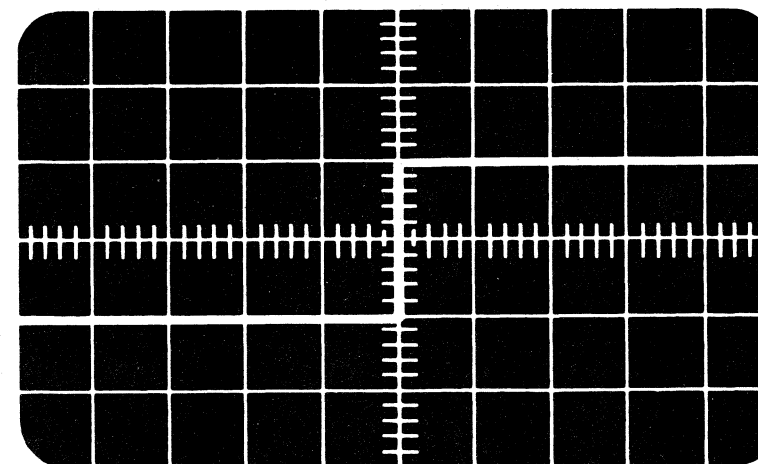
Figure B

Note: If digital data does not exist, turn the read card potentiometer until a good solid signal is obtained, as shown in Figure B.
5. Using an uncalibrated (variable) horizontal sweep, adjust the scope so that one complete cycle is displayed, as shown in Figure B.
6. Locate the correct potentiometer on the read card for the track you are adjusting. See the label on the card cover.
7. Turn the potentiometer counterclockwise while observing the negative pulse until a dim trace exists, as shown in Figure A.
8. Then, turn the potentiometer slightly clockwise until you have a solid digital data pulse, as shown in Figure B.
9. Repeat steps 4 through 8 for each track.
10. Remove the attenuator card, field tester, and the jumpers if used.

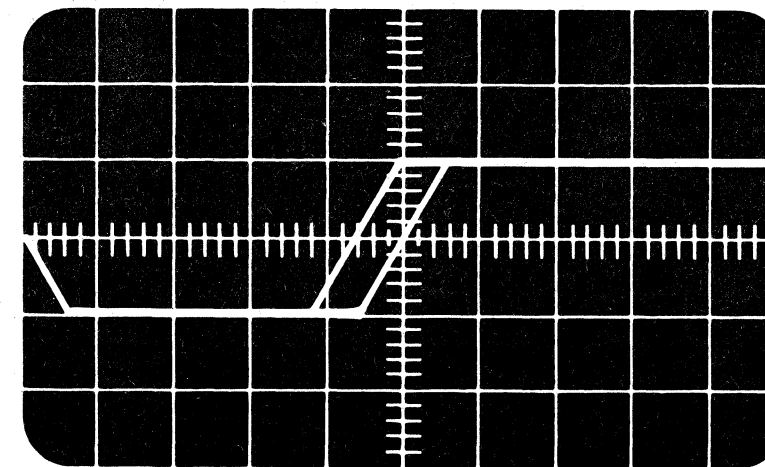
Figure B

Note: If a double trace at the positive transition is apparent, as shown in Figure B, use the outermost transition to obtain the 5 cm negative pulse width.
6. Locate the correct potentiometer on the read card for the track you are adjusting. See the label on the card cover.
7. Turn the potentiometer until the leading edge of the positive-transition waterfall starts 4 cm from the midpoint of the negative transition, as shown in Figure C.

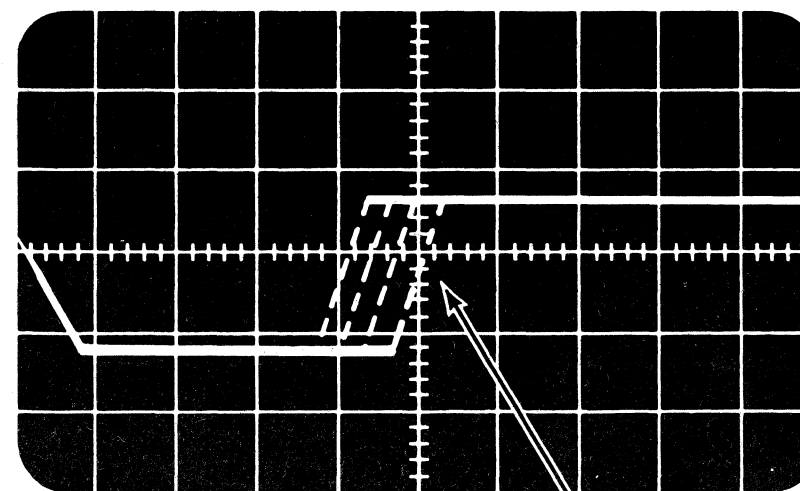
Figure C

Note: An occasional trace before 4 cm is acceptable when the adjustment is completed.
8. Repeat steps 4 through 7 for each track.
9. Remove the attenuator card, field tester, and the jumpers if used.

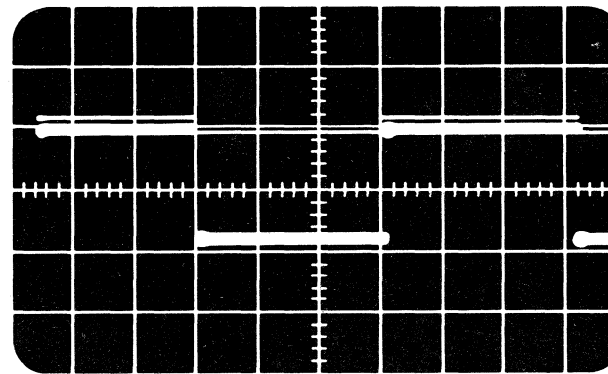
Figure 1. Read Amplitude Signal

1. Only the track 1 potentiometer (test point T-A1N3B07) is present on a 6250 bpi card.
2. Digital read signals for 1600 and 6250 bpi are:

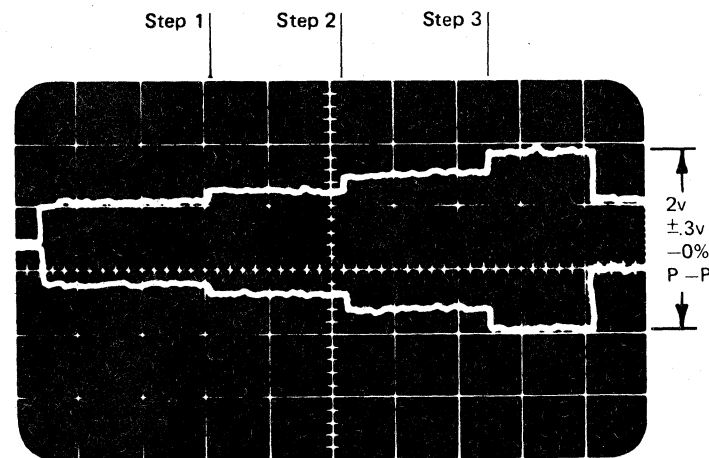
Ⓐ. The SAGC setup must be completed in 14 or less steps on all tracks while writing. If the setup in any track exceeds 14 steps, check: (If the SAGC sets up in less than two steps, replace the read/write head)

1. Read head card
2. Vacuum level for low vacuum
3. Write head card
4. Read/write head
5. Capstan tracking

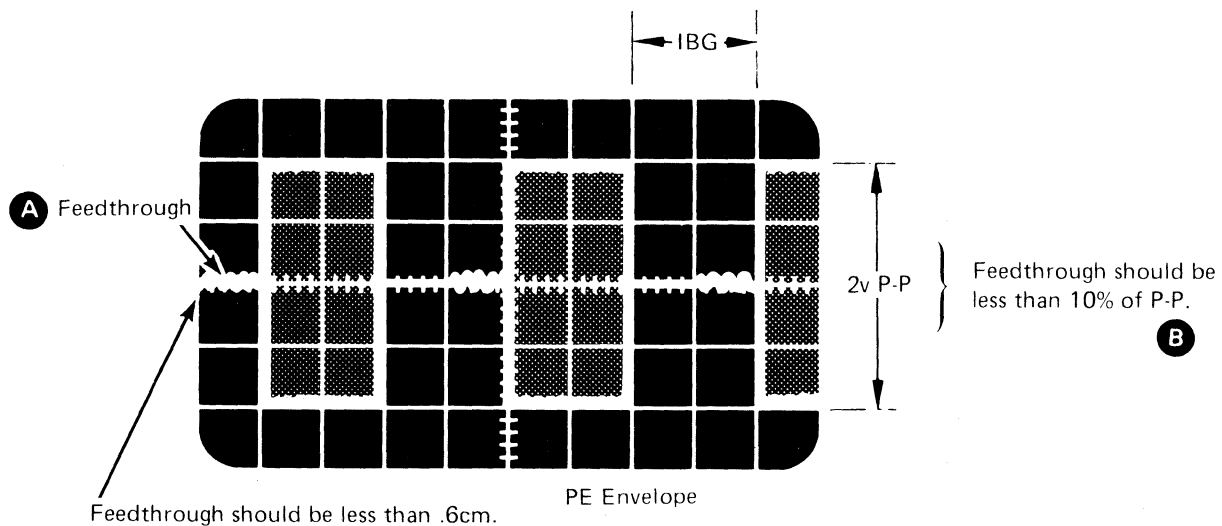
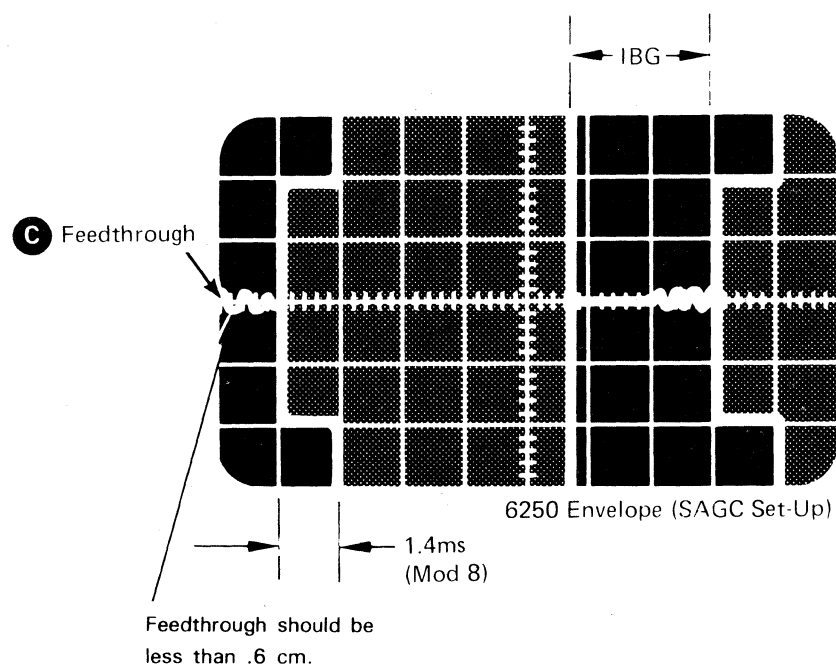
Note: The feedthrough signal precedes the record by 2.0 ms on Models 3 and 4; 1.2 ms on Models 5 and 6; and 750 usec on Models 7 and 8.

7. Replace the read/write head on a Model 3, 5 or 7 if the feedthrough **A** exceeds 10% **B** of the read signal. For a Model 4, 6 or 8 tape unit, set the amplitude of the first SAGC step to 4 cm. Replace the read/write head if the feedthrough **C** amplitude is greater than 0.6 cm (7% of the total read signal).
8. Remove jumper T-A1M2D06 to T-A1K2P02 installed in step 4b.

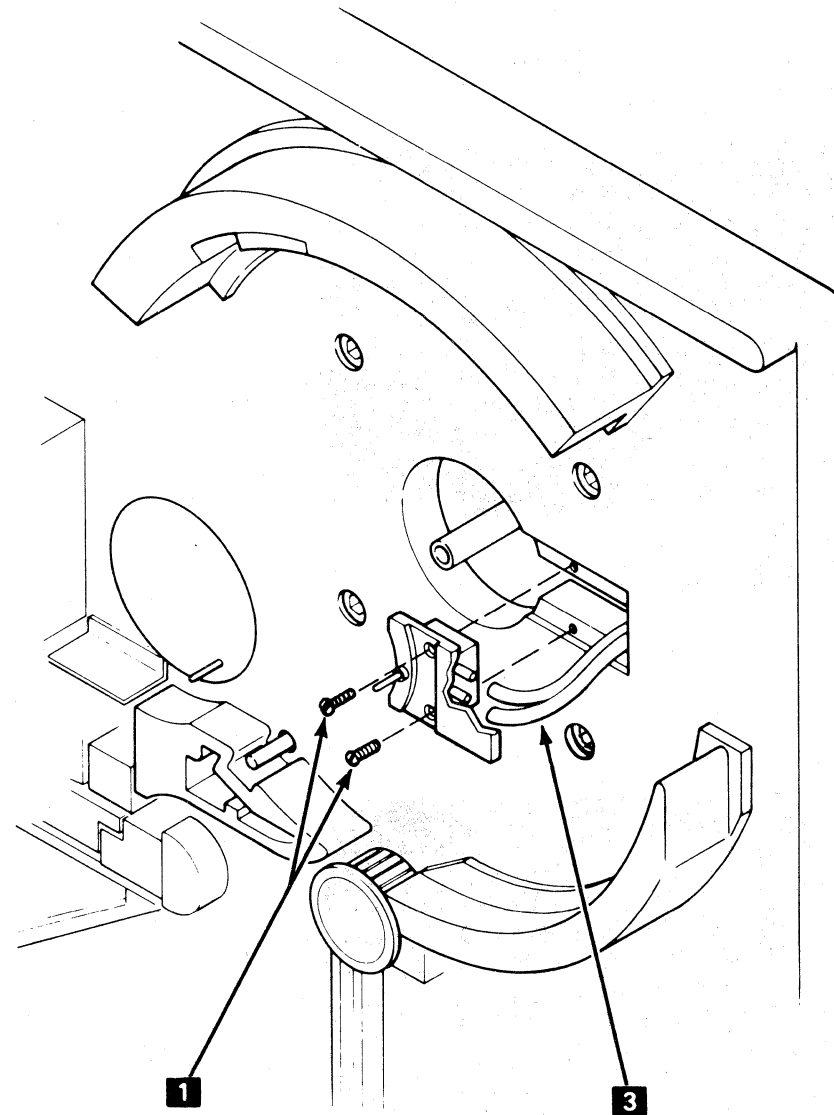
Do not lubricate any part of the file-protect mechanism. If the assembly does not operate correctly because the plunger is binding, replace as follows:

Note 1: Identify the hoses (mark) before removing them. Replace the hoses in the same location.

Note 2: It may be necessary to trim the end of the hoses to ensure that they have a good seal when reinstalling them.

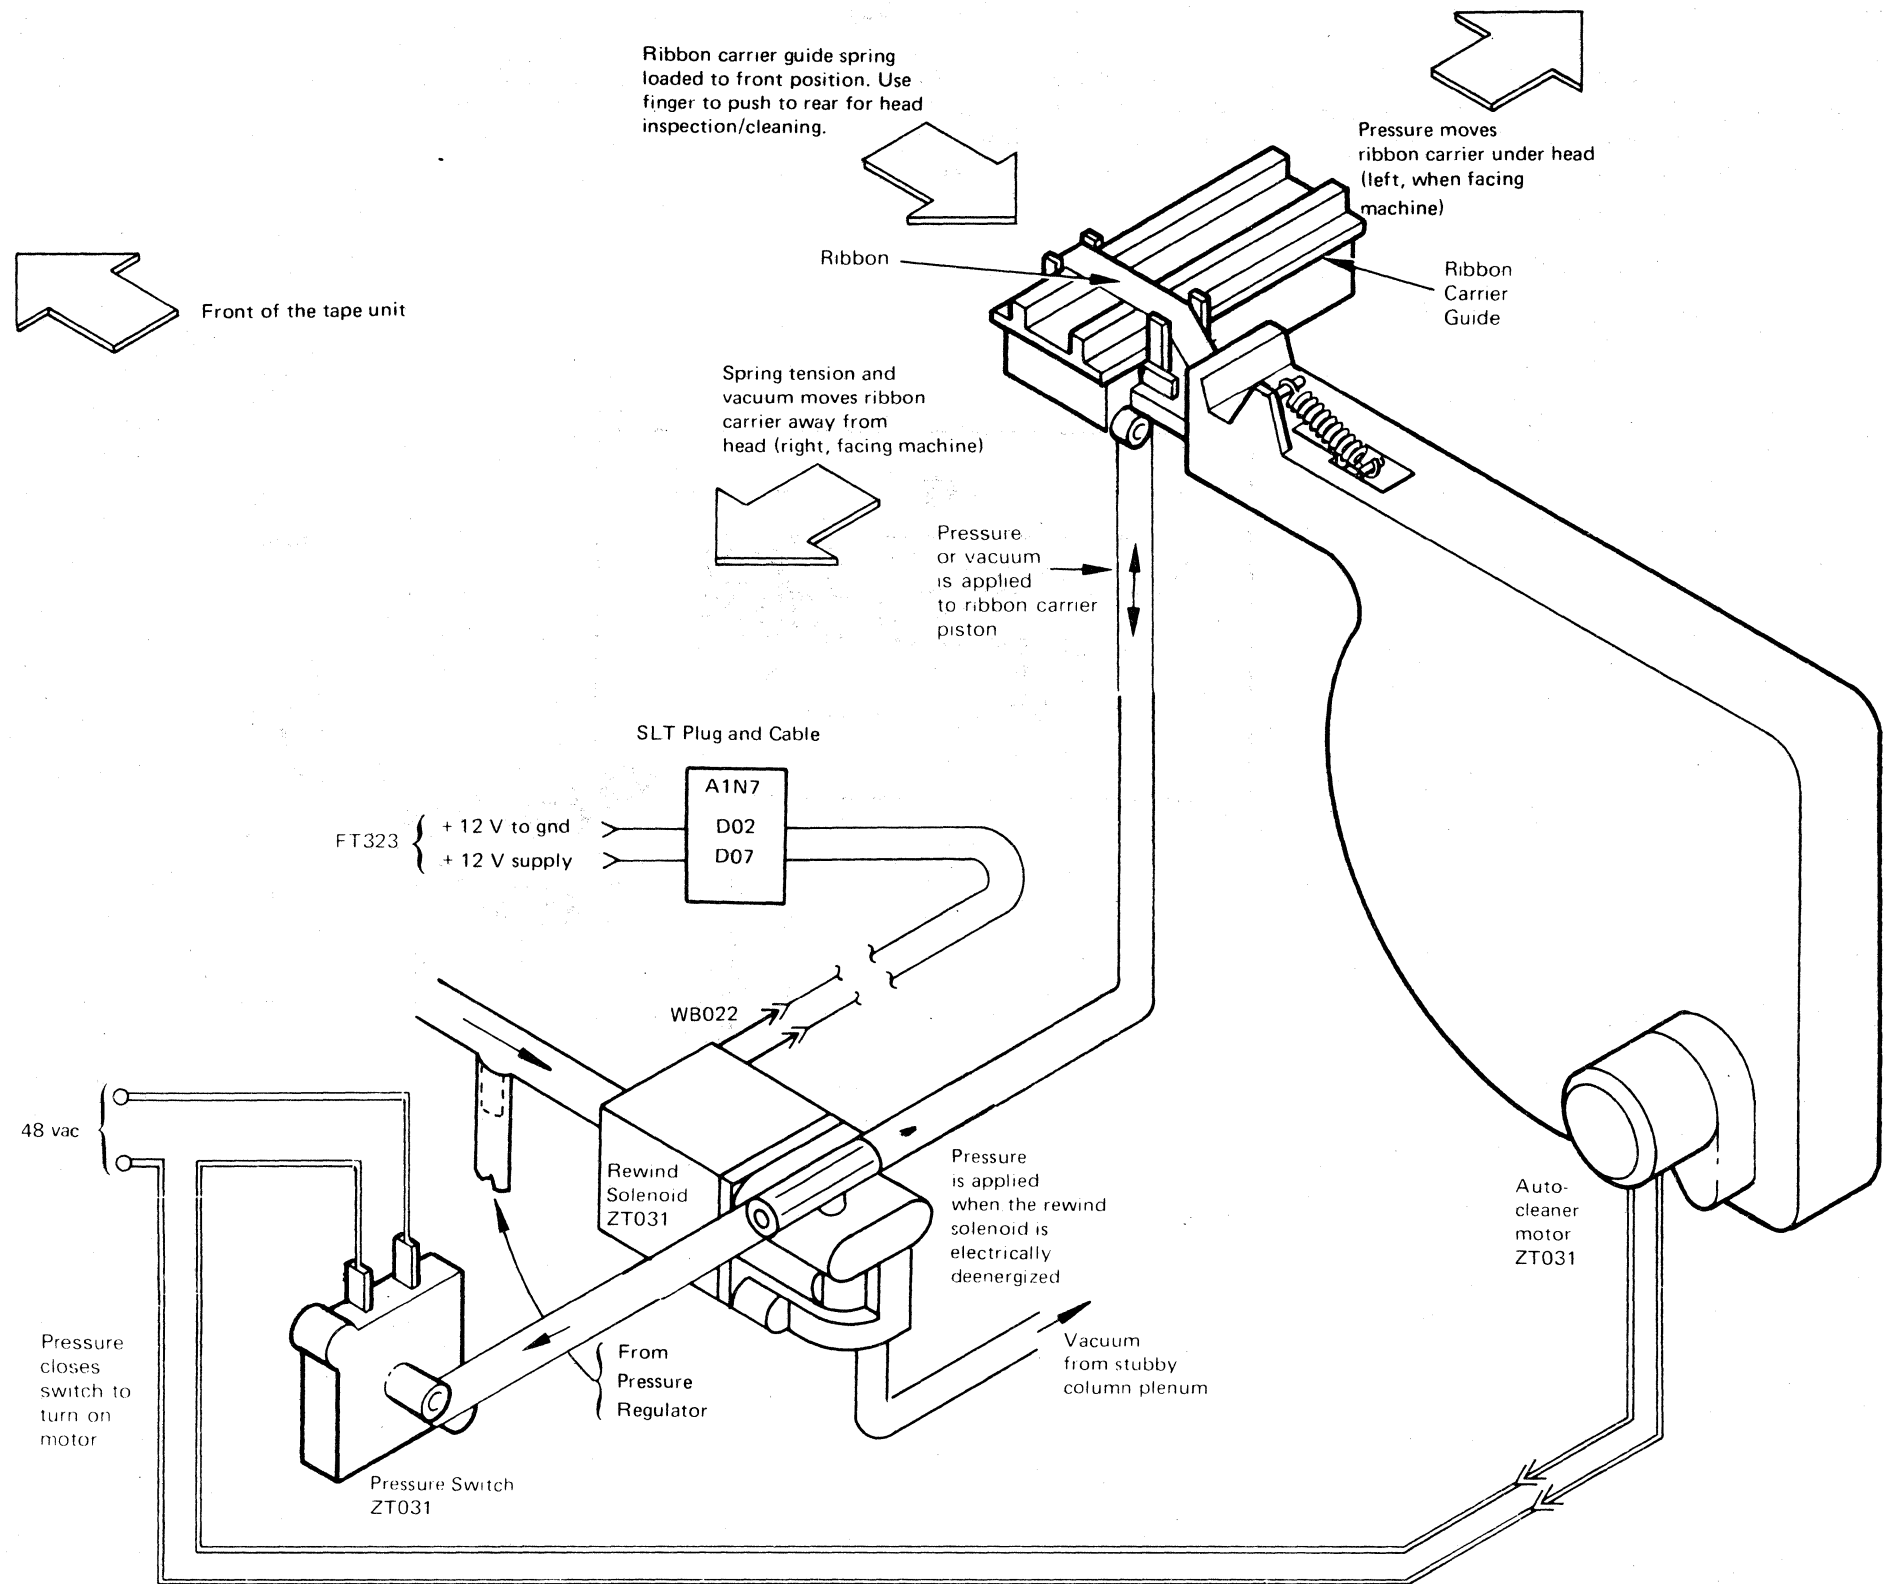
In use, the autocleaner is self-adjusting. Initial adjustment is necessary only after replacement.

There is a cutout on the plastic cover over the erase head which enables you to see the white ribbon when the autocleaner is not activated.

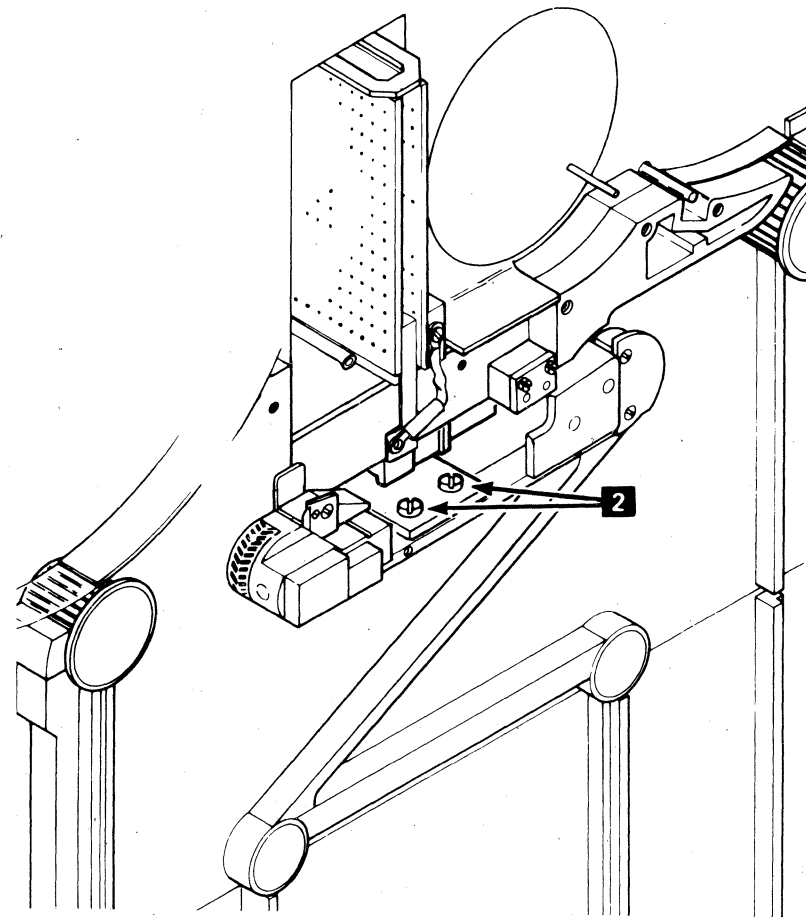
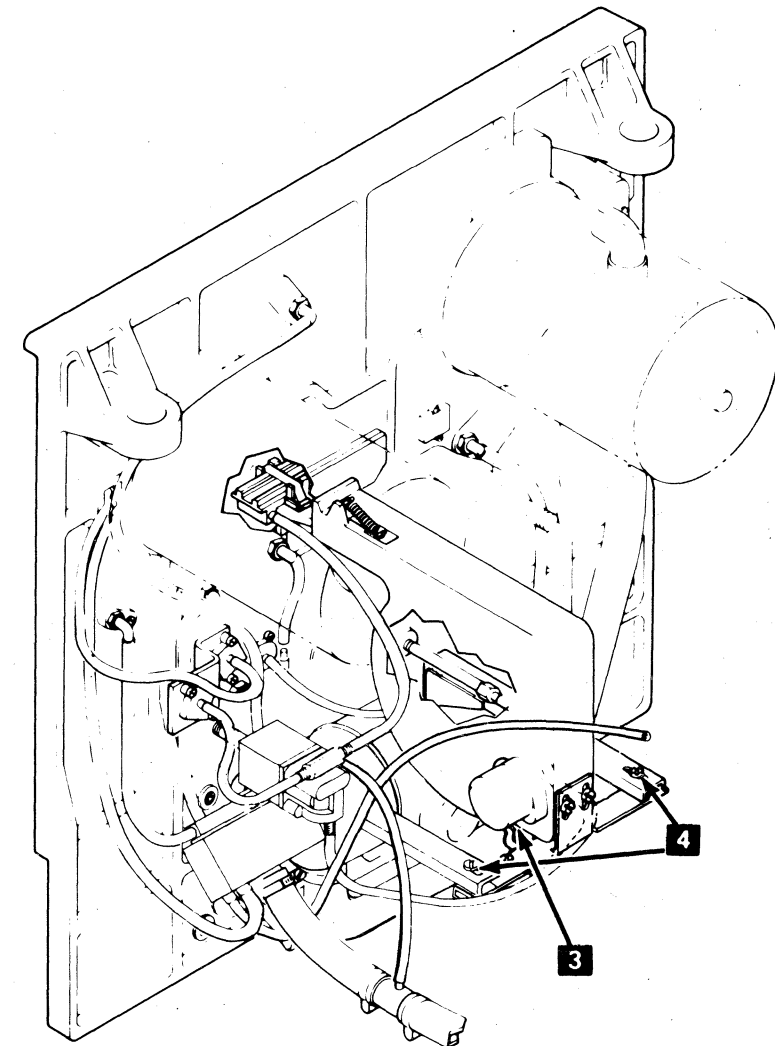
**AUTOCLEANER REMOVAL/REPLACEMENT
(TAPE UNIT MODELS 4, 6, 8)**

6. Reverse the above procedure to replace the autocleaner.

7. After replacing the autocleaner, perform the Autocleaner Adjustment procedure on 08-382.

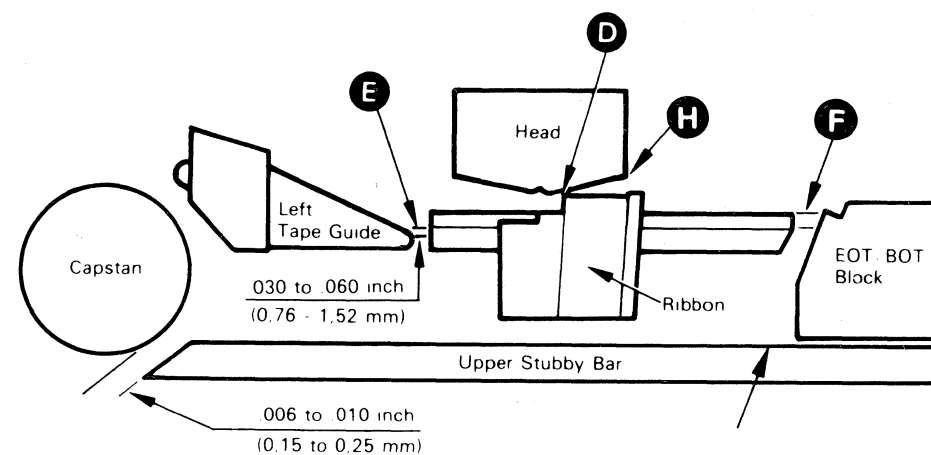
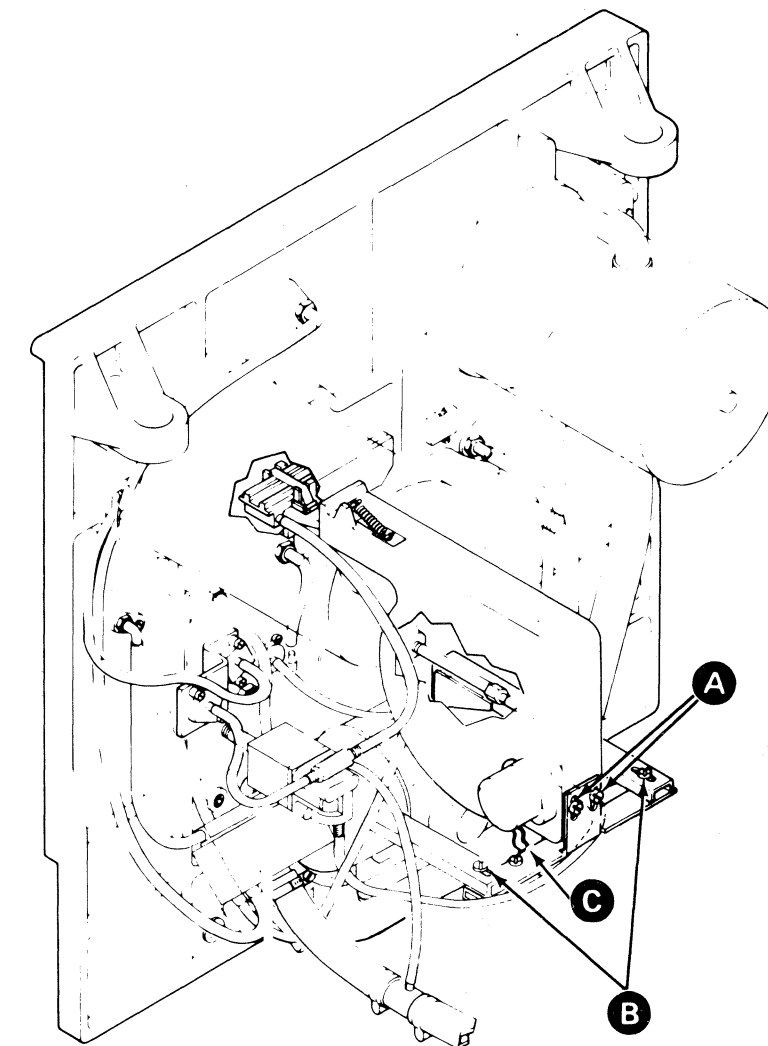
1. If required, take up the loose ribbon by turning counterclockwise the screw located at the rear of the autocleaner on the side opposite the motor.
2. Loosen the two adjustment screws at **A**. Position the screws to the center of their slots and tighten them.

3. Loosen the two adjustment screws at **B**.
4. Observe the autocleaner ribbon position relative to the read/write head surface. The left edge of the ribbon may just touch the head at point **D**. (Maximum clearance 0.015 inches (0.38 mm)). The ribbon should not touch any part of the head between point **D** and point **H**. (If the edge of the ribbon is folded, the ribbon position is too high). If the ribbon is too high, adjust bracket **E** toward the rear of the machine. If the ribbon is too low, adjust bracket **C** toward the front of the machine. To ease the adjustment:

- a. Loosen screw **E** on one side, adjust bracket the desired amount, then tighten the screw.
 - b. Repeat for the other side, moving the bracket an equal amount.

6. If either step 5a or 5b is incorrect, loosen the screws at **A** and reposition the autocleaner assembly by tilting in the appropriate direction. Loosen and tighten the screws for each trial position.

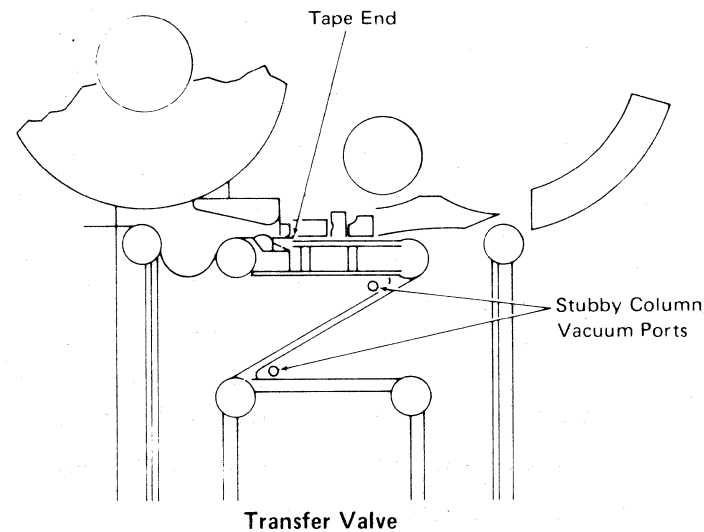
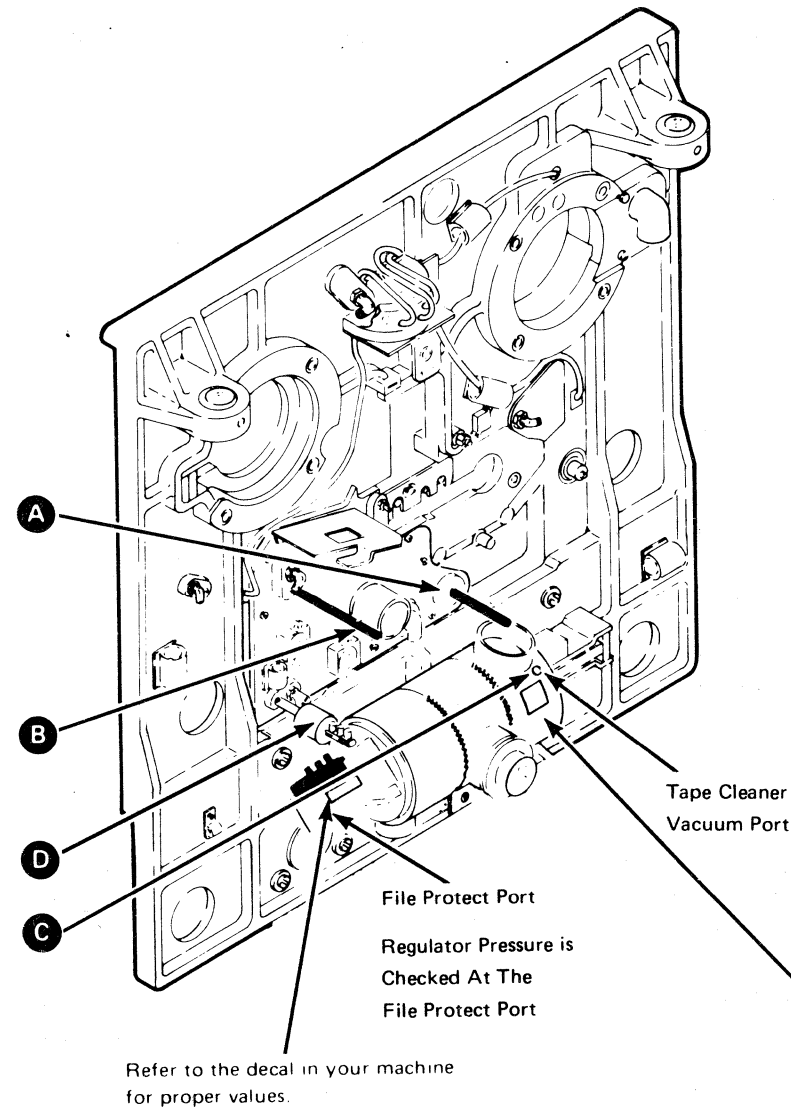
Transfer Valve Leakage Test

1. Cover the stubby column ports with masking tape. See Figure 1. Do not let the tape overlap the stubby bars.

2. Place an 8-inch piece of magnetic tape in the bottom of the right vacuum column to prevent vacuum from entering the column.
3. Cut a 12-inch piece of magnetic tape and lay it over the left reel tach just below the read/write head. Ensure that the tape loop is approximately in line with the bottom of the capstan. See Figure 1. Bypass the door interlock.
4. With no tape on the right reel, press LOAD REWIND. If the tape strip is pulled into the left column before load check occurs, there is sufficient leakage to cause intermittent problems and the transfer valve must be replaced. Repeat the test several times to ensure that the valve is bad.
5. Remove the masking tape from the stubby column ports and clean the area thoroughly with a cloth dampened with tape cleaner. Remove the magnetic tape from the right and left vacuum columns.

Column and Threading Vacuum Label.
(See chart of values for correct vacuum model levels.)

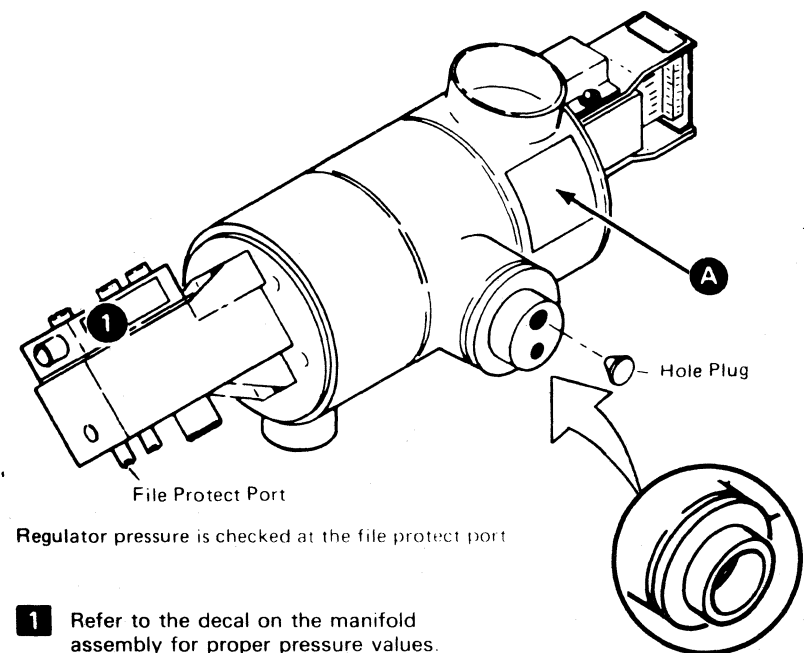
Figure 1.

Model 8 transfer valve has an open end on the orifice leading to the capstan motor.

Measure the vacuum as shown on the transfer valve label **A**. (See Figure 1.) If incorrect, check the settings as follows:

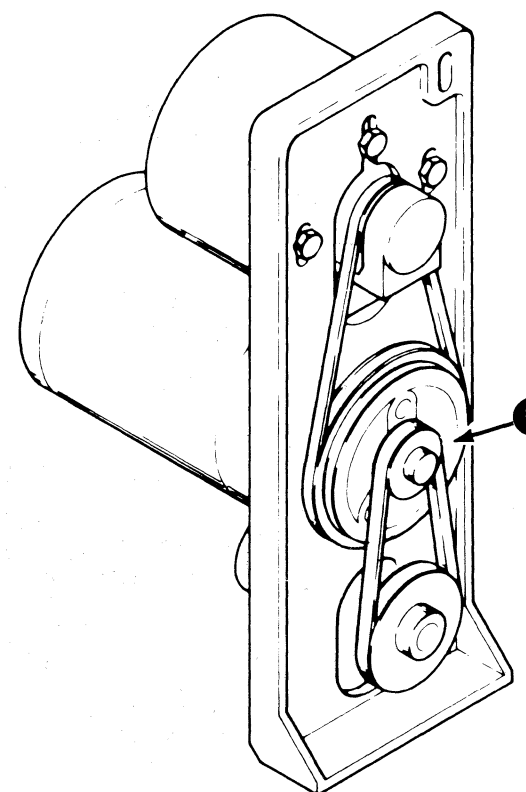
Figure 2.

Note 1: The belt must be changed on Model 8 when changing the pulley diameter. The high-altitude belt is stored behind the pneumatic supply.

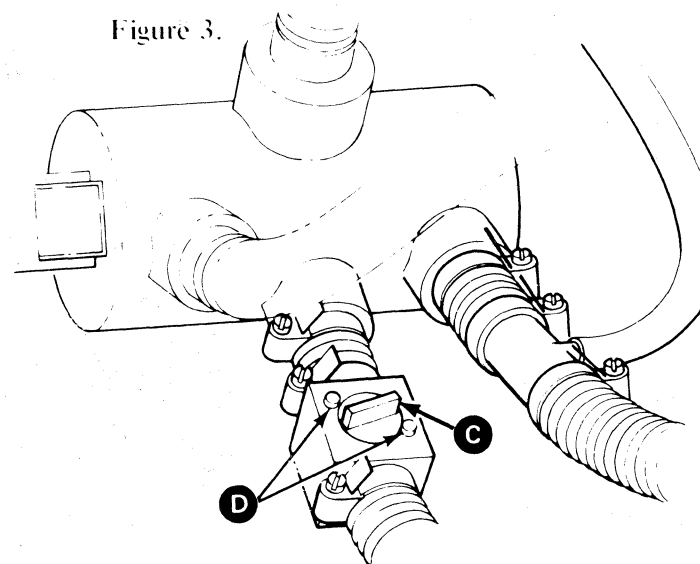
Figure 3.

*The Model 8 has a restrictor **C**, P N 1765760, in the line between the pump and transfer valve (see Figure 3). The restrictor is adjusted for 31.5 inches (800 mm) of water. If 31.5 inches (800 mm) is unobtainable, adjust to the highest vacuum level between 29.0 and 31.5 inches (737 and 800 mm). If 29.0 inches (737 mm) is unobtainable, check for leaks, pinched hoses, or wrong pulley size.

- Measure the column vacuum (see 08-400).
- Loosen retaining screws **D**.
- Rotate the handle of the restrictor for adjustment **C**.
- Tighten retaining screws **D**.

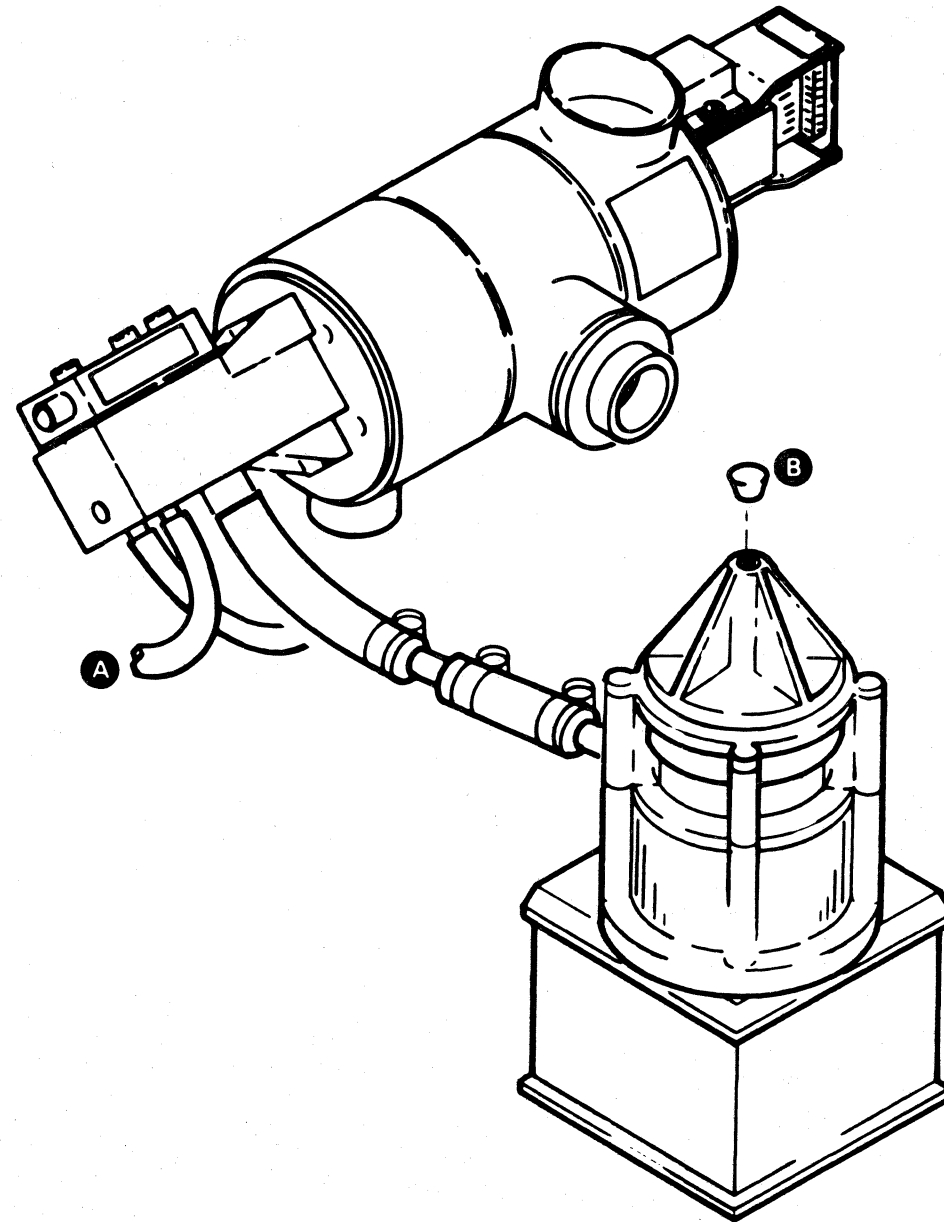
The pressure regulator is adjusted before shipment and should not require further adjustment in the field. If you suspect a pressure variation, check the pressure at the regulator test point on the distribution manifold **(A)**. If the level is not within the specifications listed in the chart on 08-400, check thoroughly for a kinked or leaking hose, a loose clamp or belt, or another faulty component in the pneumatic area.

1. Pry the small plastic plug from the top center of the regulator **(B)**.
2. Insert a hex wrench in the adjustment port. Engage the adjustment screw inside the port.
3. To decrease the pressure, turn the wrench clockwise; to increase the pressure, turn the wrench counterclockwise.
4. Thread and load the tape unit and measure pressure again at the regulator test point. See 08-400, "Pneumatic Pressure/Vacuum Checks."
5. If correct, replace the plastic plug. If not, repeat steps 2, 3, and 4.

Note: The replacement regulator for Models 3, 4, 5, and 7 is P/N 2523048 and for Models 6 and 8 is P/N 1845566. Any new pressure regulator may require adjustment for the tape unit in which it is installed. Check the chart on 08-400 for the right setting.

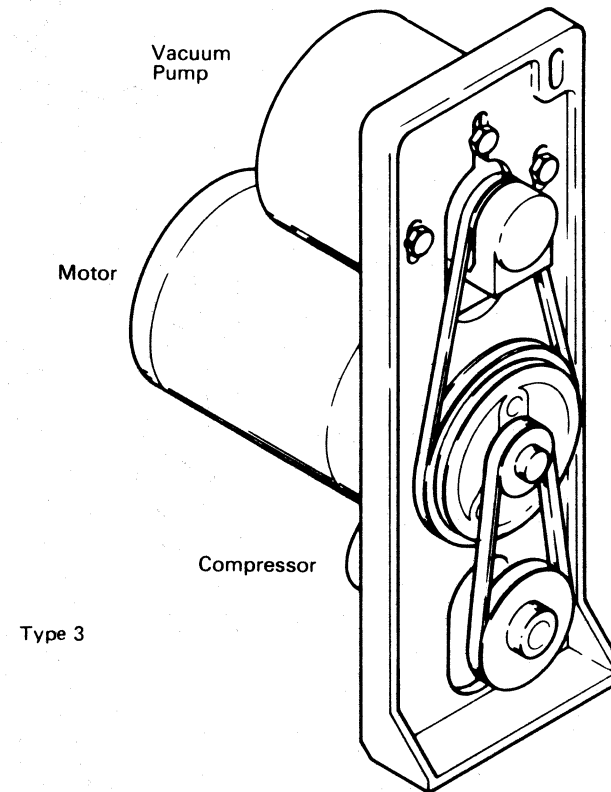
Vacuum Pump Pulley Adjustment

1. Check the belt alignment between the vacuum pump pulley and the motor pulley.
2. If necessary, remove the drive motor pulley to expose the hub setscrews.
3. Adjust by moving the drive motor hub in or out on the shaft after loosening the setscrews.
4. Tighten the hub setscrews.
5. See 08-430 for the pulley replacement procedure.
