IBM Maintenance Library

Magnetic Tape Subsystem Maintenance Manual

3803-2/3420

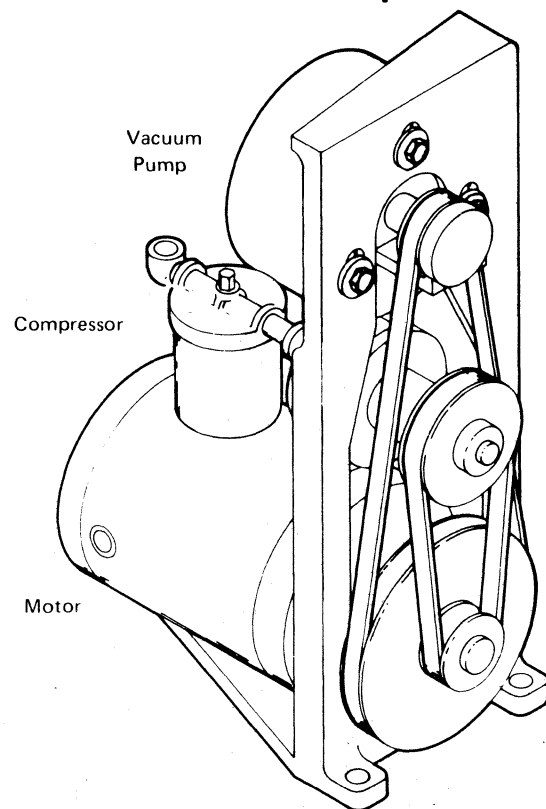
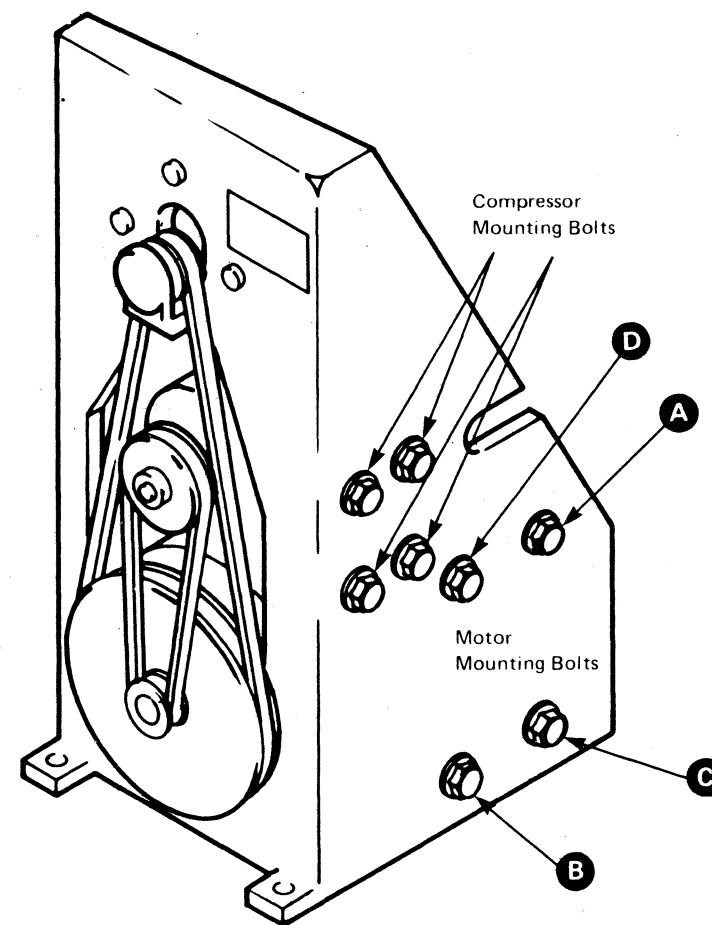
PNEUMATIC MOTOR LARGE
(STEPPED) PULLEY ALIGNMENT

1. Check the belt alignment between the large drive motor pulley and the compressor pulley.
2. To adjust, loosen mounting bolts **A**, **B**, and **C** holding the motor mount.
3. Slightly loosen mounting bolt **D** and use it as a pivot point.
4. Rotate the motor and mount around the pivot bolt until the pulley is parallel to the belt.
5. Tighten the mounting bolts.

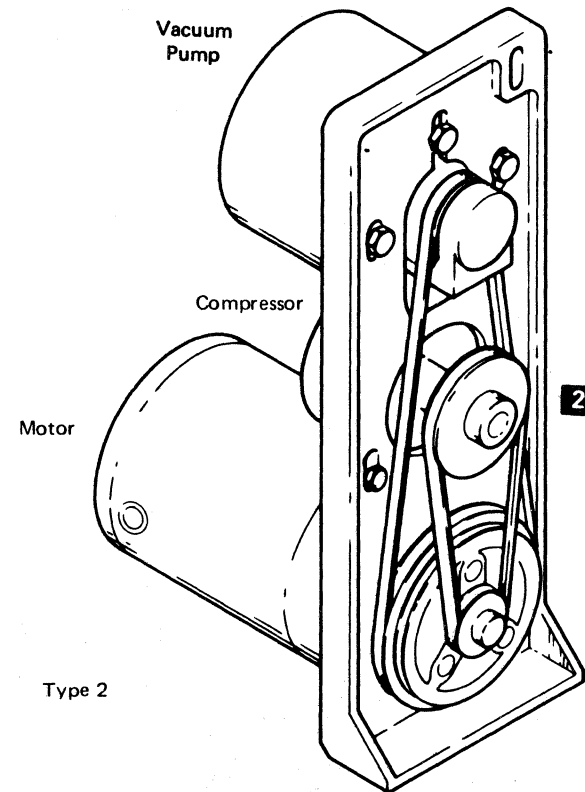
**PNEUMATIC COMPRESSOR PULLEY
ALIGNMENT
(TYPE 2 SUPPLY)**

1. Check the belt alignment between the small drive motor pulley and the compressor pulley.
- 2** Adjust by moving the compressor pulley in or out on the compressor shaft after loosening the pulley setscrews.
3. Tighten the setscrews.

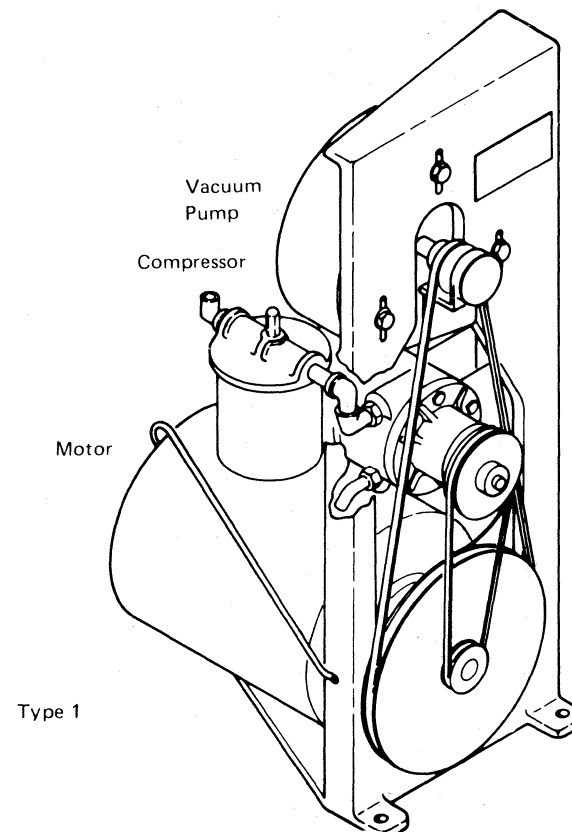
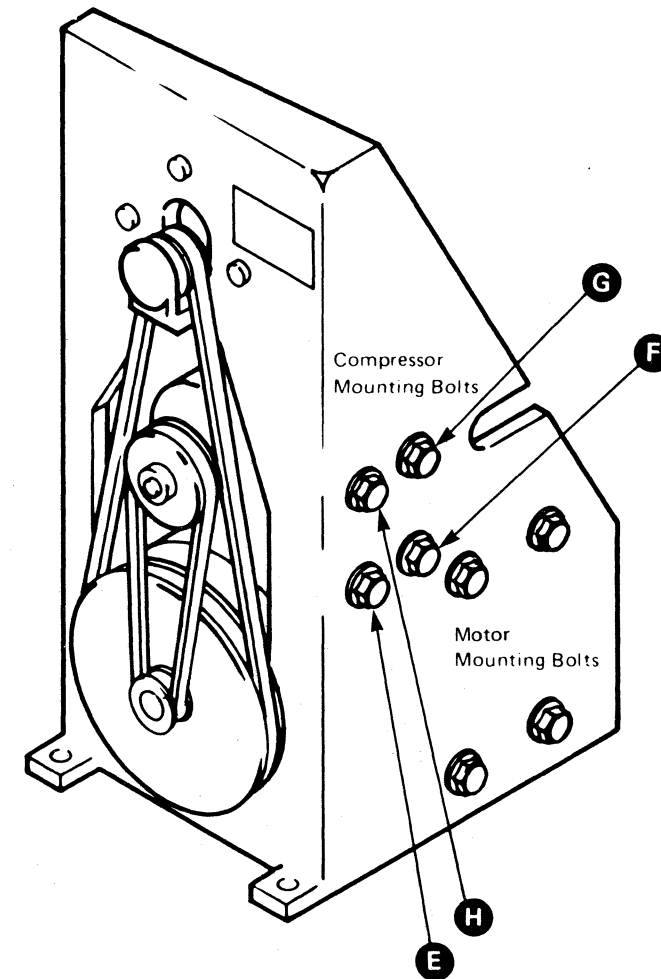
PNEUMATIC COMPRESSOR PULLEY ALIGNMENT (TYPE 1 SUPPLY).

1. Check the belt alignment between the compressor pulley and the motor pulley.
2. Adjust by loosening mounting bolts **E**, **F**, and **G**.
3. Slightly loosen mounting bolt **H** and use it as a pivot point.
4. Rotate the compressor and mount around the pivot point until the pulley is parallel to the belt.
5. Tighten the mounting bolts.

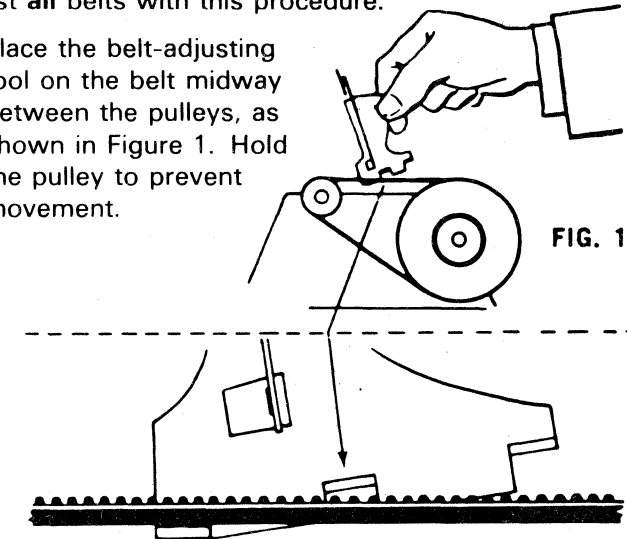
1. Place the belt-adjusting tool on the belt midway between the pulleys, as shown in Figure 1. Hold the pulley to prevent movement.

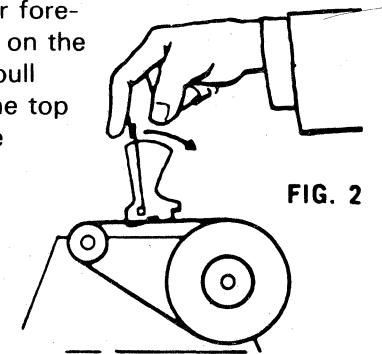
2. With the end of your fore-finger on the button on the top of the spring – pull the button around the top circumference of the belt-adjusting tool. See Figure 2.

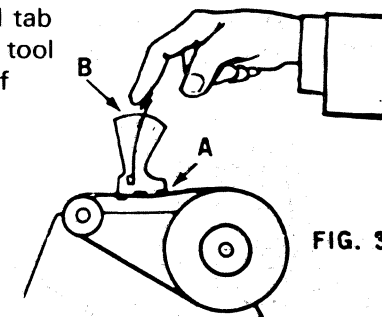
3. When the right-hand tab of the belt-adjusting tool just touches the top of the belt (see A in Figure 3), read the belt tension in pounds on the scale. (See B in Figure 3. Read at left of the spring.)

4. Set the tension to:
 - 18 to 25 pounds (8.2 to 11.3 kg) when adjusting existing belts.
 - 23 to 28 pounds (10.4 to 12.7 kg) when installing new belts.

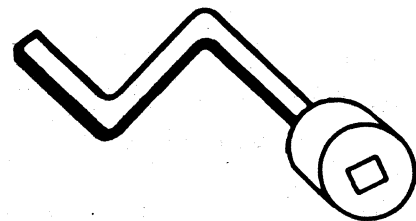
Mounting adapter bar.
P/N 1766510

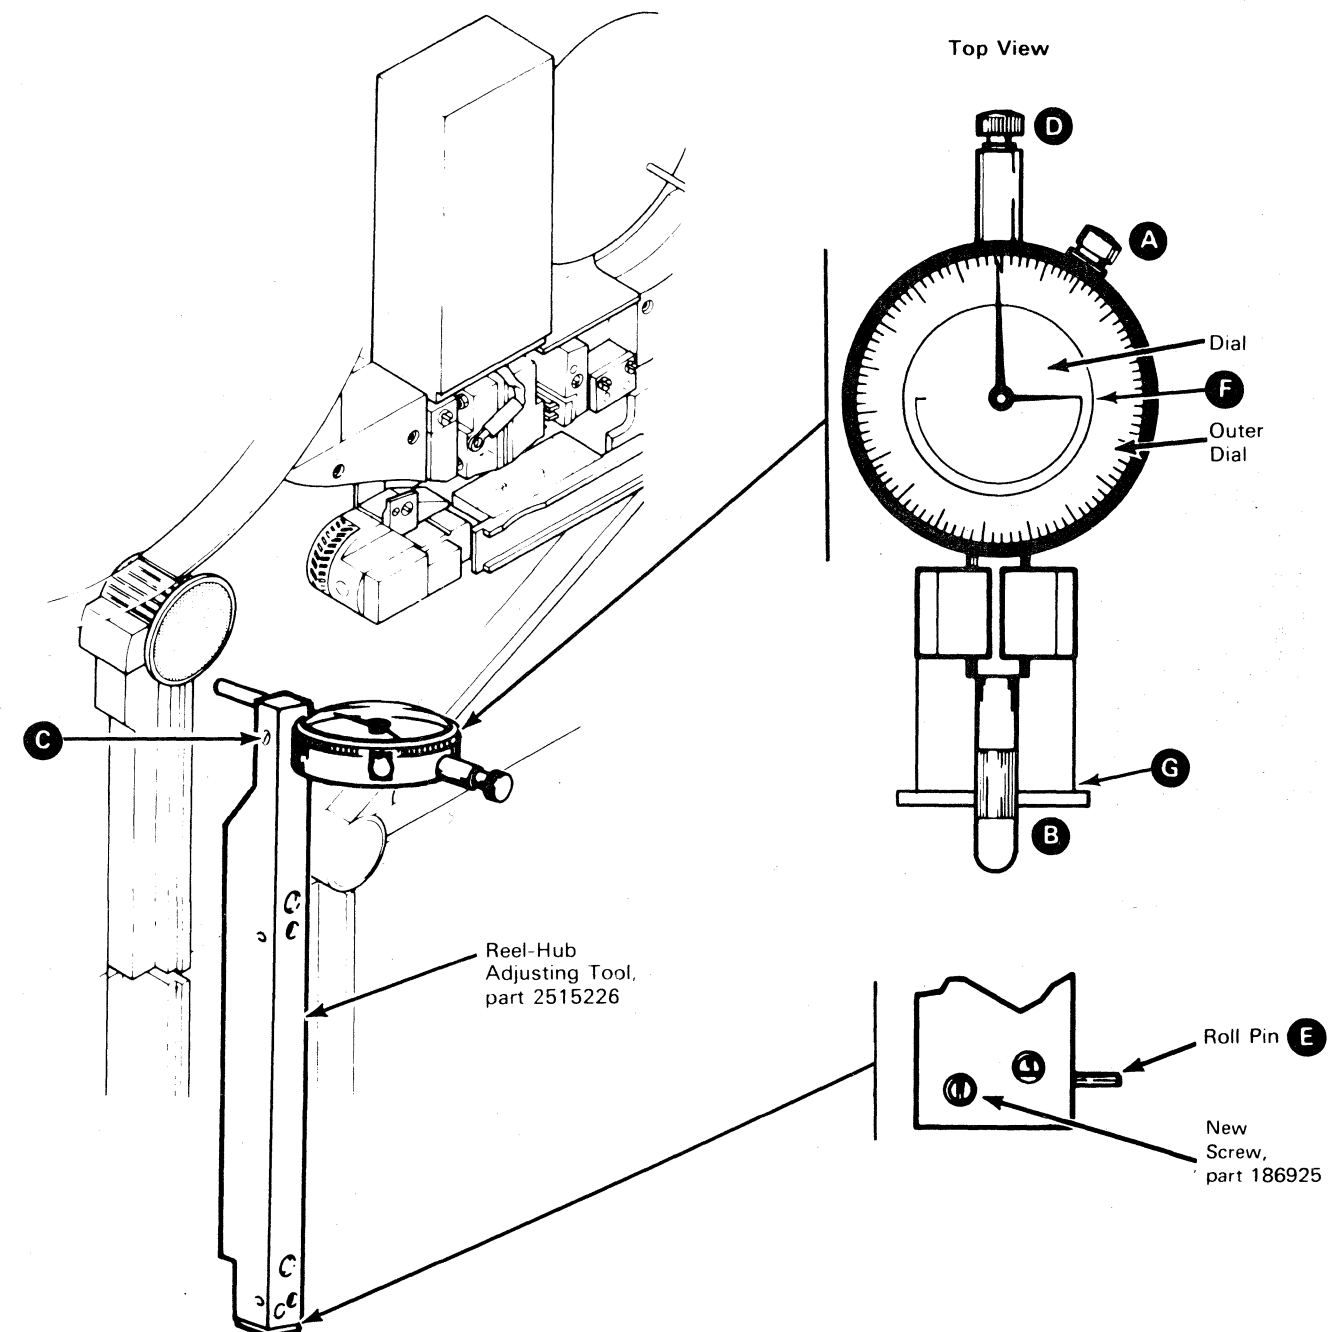
1. Loosen screw **A** and rotate the outer dial to position the markings as shown. Tighten screw **A**.
2. Turn sensing rod **B** to align the pointers as shown. This should allow a zero reading of both pointers, with a 90-degree movement of the large pointer when sensing rod **B** is depressed.
3. Extend the set-up spacers as shown by pulling out and rotating a 1/4 turn **C**.
4. Carefully place the tool against either vacuum column as shown. (The vacuum column is used as a reference surface.)
5. Loosen screw **C** and slide the gauge in the holder until both dial pointers read approximately zero.
6. Tighten screw **C**.

8. Remove the tool from the vacuum column. The large pointer should move only about 90 degrees and both pointers should come to rest positioned approximately as shown **F**.

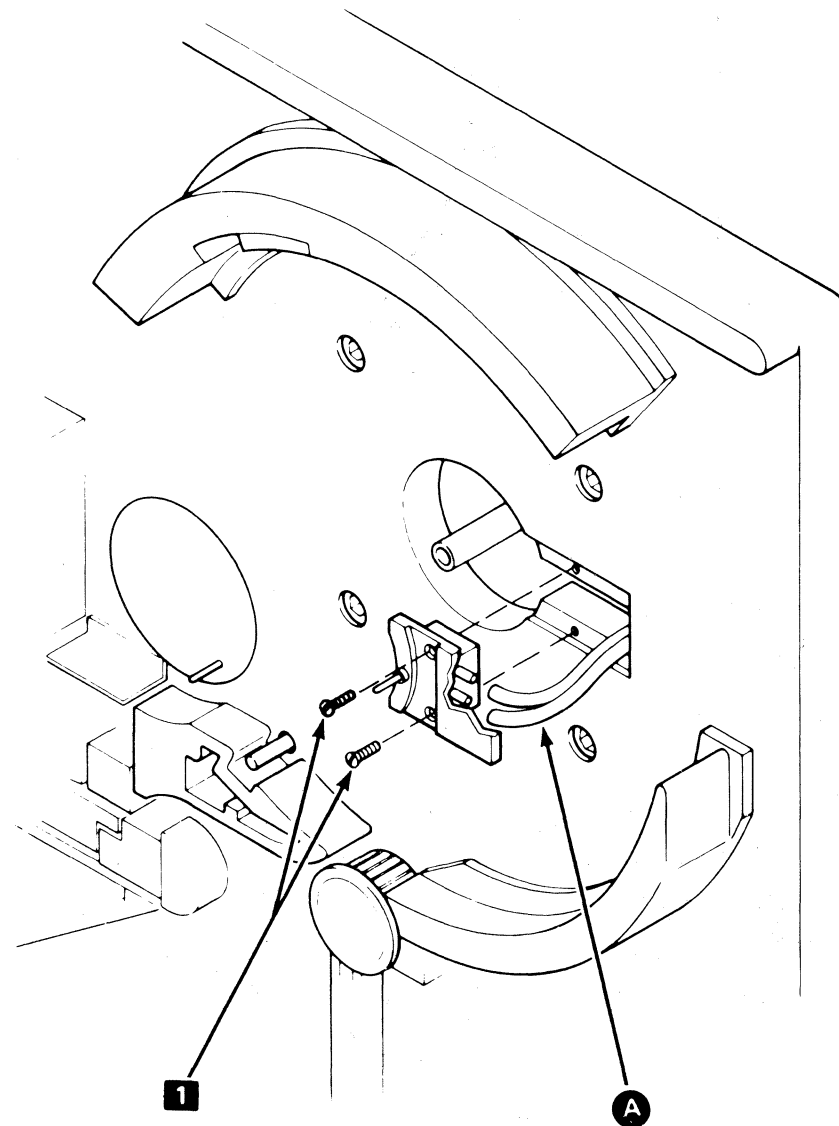
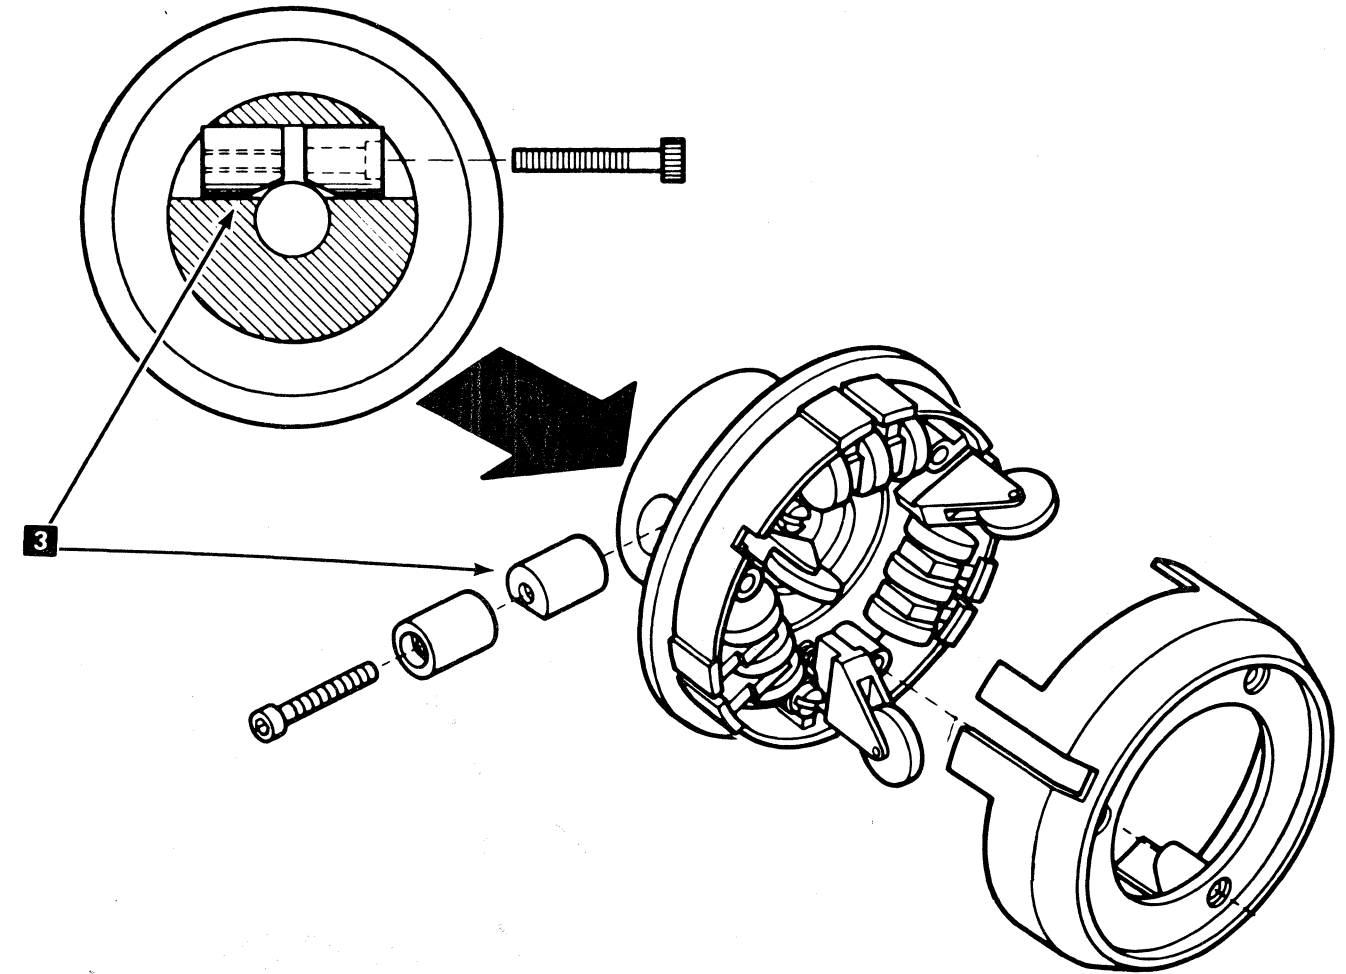
To remove the hub:

- 1 Remove the two mounting screws from the file-protect plunger assembly and slide the assembly out of the front casting. Do not disconnect hoses **A**. Move the assembly out of the way.
- 2 Rotate the hub to allow access to the hub clamp screw through the file-protect assembly casting opening.
- 3 Loosen the clamp screw with a hex wrench, P/N 1846252, and slide the hub off the shaft.
- 4 Go to 08-500, "Right Reel Hub Replacement/Adjustment."

Note: Hub shown removed for illustration only.

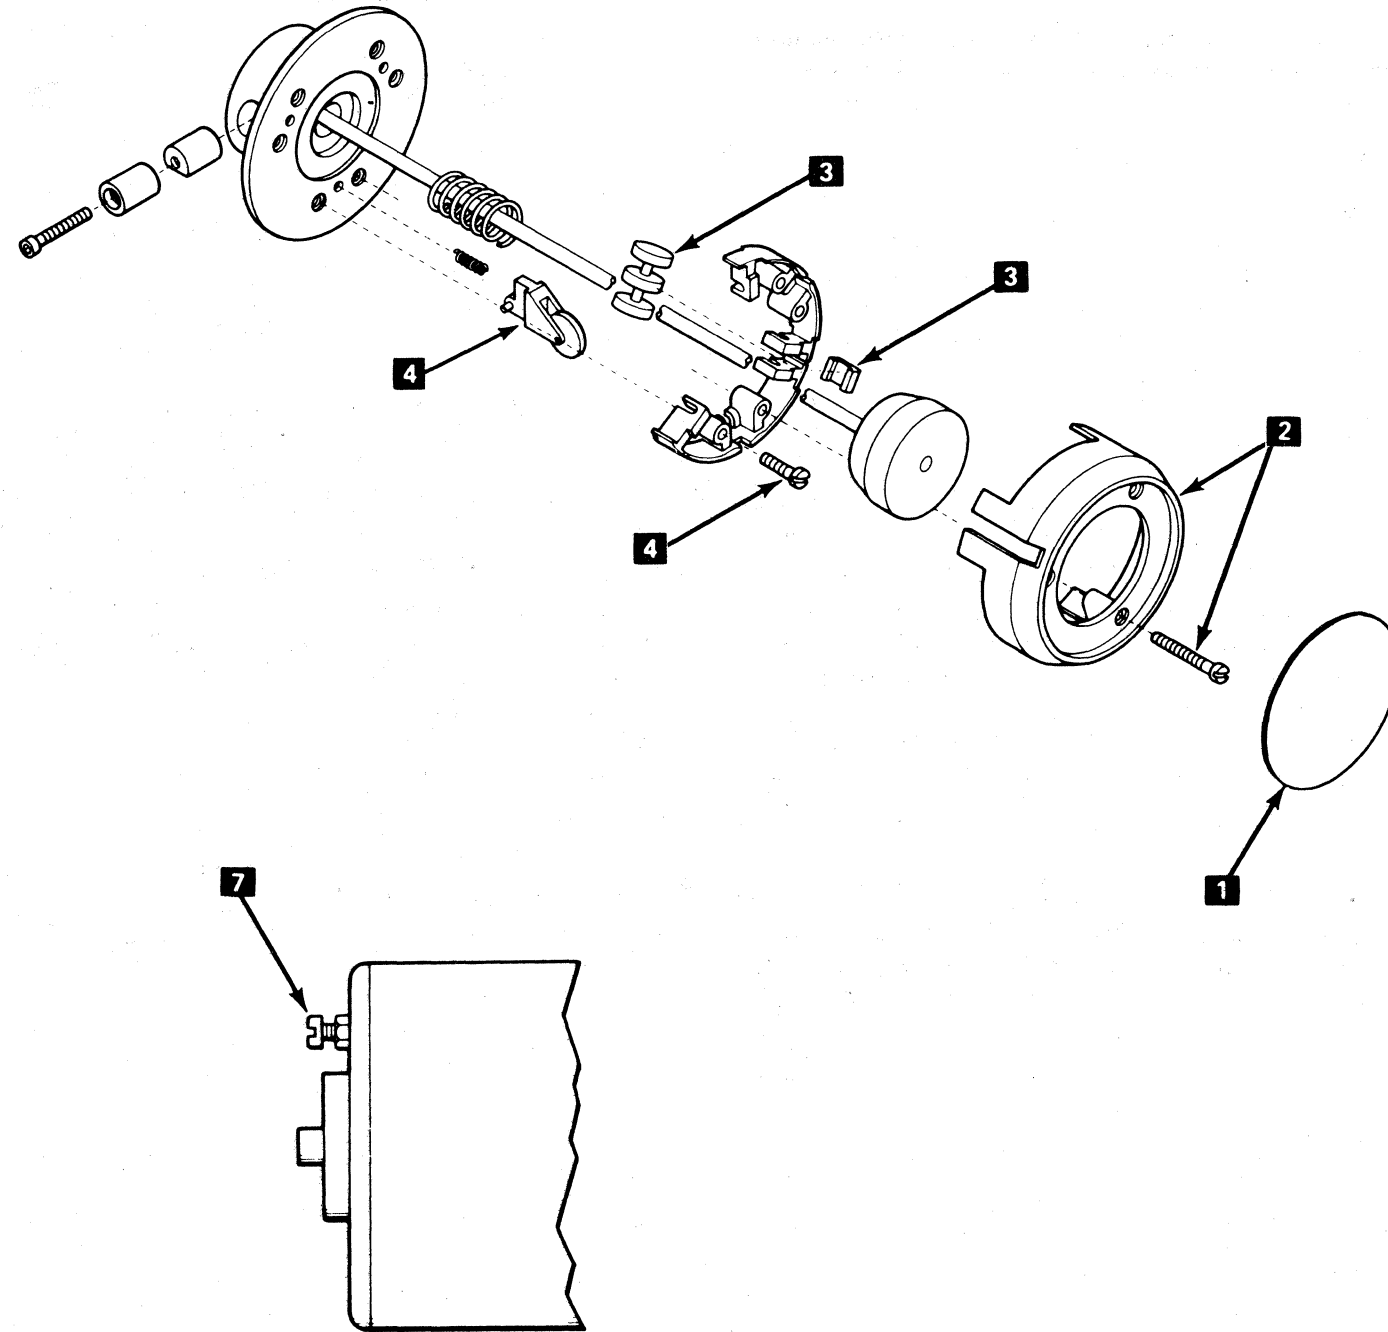
RIGHT REEL HUB INDIVIDUAL PARTS REPLACEMENT

To replace the latch segments, friction pads, triple roller assemblies, or single roller assemblies (and their springs), proceed as follows:

- 1 Remove the hub decorative cover.
- 2 Remove the three hub cover mounting screws and the hub cover.
- 3 The friction pads and rollers can be replaced without removing the remaining screws. Carefully "strip" the pads to be replaced off the ends of the latch segments. Replace them carefully.
- 4 To replace the rollers and spring, the screws must be removed.

- 5 After replacing the parts, assemble the hub in the reverse order. The shorter screws must be replaced in the holes located clockwise from the single roller assemblies. As these screws are tightened, ensure that the springs under the single roller assemblies seat in their recesses in the hub.
- 6 Replace the hub cover and tighten the three mounting screws.
- 7 Check the operation of the hub by manually operating the cam assembly. Take care not to unseat the rear housing assembly from its antirotation screw on the back of the right reel motor.
- 8 Install the hub decorative cover, P/N 2523727.

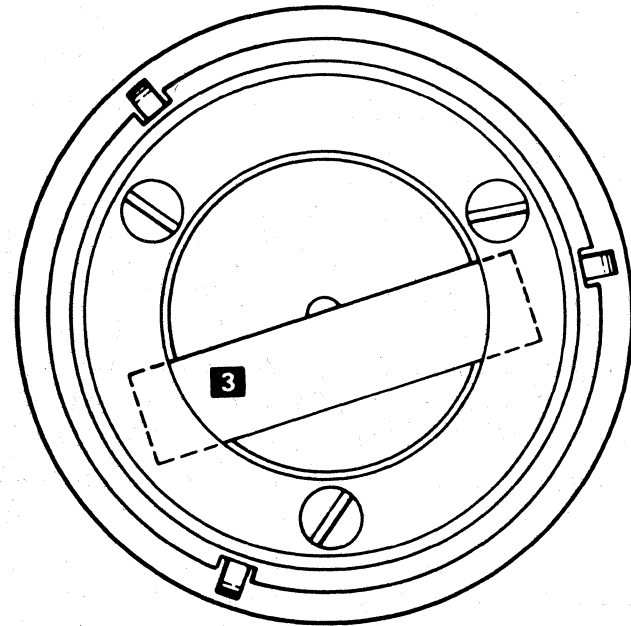
1. Slide the 1.19 inch (30.2 mm) diameter spring onto the camshaft.
2. Insert the camshaft assembly through the hub into the motor shaft. Ensure that the spring seats correctly in the hub recess.
3. Install the adjustment shim 0.030 inch (0.8 mm), P/N 1846251, as shown.

Note: This shim must be installed to retain the camshaft until the rear housing is installed. It also supplies the correct clearance adjustment for the cam.

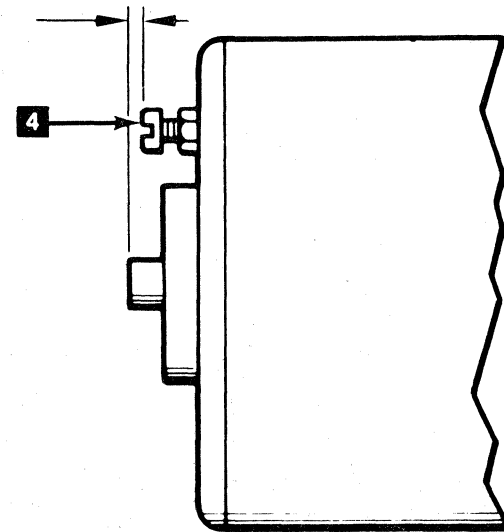
4. Ensure that the antirotation screw on the rear of the right reel motor is adjusted flush to 0.25 inch (6.4 mm) below the end of the reel motor shaft, as shown.

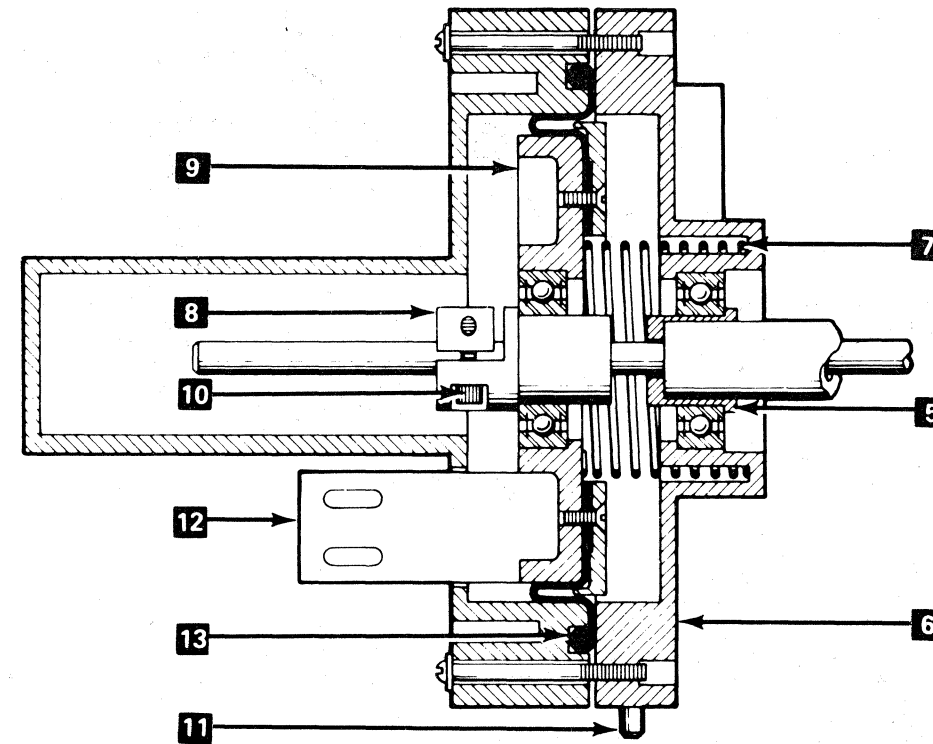
5. Install the bushing on the end of the reel motor shaft, as shown.
6. Install the rear housing over the bushing. Ensure that the antirotation screw enters the slot in the rear of the housing.

7. Insert the 1.75 inch (44.4 mm) diameter spring into the recess inside the rear housing, as shown.
8. Insert the clamping collar into the bearing of the piston assembly from the side with the guide extension.

11. Rotate the piston assembly to position the guide extension between the air connections on the rear housing.
12. Position the cover so that its slot is over the guide extension.

13. Ensure that the bead of the diaphragm fits into the cover channel.

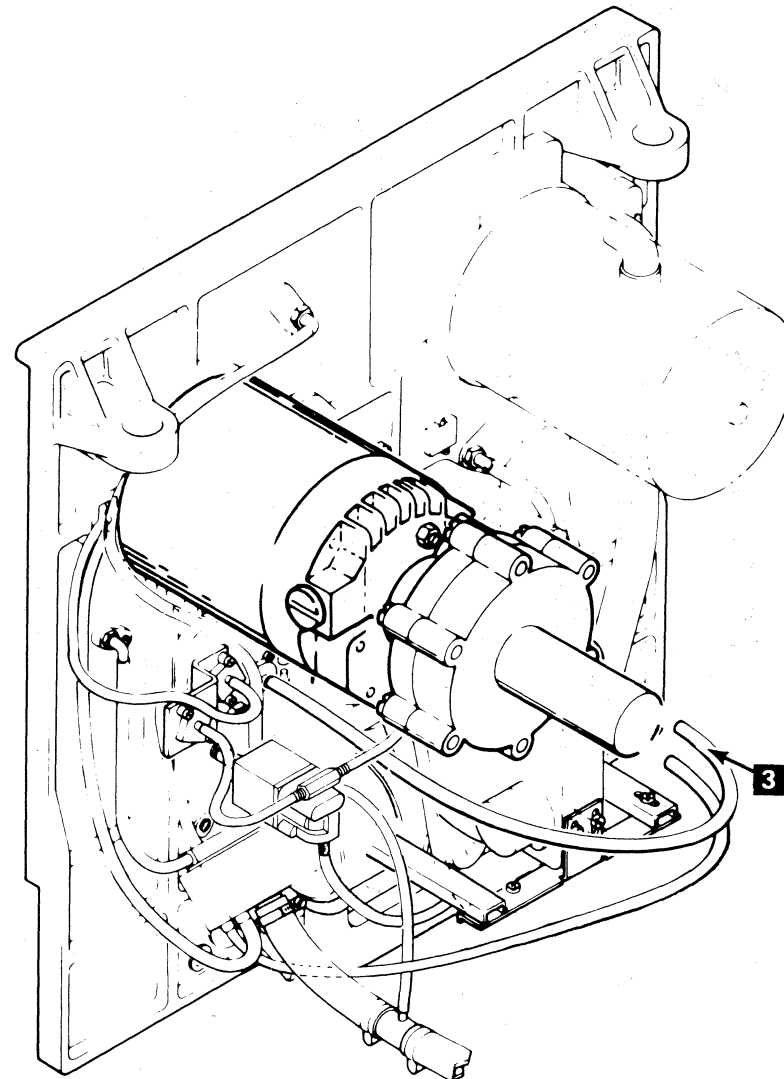
To check the rear housing for leakage:

1. Load the tape unit with a CE work tape.
2. Jumper A-A5B13 to ground to bypass the pressure switch so that the vacuum and pressure stay up.
3. At the rear housing, disconnect the hose to the pressure sensing switch. This causes the tape unit to drop READY.
4. Attach a pressure/vacuum gauge, P/N 5495384, or a water manometer with a pressure divider to the same rear housing air connection.
5. With the tape loaded in the columns, minimum pressure should be:

6. If the pressure is not correct, first check the pneumatic adjustment. See 08-420, "Pneumatic Pressure Level Adjustment." If the problem remains, replace the piston assembly (including the diaphragm). See 08-470, "Right Reel-Latch Rear Housing Removal." If the problem still remains, replace the rear housing. See 08-470, "Right Reel-Latch Rear Housing Removal" and 08-510, "Right Reel-Latch Rear Housing Replacement."
7. If the pressure is below 40 inches (1016 mm) of water on any model tape unit, and the monitoring circuits did not indicate a failure, replace the pressure sensing switch. If the failure is still not corrected, check the monitoring circuits.

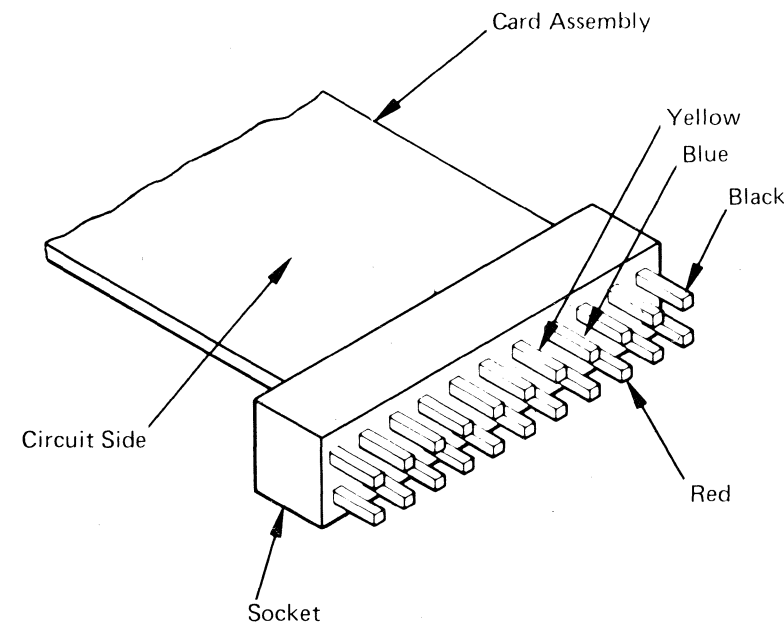
Figure 1.

4. Loosen the top 2 screws of cartridge motor, lift off SMS socket assembly. Remove the four cartridge motor leads noting their location (see Figure 1). Move assembly out of the way.

9. Install new motor and loosely install screws.
10. Replace colored motor leads on the back of the SMS card connector (see Figure 1).
11. Install SMS socket assembly on top 2 screws.

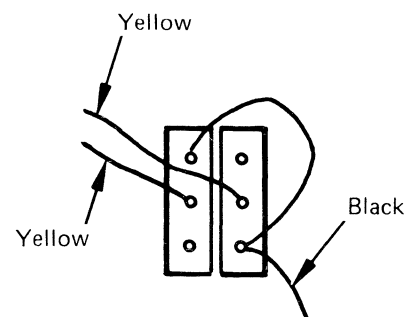
6. Mark the yellow and black wires so they can be easily replaced (see Figure 2). Unsolder yellow and black wires.
7. Remove the defective motor.
8. Rest the new motor on the transfer valve and resolder wires removed in step 6. See Figure 2.

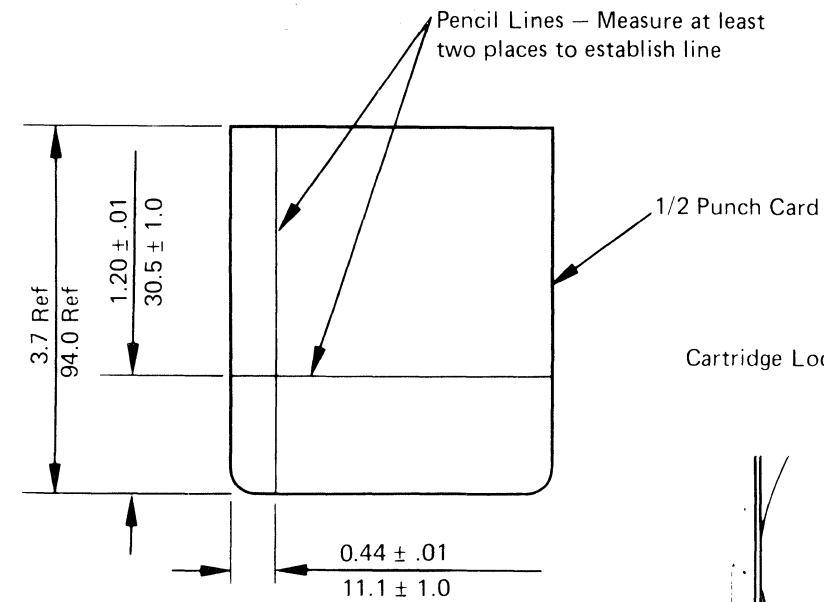
Figure 3.

12. Remove the right threading channel and cartridge opener cover if not removed.
13. Construct a template from a punch card (see Figure 3).
14. Tape the cartridge present plunger flush to the base plate (see Figure 4).

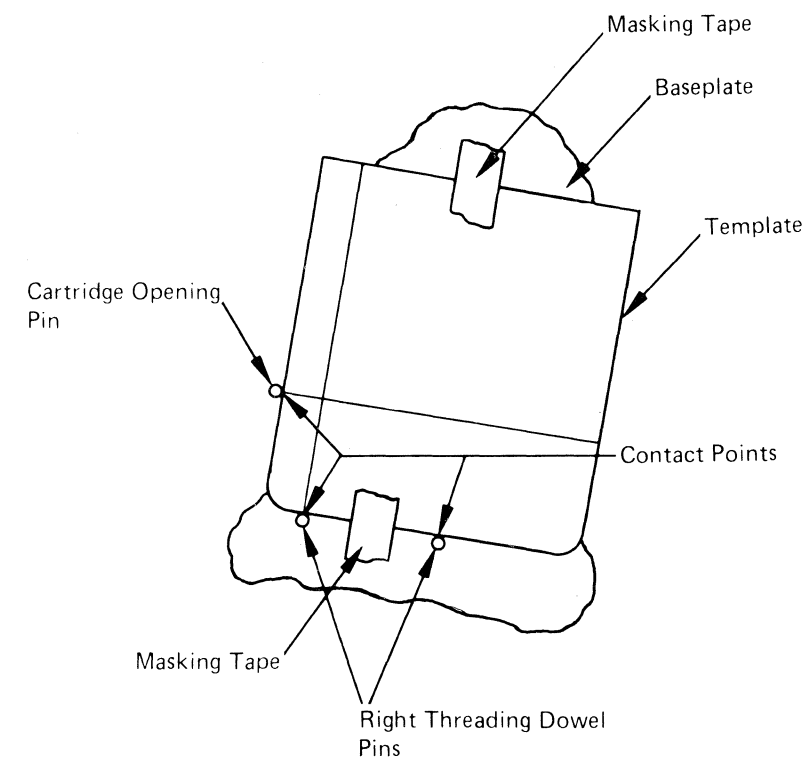
15. Move the locating pin on the cartridge motor counter-clockwise against the stop. This puts the motor in the fully closed position.
16. Position the template on the tape unit as shown in Figure 5.

17. Tape the template to the right threading channel on the bottom and to the base plate on the top.
18. Adjust the motor so the edge of the cartridge opening pin contacts the point made on the template with the other template point aligned as in Figure 5.

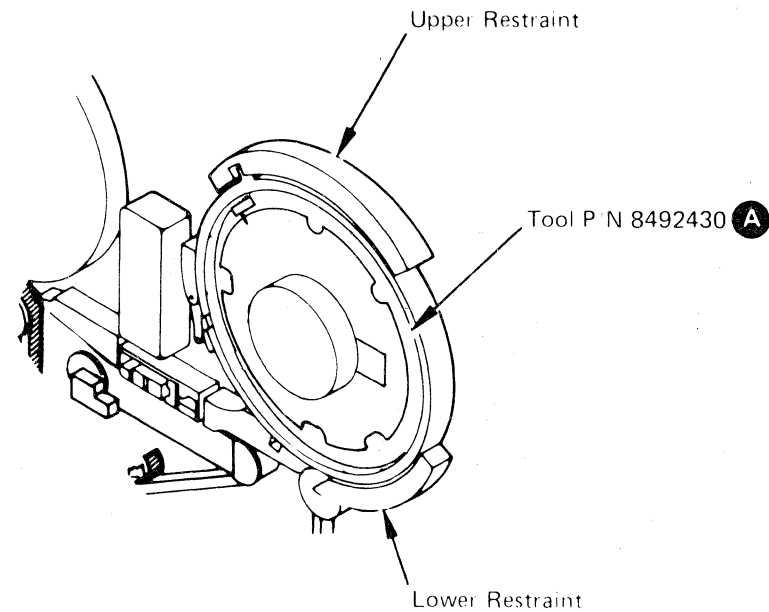
1. Open power window door and bypass the door interlock.
2. Attach the manometer or pressure gauge hose to the upper restraint cartridge leakage tool.
3. Install the upper restraint cartridge leakage tool **A**. Tool will be held in place when cartridge motor goes to the cartridge open position.

4. Push RESET and LOAD REWIND. Pneumatics will come up and cartridge motor will open tool.
5. Pressure should be between 18-32 inches of water, if not check the list of probable causes below.

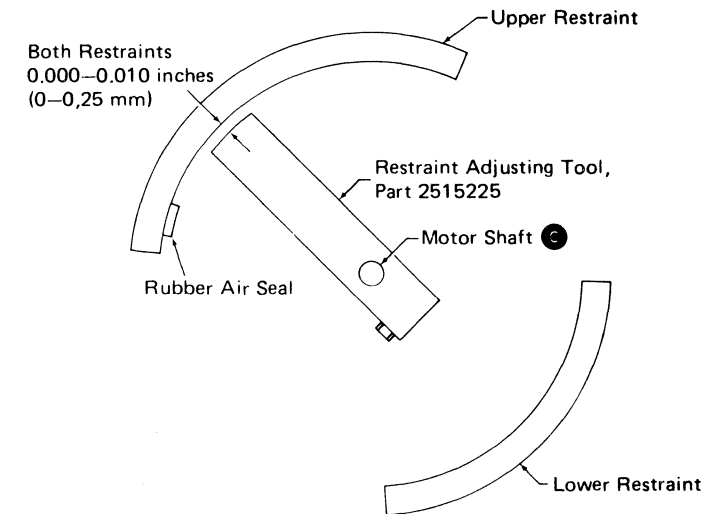
Caution: Press the rubber air seal when rotating the adjusting tool or the seal may be damaged. Do not allow the tool to rotate by its own weight until the clearance to both restraints is ensured.

6. Adjust upper and lower restraints so tool will turn 360° and clear by 0.000-0.010 inch (0-0.25mm) surfaces **A** and **B**.
7. Replace the top cover.
8. Install the right reel hub. See 08-500, "Right Reel Hub Replacement/Adjustment."
9. Install the right reel latch. See 08-510, "Right Reel-Latch Rear Housing Replacement."
10. Do the right reel-latch pressure check. See 08-520, "Right Reel-Latch Rear Housing Pressure Test."

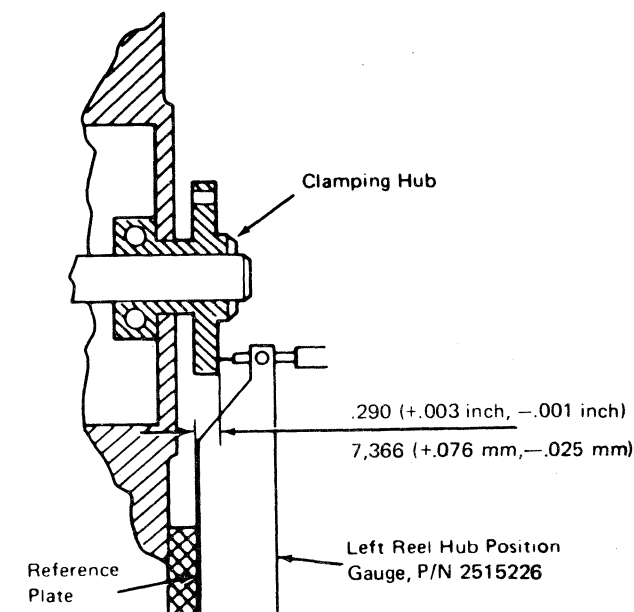
Figure A. Left Reel Setup

11. If the hub is loose, adjust it as follows:
 - a. Remove the left reel tach (see 08-550) for reel-hub adjustment tool clearance.
 - b. Place the reel-hub adjusting tool, P/N 2515226, on a flat surface and set it to 0.100 inch (2.54 mm).

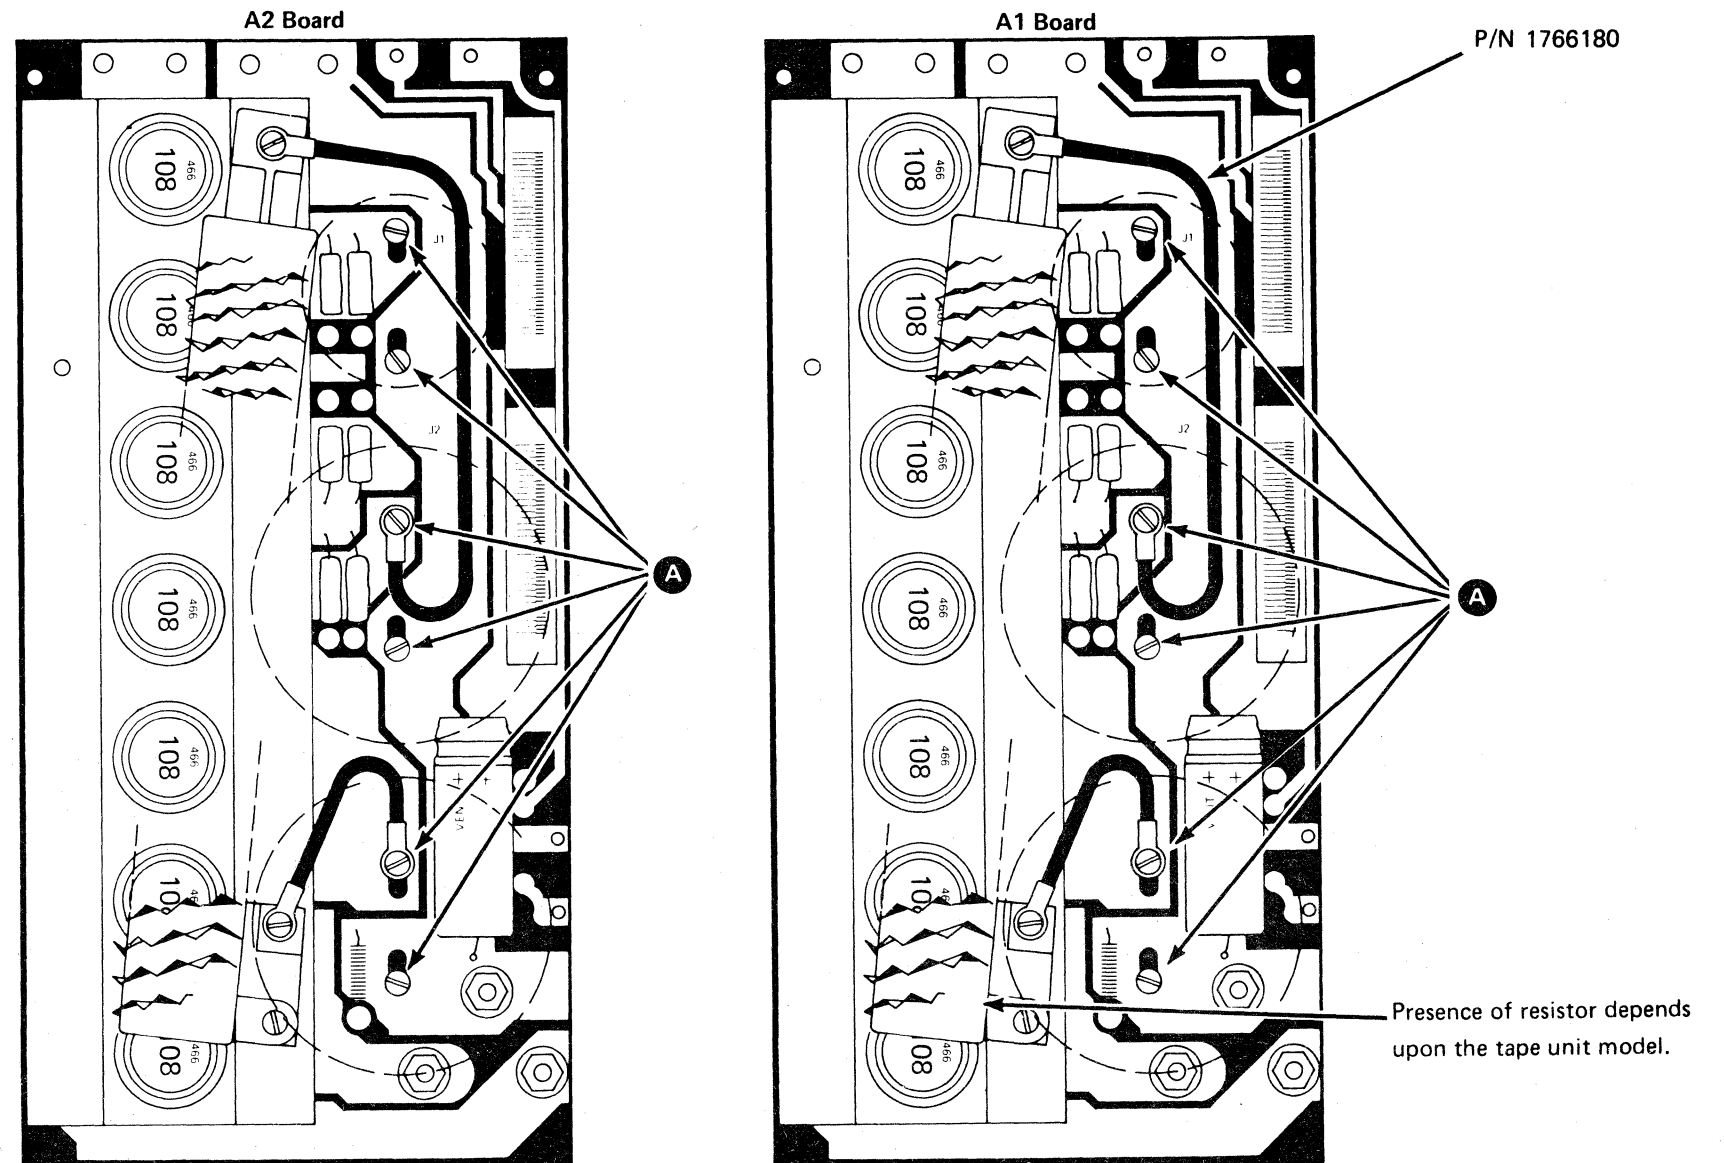
Figure 1. 3803 MODEL 2 -4V SUPPLY

1. Remove all power from the tape control unit (TCU) by tripping main line CB1, and remove the power plug.
2. Remove the plastic cover from the power supplies.
3. Remove the regulator cards to prevent damage. Note their location for later replacement.
4. Remove all external cables and laminar bus connections from the power supply board to be removed (A1, A2, A3). Note their locations for later reassembly.
5. Remove the ground strap at the top of the power supply.
6. Remove the six screws **A** that fasten the printed circuit board to the three large capacitors behind the board. Note the location of each of the screws as some are slightly longer than the others. Also, note the cable dress position of the jumper wires on the A1 and A2 PCB. See Figure 1.

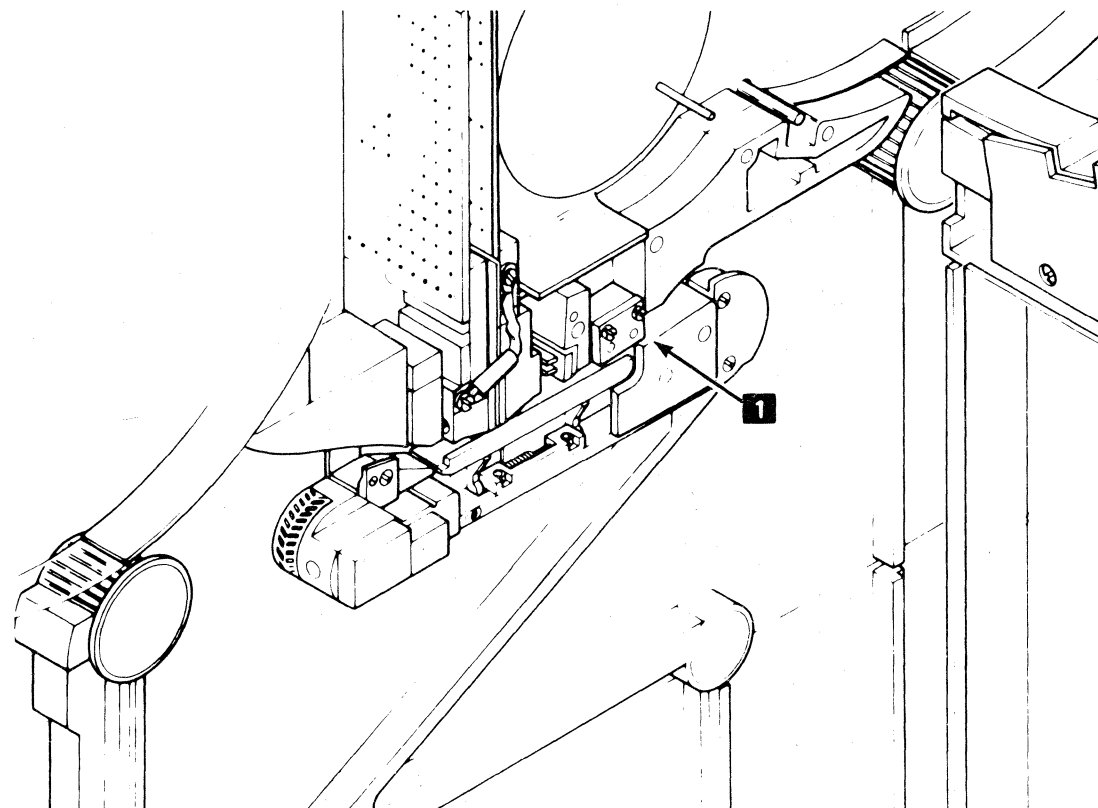
- 1 Turn off tape unit power. Clean the dust off the ends of the fiber optic bundle at the BOT/EOT block, the phototransistor lens, and the reflective mirror. Wipe with a lint-free cloth if necessary. (See 85-001.)
- 2 Clean the fiber optic lamp. Use a cloth lightly moistened with water. (See 08-620, "Fiber Optics Lamp Cleaning Procedure.") Inspect the inside of the fiber optic lamp for any sign of discoloration. Replace if necessary (see 08-620).
- 3 Turn on the tape unit power and allow the lamp to warm up for 20 to 30 minutes before continuing. Load a customer good-quality representative tape to ensure an average light reflectivity of the tape backing.

- 8 Adjust the EOT pot on the upper portion of card T-A1D2 for 4.7 +0.1, -0 volts.

- 9 Remove the tape from the BOT/EOT area so that the light falls on the reflective mirror.
- 10 Measure the BOT and EOT voltages again. The voltages should be 1.5 volts or less. Ensure that there is dc common to the BOT/EOT phototransistors by measuring 0 ohms between the center pin on the EOT/BOT block and any D08 pin on the logic panel. It may be necessary to remove the EOT/BOT block (see 08-590). If not, replace the BOT/EOT assembly (see ALD ZT031).
- 11 Perform the Capstan Tachometer Check/Adjustment procedure on 08-120 or 08-130.

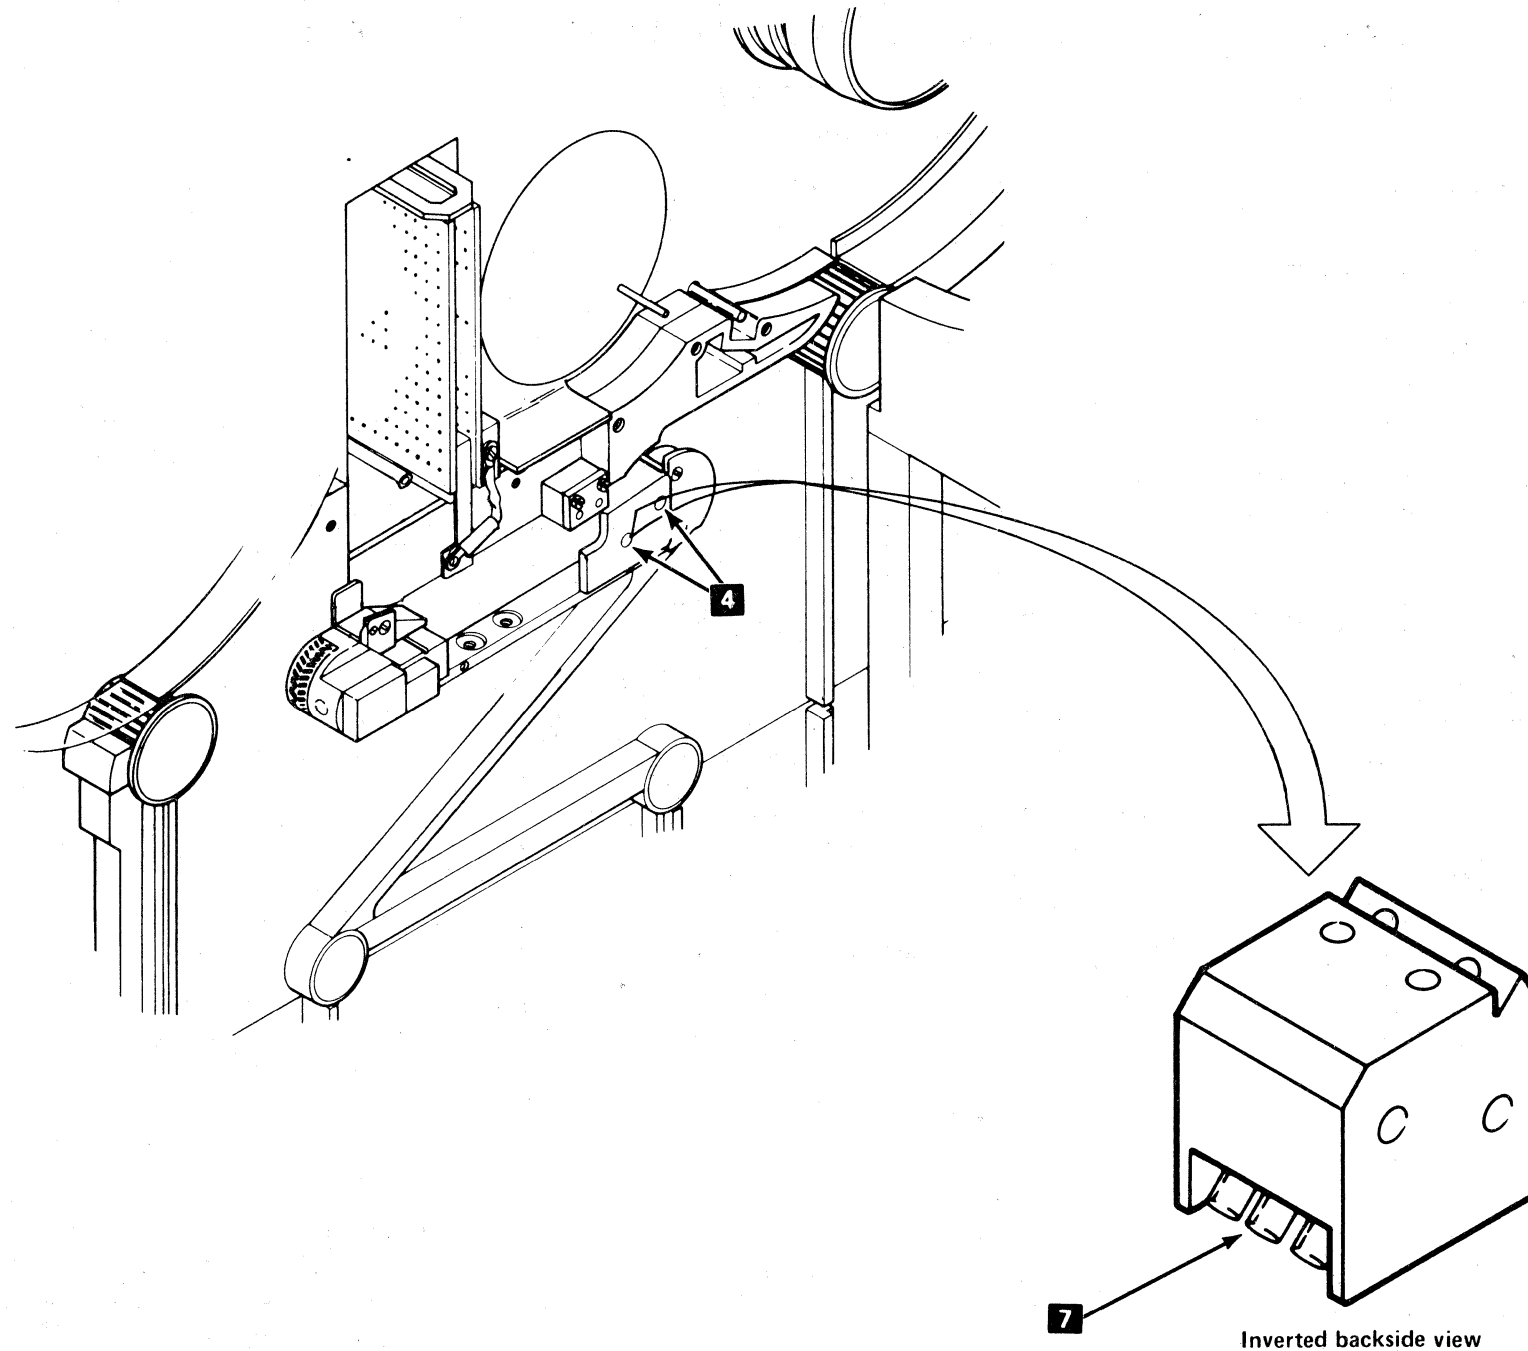
1. Turn off tape unit power.
2. Pry the retaining wedge from the BOT/EOT fiber optic bundles at the manifold.
3. Push the bundles toward the BOT/EOT assembly to obtain sufficient slack.
- 4 Remove the two screws holding the assembly in place.
5. Pull the assembly out carefully.
6. If the fiber optic bundles are **not** being replaced, remove the screws which fasten the metal clips in place on the BOT/EOT assembly and remove the metal clips.
- 7 Turn the BOT/EOT assembly over. Unsolder the three wires (noting their position carefully to allow correct replacement), and remove the assembly, and fiber optic bundles if step 6 was omitted.

1. If the old fiber optic bundles are being used, blow dust off both ends (wipe with lint-free cloth if necessary) and install the clips which hold them to the BOT/EOT assembly.
2. Solder the wires to the assembly. Ensure that they are positioned as before.
3. Push the fiber optic bundles carefully back into the tape unit.
4. Attach the assembly with the two mounting screws.
5. Route the fiber optic bundles back to the manifold. Be careful to route them away from the autocleaner on Models 4, 6, and 8.
6. Insert the bundles into the light manifold and replace the retaining wedge.
7. Adjust the BOT/EOT voltages. See 08-580.
