IBM Maintenance Library

Magnetic Tape Subsystem Maintenance Manual

3803-2/3420

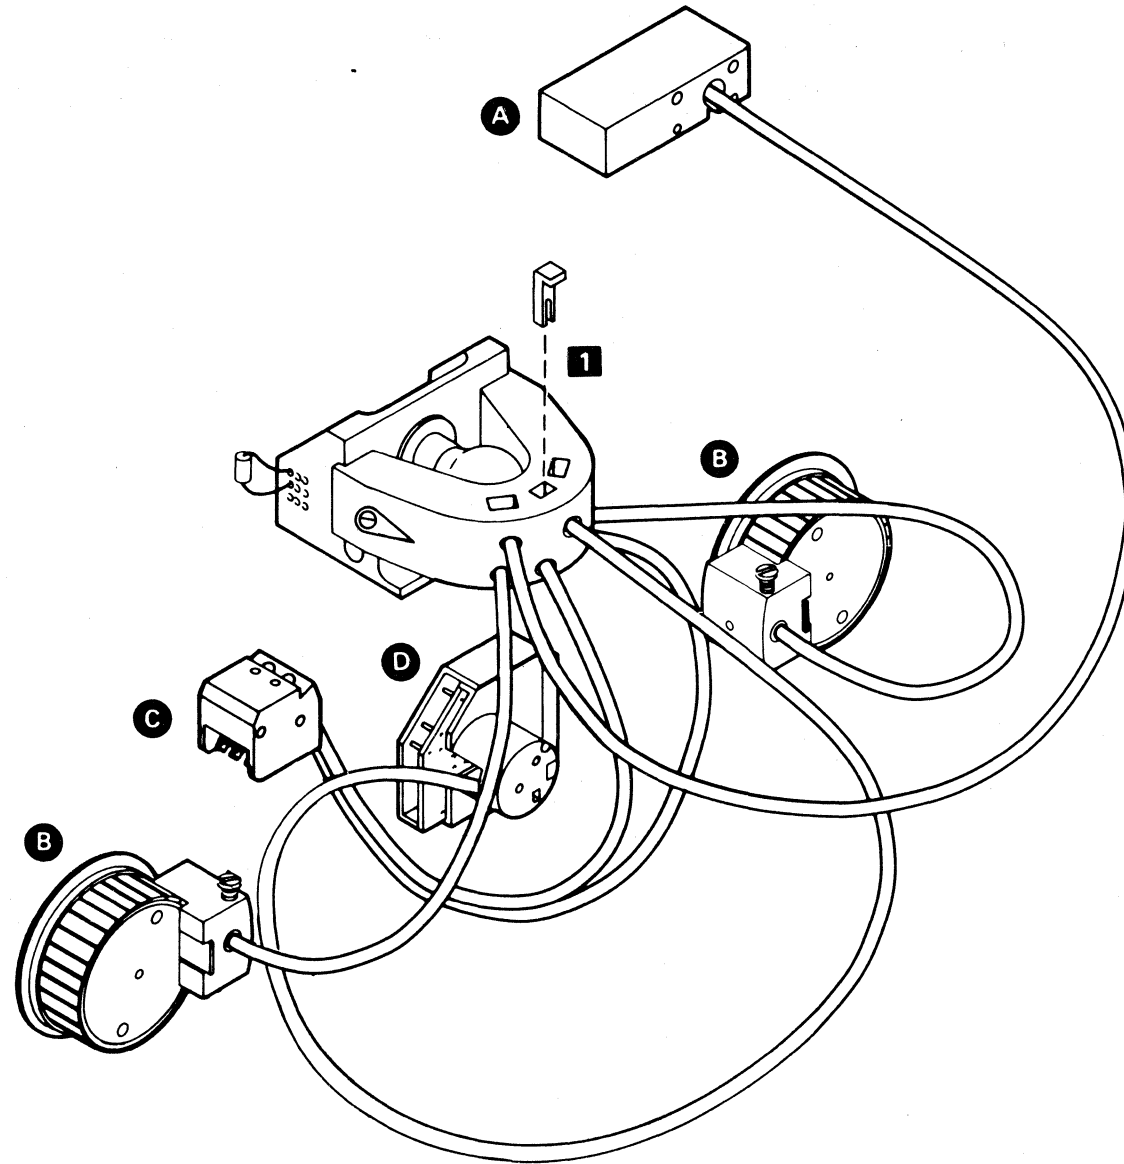
1. Pry the retaining wedge from the light manifold.
2. Pull the defective bundle out of the manifold.
3. Disconnect the other ends of the bundle by removing or loosening each retainer.
 - A The radius sense assembly uses the same type of wedge as the manifold.
 - B The reel tachometers use a nylon setscrew.
 - C The BOT/EOT assemblies use metal clips that are held in place by screws.
 - D The capstan tachometer uses a plastic taper pin on earlier parts. On later models the fiber optic bundle is not removable.
4. Reverse the procedure to install a new bundle.

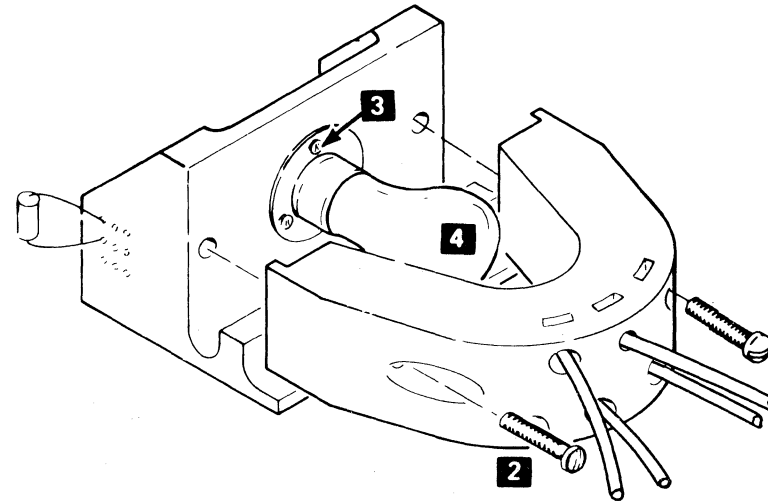
1. Turn off tape unit power and allow the lamp to cool.
- 2 Remove the two screws that hold the light manifold to the front panel and carefully lower the manifold out of the way.
Caution: Do not pinch, kink, or stretch the fiber optic bundle.
- 3 Loosen the three flat-head screws that fasten the lamp base.
- 4 Rotate the lamp counterclockwise to remove it.
5. Reverse the procedure to install a new lamp. The lamp filament should be vertical to ensure correct operation.
6. Replace the light manifold.

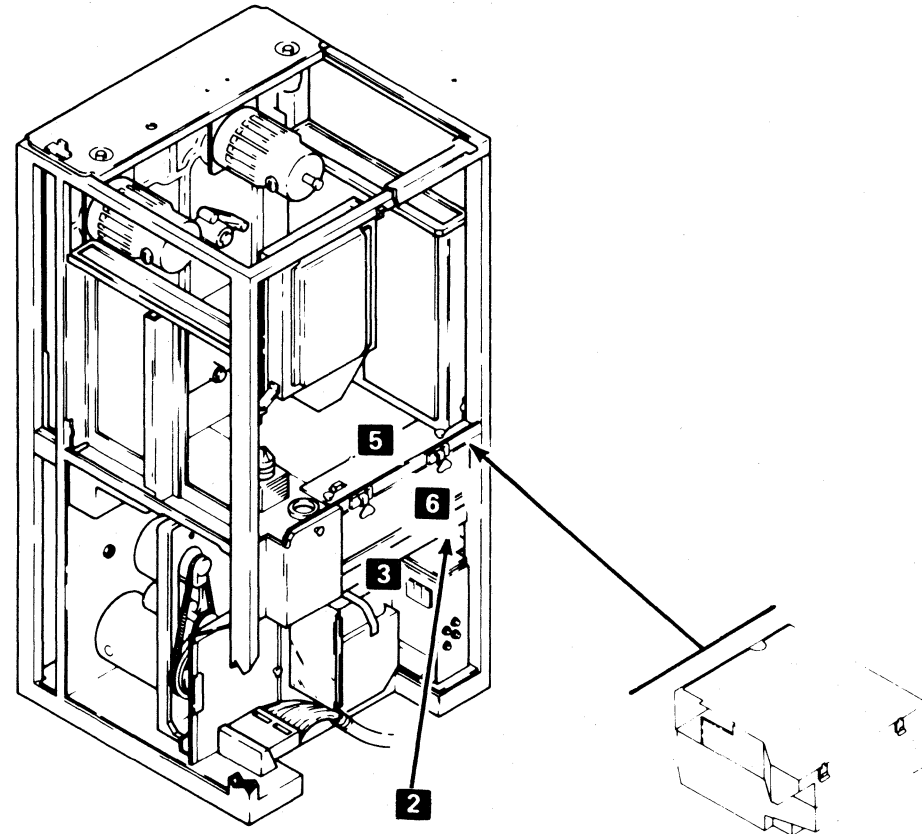
1. Turn off tape unit power.
2. Disconnect the blower motor plug from the power supply.
3. Remove the air filter.
4. From the extreme rear of the blower assembly, unplug the cable that leads to the resistor frame.
5. Unlatch the two fasteners that hold the resistor frame and move the entire resistor assembly out of the way.
6. Unlatch the two fasteners on the rear vertical surface of the blower assembly.
7. Reach under the blower assembly and pull on the motor housing with one hand, while guiding the assembly out with the other hand.
8. After partially inserting a new assembly into its holder, push up from beneath the motor and lift the front end.
9. Push the assembly completely into place. Ensure that the front mounting lip slides over the front-edge frame.
10. Reverse steps 2 through 6 to complete the installation.

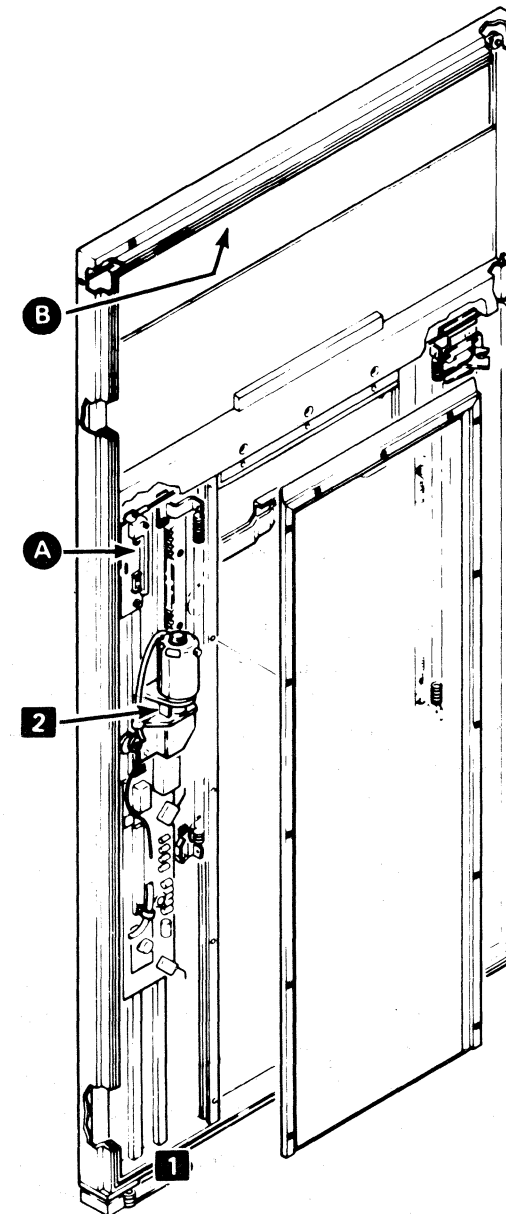
This safety bail adjustment procedure is a continuation of the Power Window Alignment procedure on this page; the safety bail procedure explains how to replace many parts that were removed in the earlier procedure. Adjust as follows:

1. Move the safety bail switch and the actuator assembly as far right as possible without the switch closing. **A**
2. On all models, apply upward pressure (at the top-right side of the window) to the soft plastic strip through which the cable runs. (On models without the lower door glass, also apply pressure to the soft plastic strip at the top center of the bottom window.) The safety bail switch should close with a force of 5 pounds (2268 grams) or less, or a displacement of 0.44 inch (11.28 mm) or less. **B**
3. Replace the black accent panel.

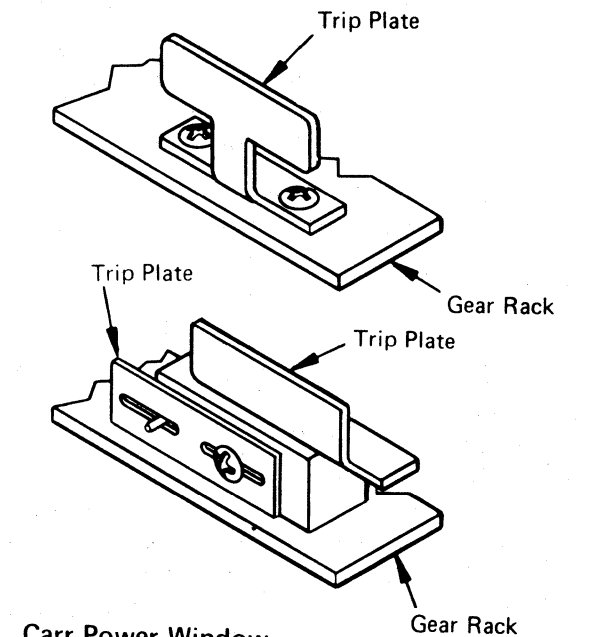
Carr Power Window

Caution: If the lower switch actuating arm is touching the switch body or any other object, shape the lower switch actuating arm up. Move the window down and check the window position, adjusting the trip plate as necessary with power off.

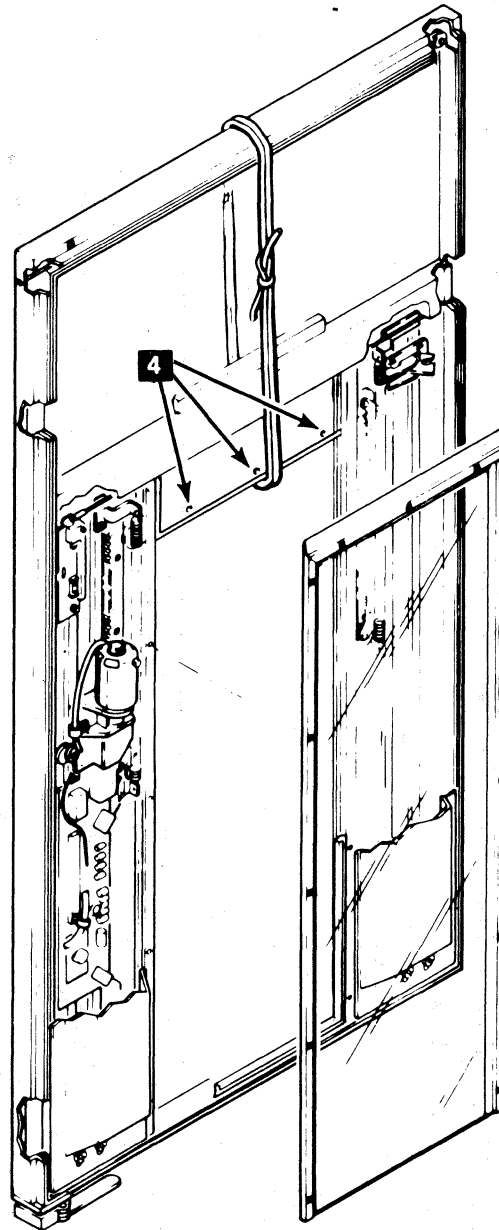
- 4 Support the glass with a rope or belt as shown. Remove three screws and two hex-head nuts from the window support.
5. Lower the window to where you earlier removed the felt strip and lift the glass out.
6. Replace the glass and reverse steps 1 through 5.

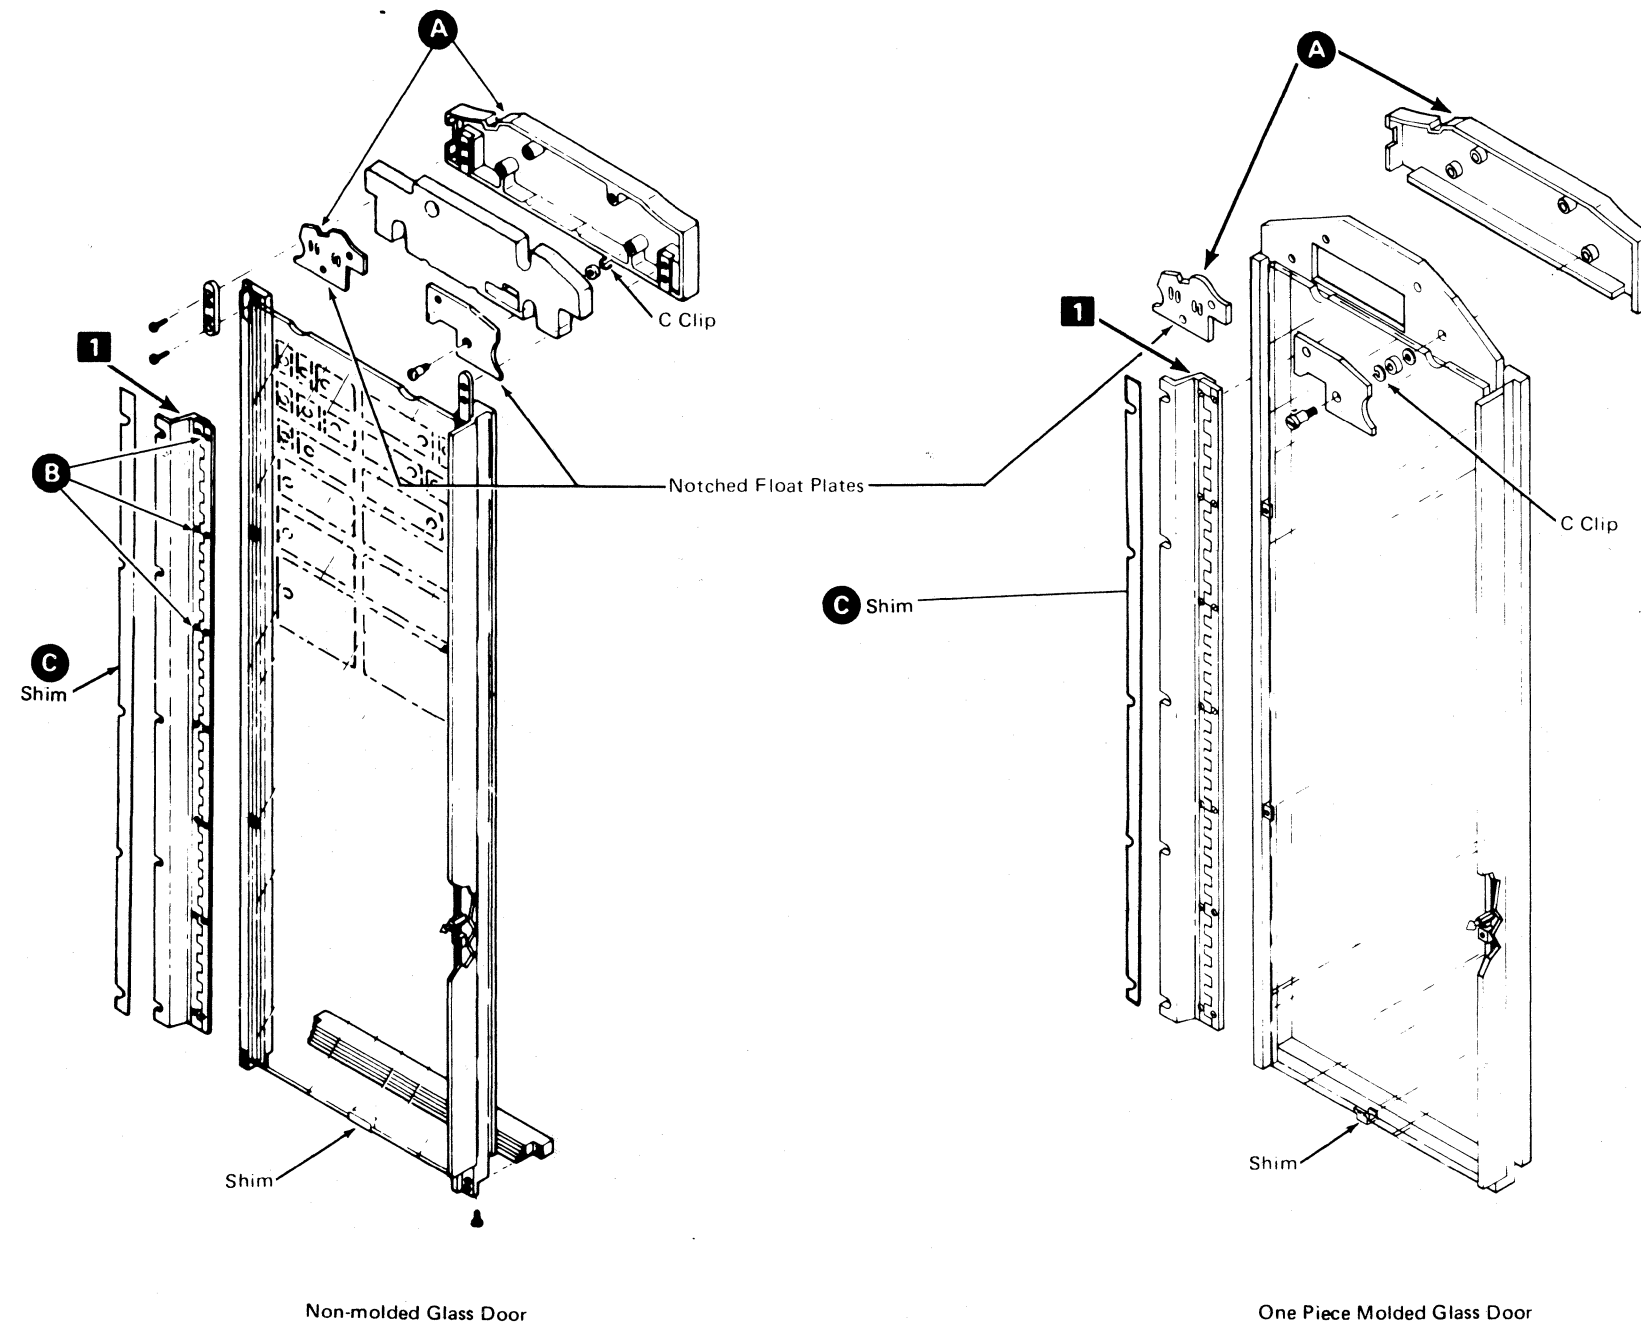
- 5 With the five screws in the Z bracket loose and with the door latches loose, move the entire door in or out to obtain a tight glass-to-column fit under vacuum-up conditions.

- 6 Check that the latches pull the door toward the columns when the door is closed.
- 7 Tighten all the screws and recheck the adjustments.
- 8 Perform the checks on 08-690.

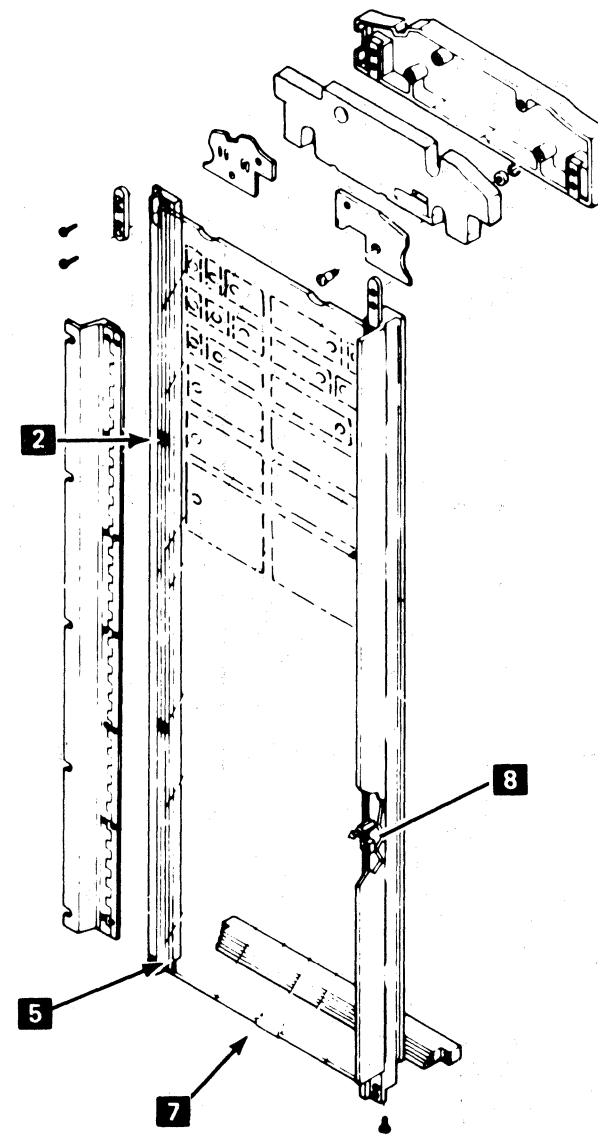
Non-molded Glass Door

- 8 Ensure that the glass is firmly held by the nonhinge side clamps and reinstall the clamps on the hinge side. There should be 0.001 to 0.013 inch (0.025 to 0.33 mm) gap.

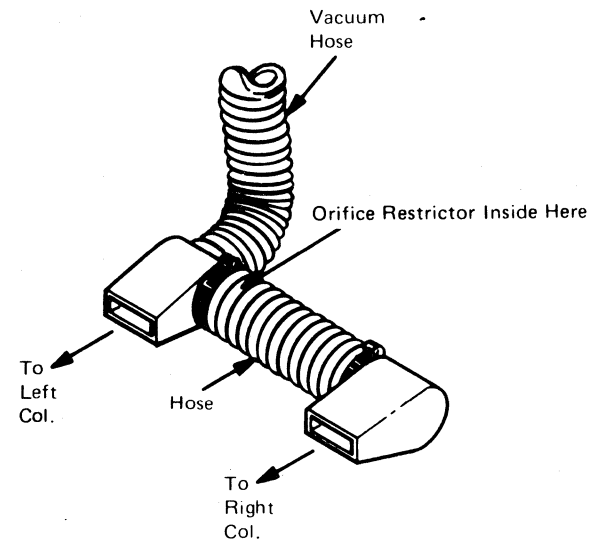
1. Inspect the hose between the column manifolds and ensure that the manifold is tight.
2. Load a full 2400-foot (731.52 m) reel and watch for any tendency for it to pull into only one column.
3. Try loading each size of minireel available. Vary the column vent for the best possible loading characteristic.

4. If reliable loading of both full and minireel tapes cannot be achieved, measure the orifice size with the 6-inch (152.4 mm) rule. Dumping in the left column indicates a need for a smaller orifice.
5. Replace the orifice and repeat steps 2 through 4.
6. If the adjustment cannot be made, ensure that both reels are attempting to lower the tape into the columns at the correct speed by comparison with an adjacent tape unit. Also check for a warped or cracked manifold.
7. You can connect the dial vacuum gauge to an unused column port to compare vacuum levels during loading. Remove an unused port cap to connect the gauge.

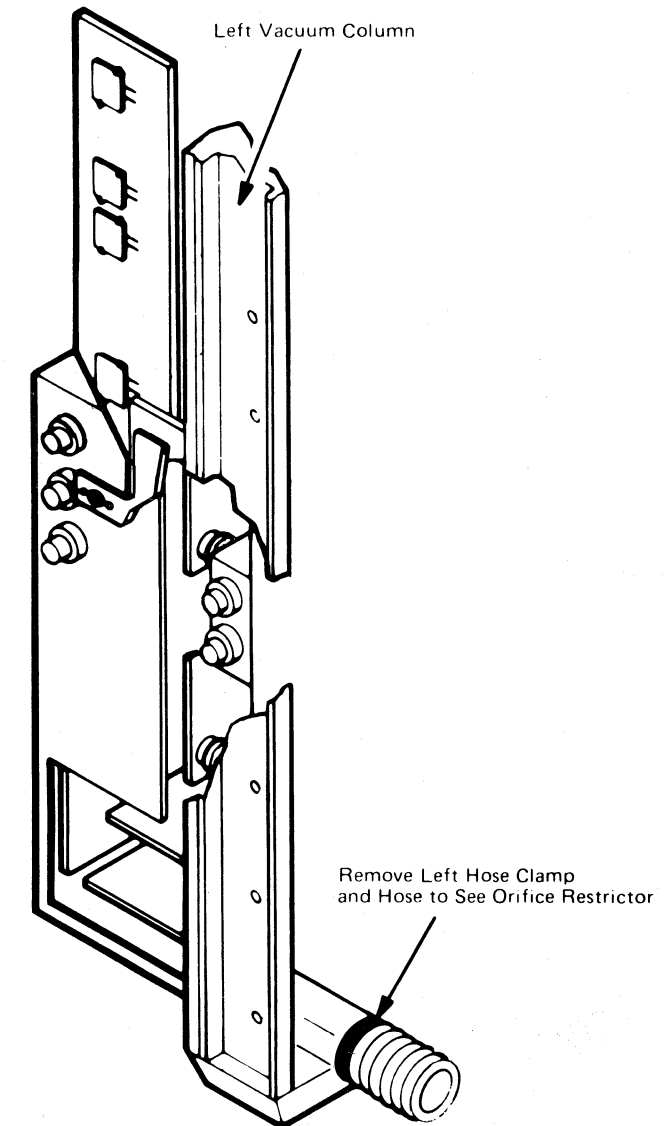
3. The size of the orifice in the left vacuum column manifold assembly (P/N 2511687) may vary. The manifold may contain the small, medium, or large orifice mentioned above, or there may not be an orifice at all. (The larger the opening, the more initial vacuum is applied to the right column.) Knowing what affects the vacuum balance between the two columns should help resolve the load problem. For example, if the tape is dumping into the left column, it indicates that the left column has

too much initial vacuum when compared with the right column. First, check that item 1 is not the problem. Second, adjust the vacuum column vents (item 2) by decreasing the vacuum in the left column and increasing the vacuum in the right column. Third, if neither items 1 nor 2 solve the problem, increase the orifice opening (item 3) until a correct load occurs. When finished, check the loading of the minireels and the 2400-foot (731.52 m) reels. Ensure that both types of reels load correctly.

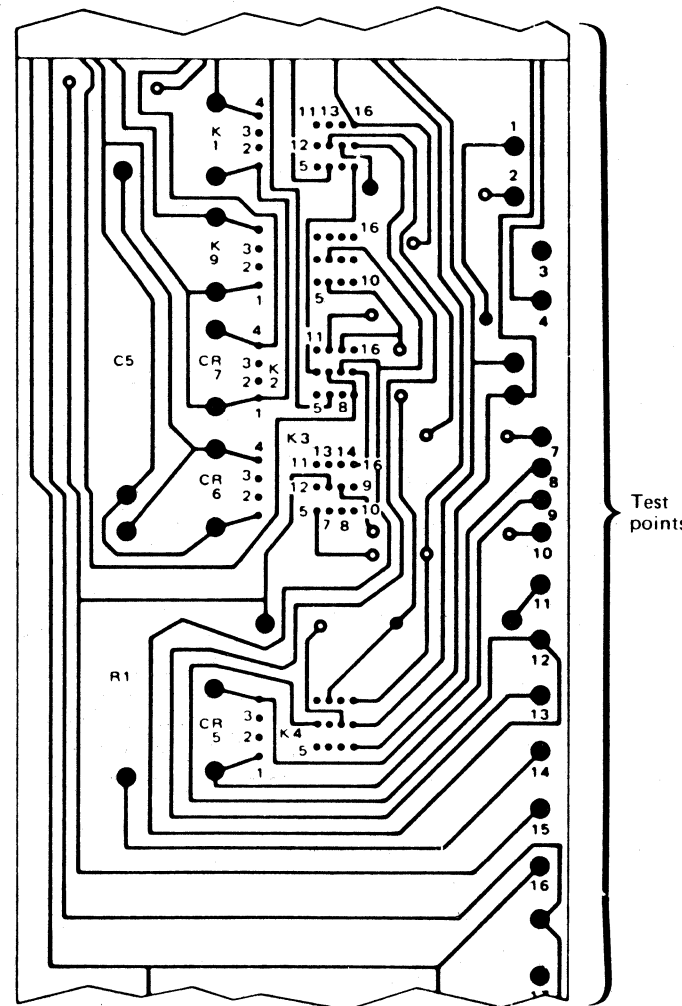
AC Printed Circuit Board

| Seq | Condition/Instruction | Action |
|---|--|--|
| 42 | The test points referred to in the following instructions are on the back of the ac printed circuit board. Measure from the test point specified to test point 16. Is -24 Vdc present at test point 7? | Repair or replace K6 (YF030) and go to 00-030. |

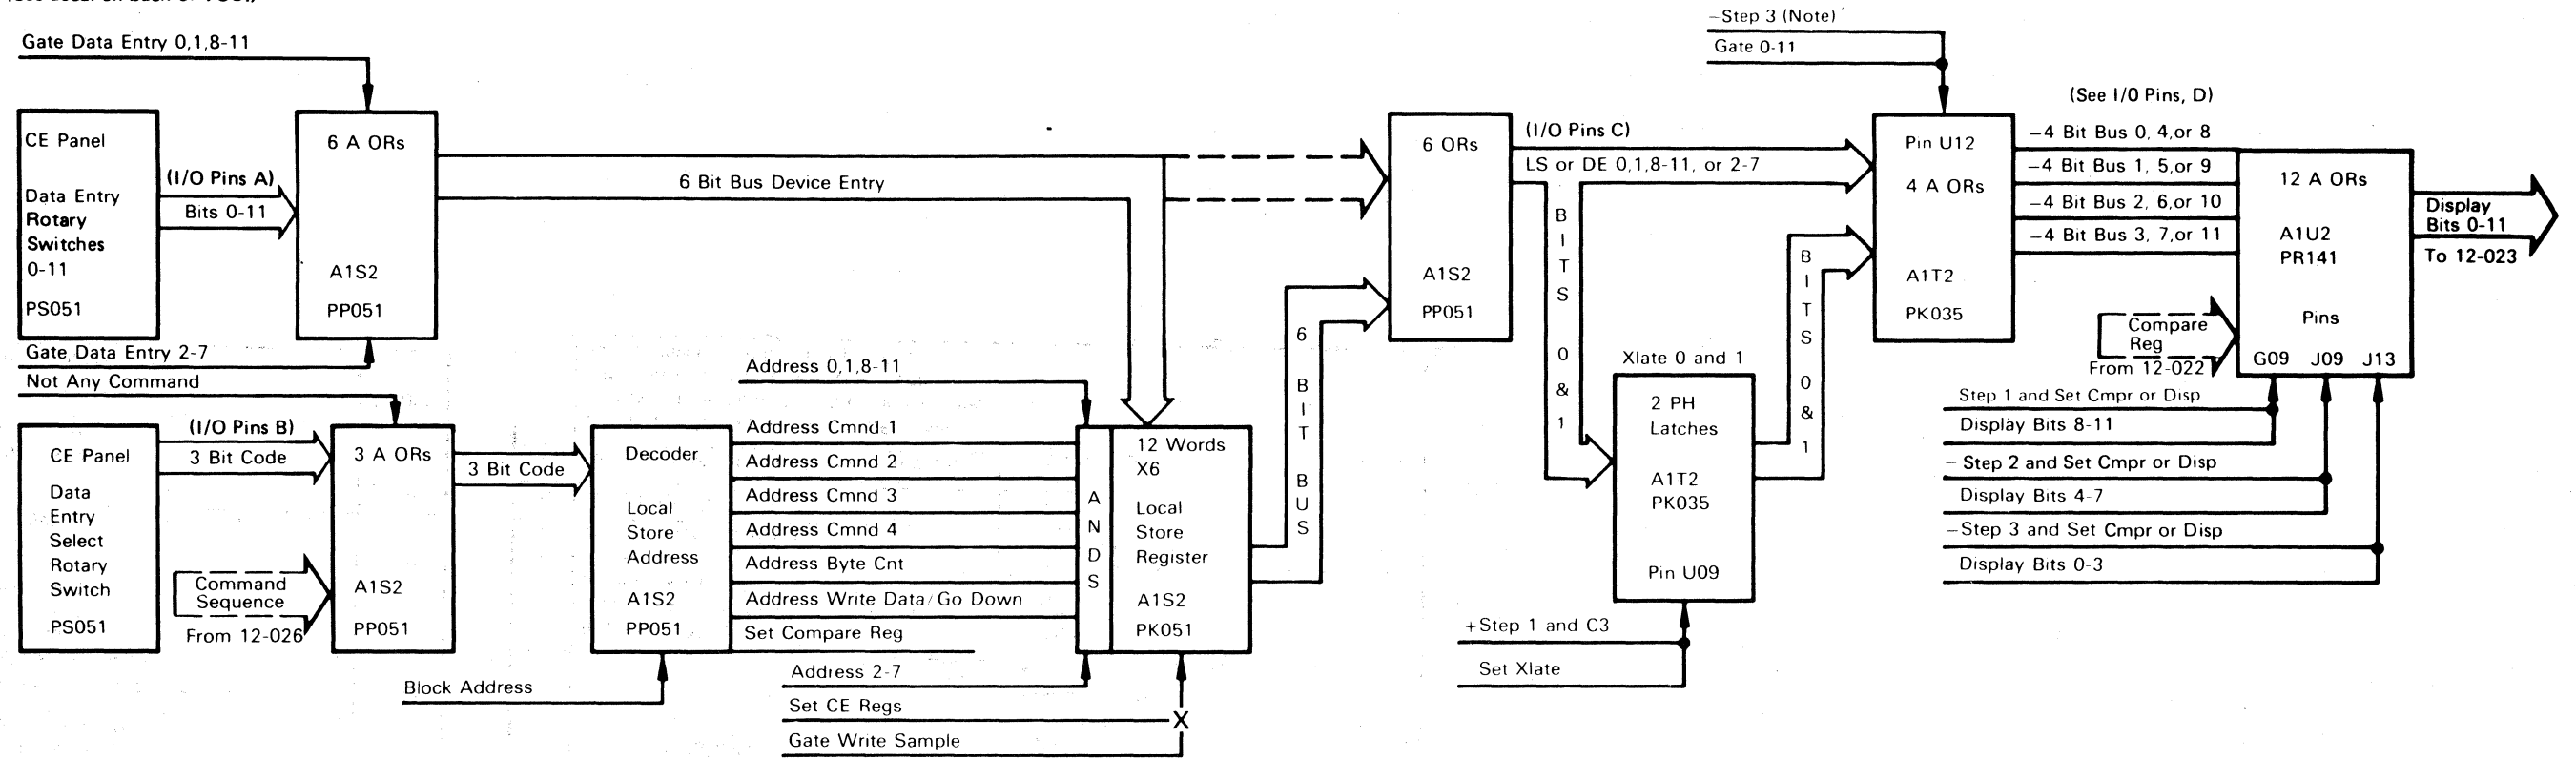
Important: Verify that the TCU dc voltages are within tolerance. (See decal on back of TCU.)

Note:
 During -Step 3, Bits 2,3 and Xlate Bits 0 and 1 are gated.
 During Not Step 3, Bits 4-7 are gated.

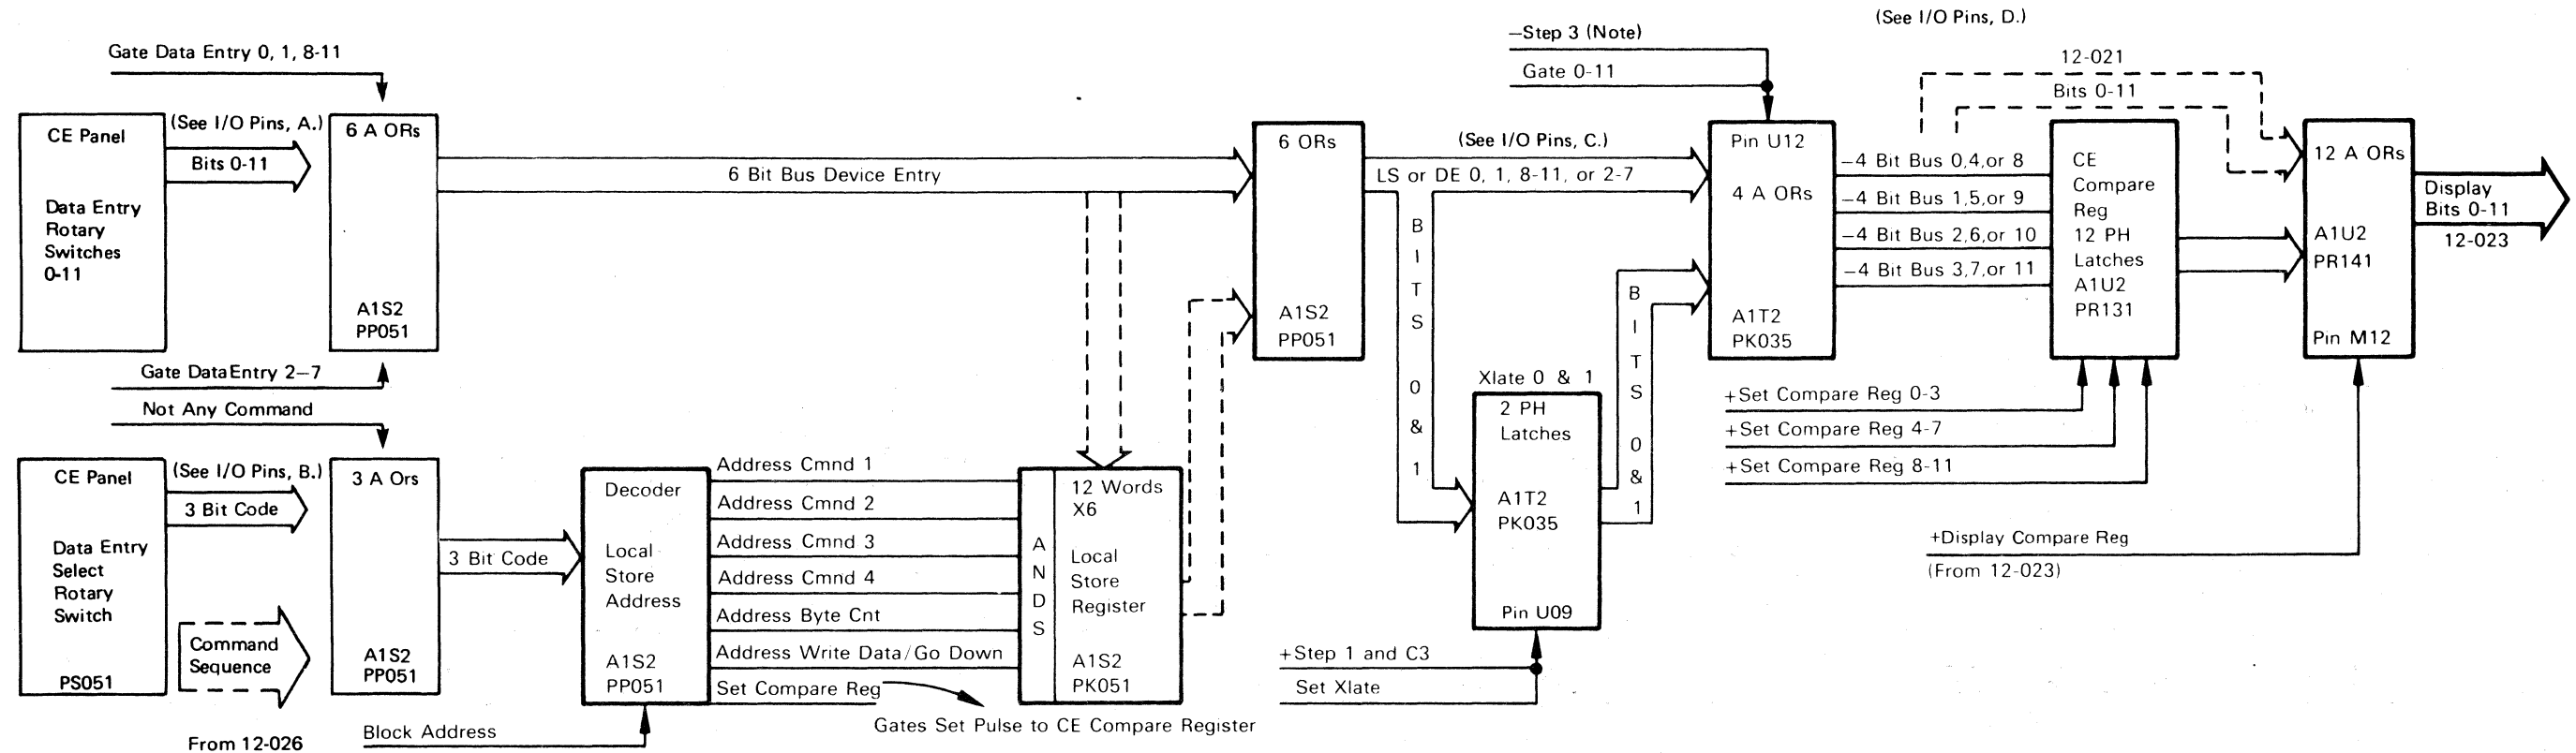
SET AND DISPLAY COMPARE REGISTER

Note: Verify that TCU dc voltages are within the tolerance. (See the decal on back of the TCU.)

Note:
During -Step 3, Bits 2,3 and Xlate Bits 0 and 1 are gated.
During Not Step 3, Bits 4-7 are gated.

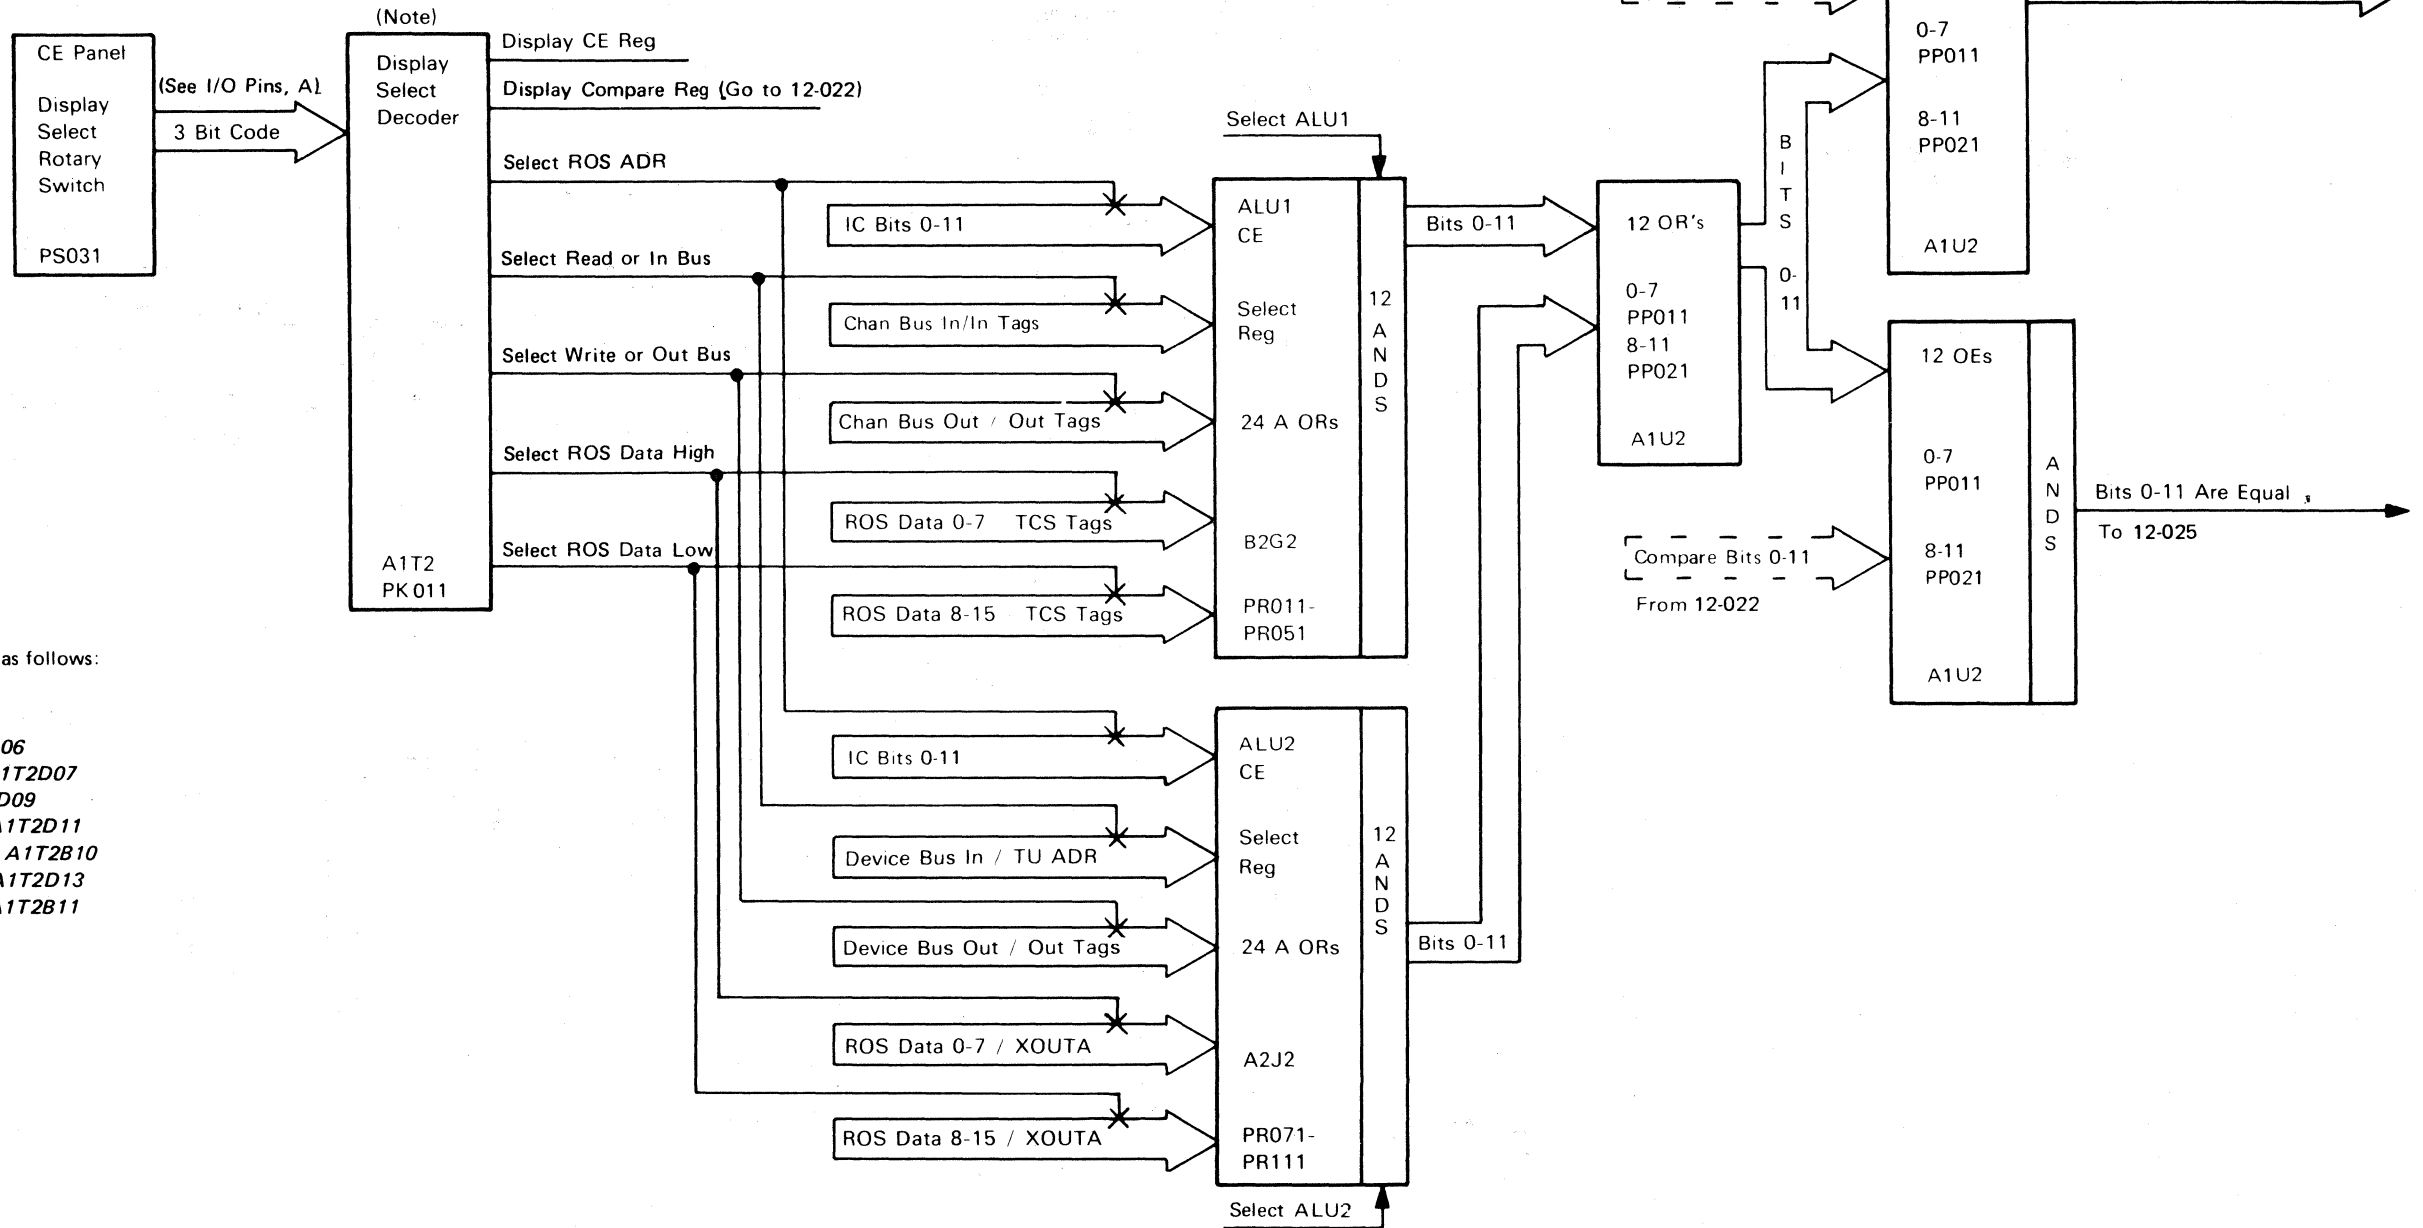
Note:
Line names that change from CE panel to logic are listed as follows:

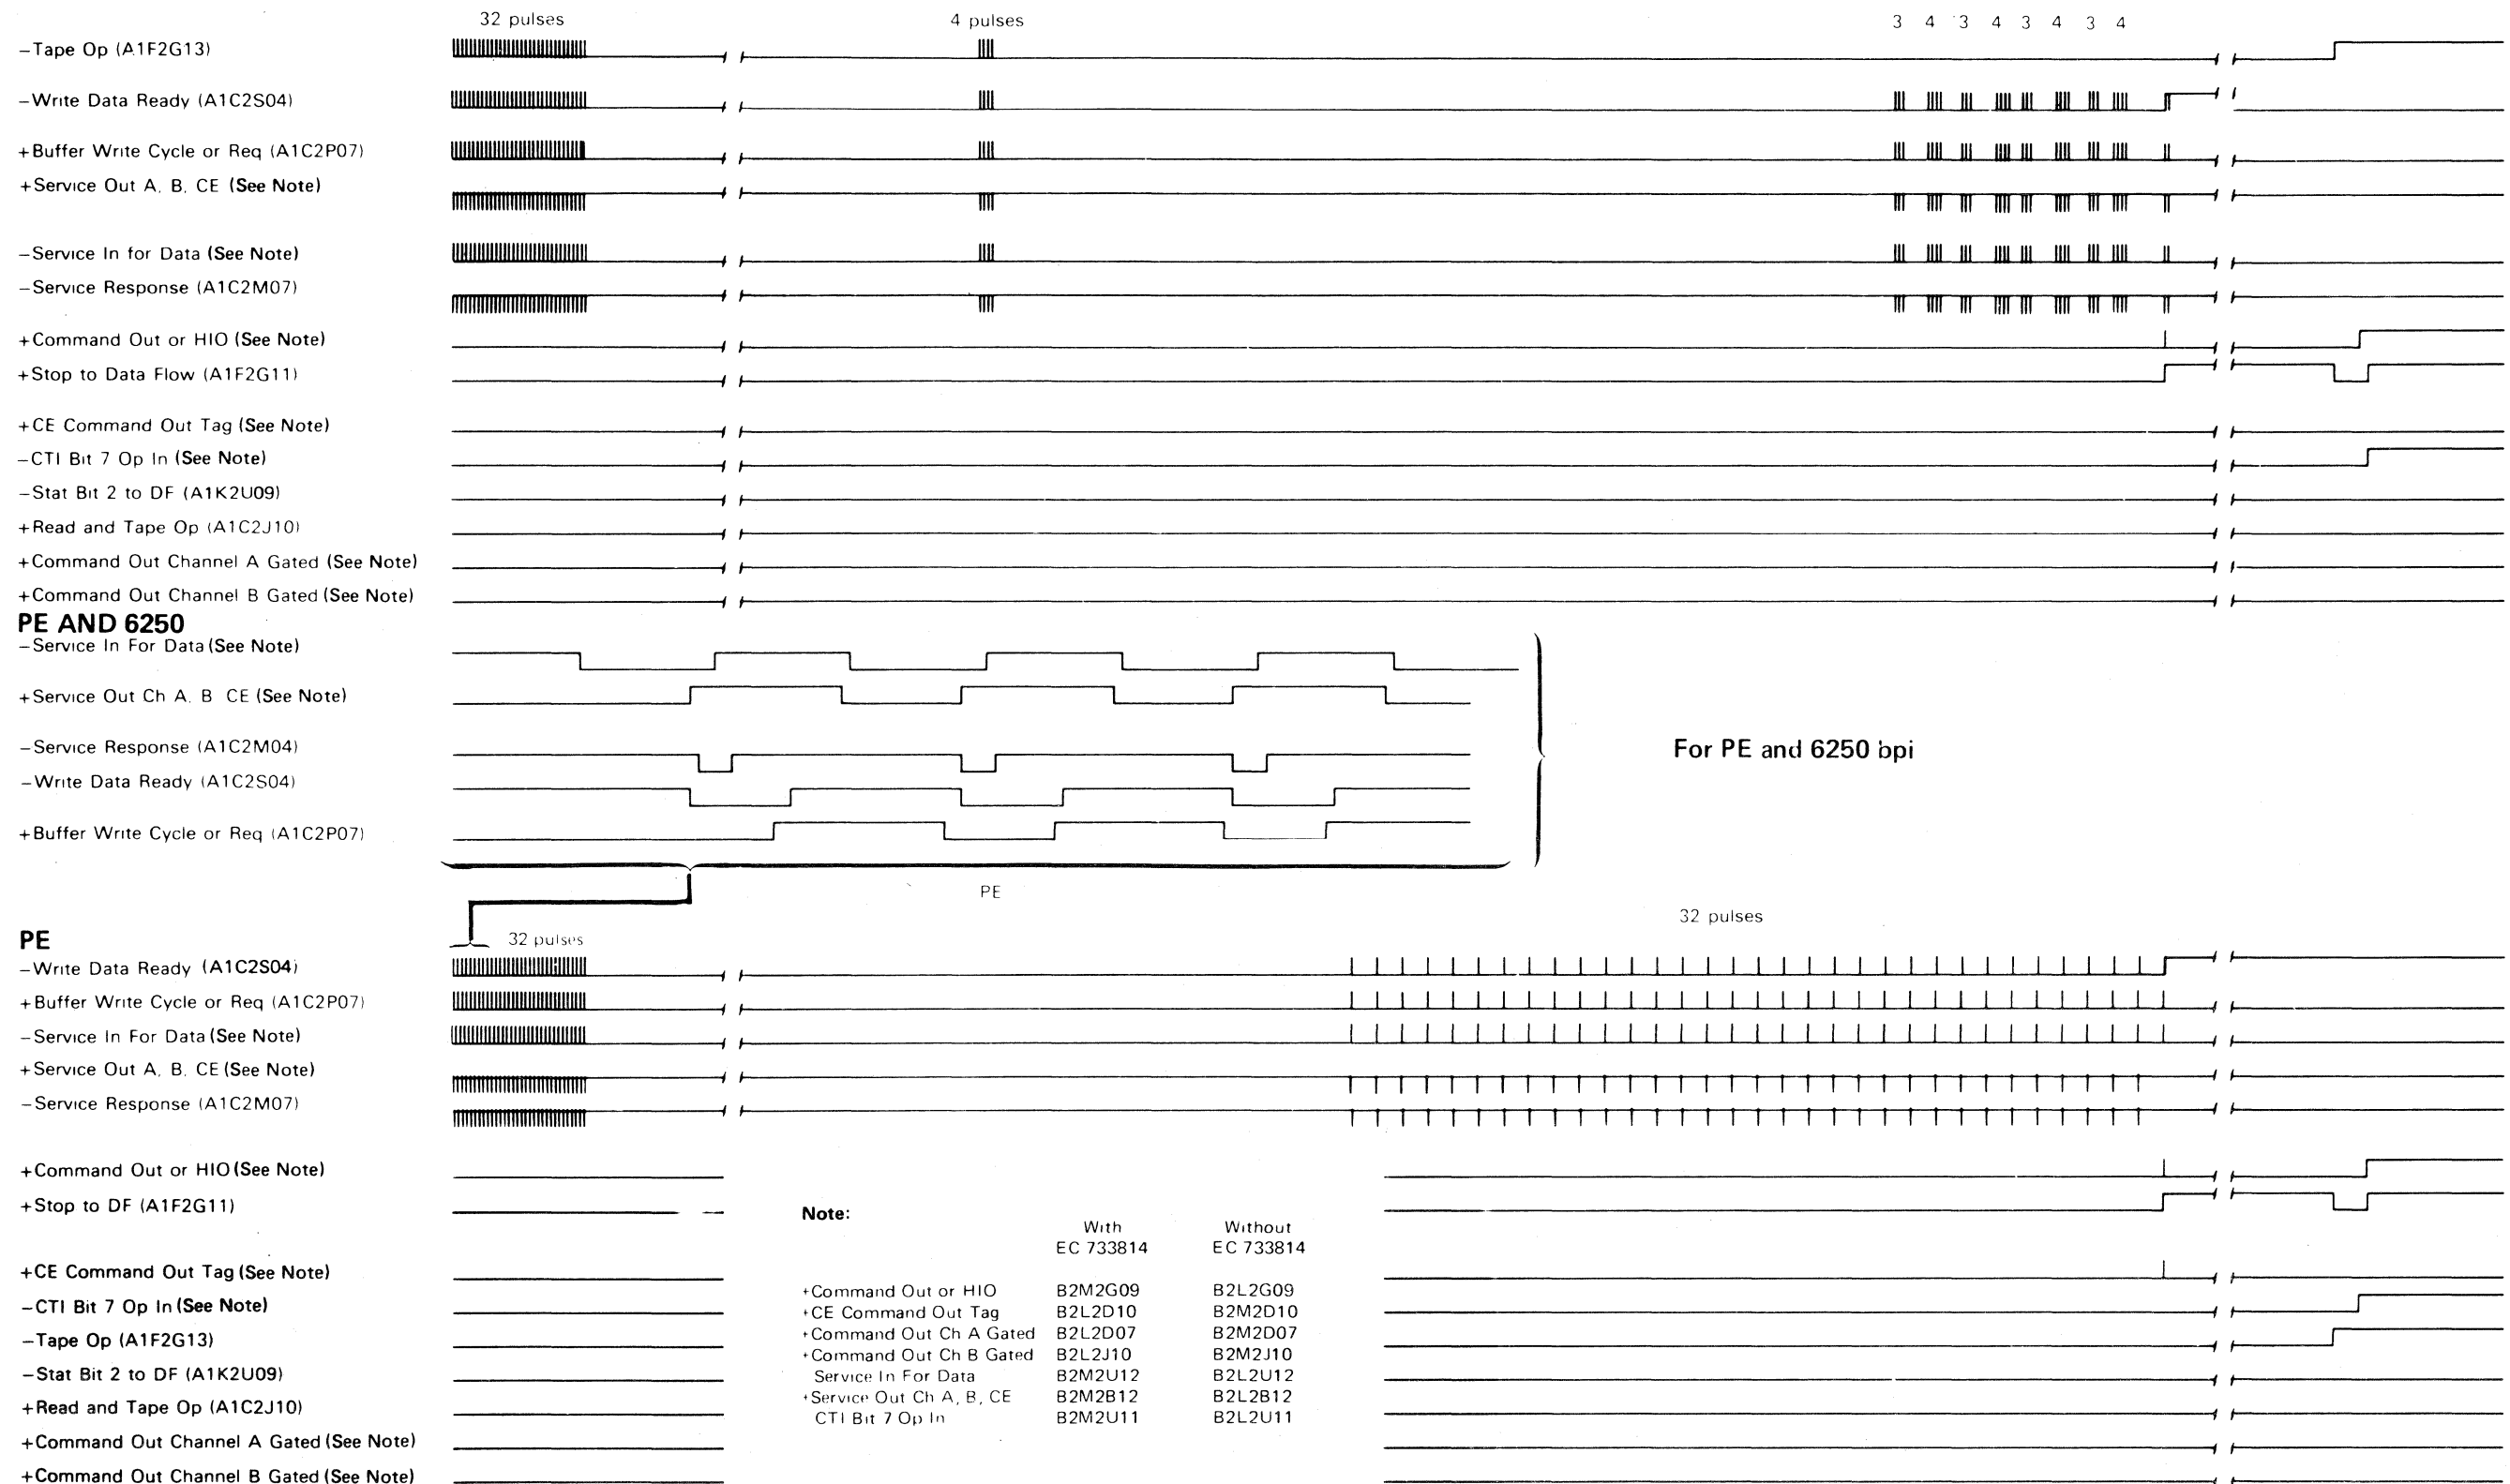
Overrun 6250 bpi

Overrun can occur with three possible conditions.

1. Channel buffer full on a Read operation. Data is not removed from the channel buffer fast enough.
2. Write buffer is empty. There are six or fewer bytes left in the channel buffer. Data is removed from the channel buffer too fast.
3. On a Read operation, if there is a P Compare or a CRC Error.
