8265 Nways ATM Switch

Problem Determination and Service Guide

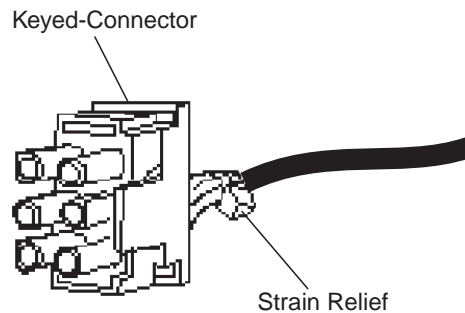
Figure 0-2. Ground Pin on Mainline dc Power Cable

- Measure the resistance of the disconnected mainline dc power cable from the ground pin on one end to the cable ground (green and yellow) on the other end.

The measurement should be 0.1 ohms or less.

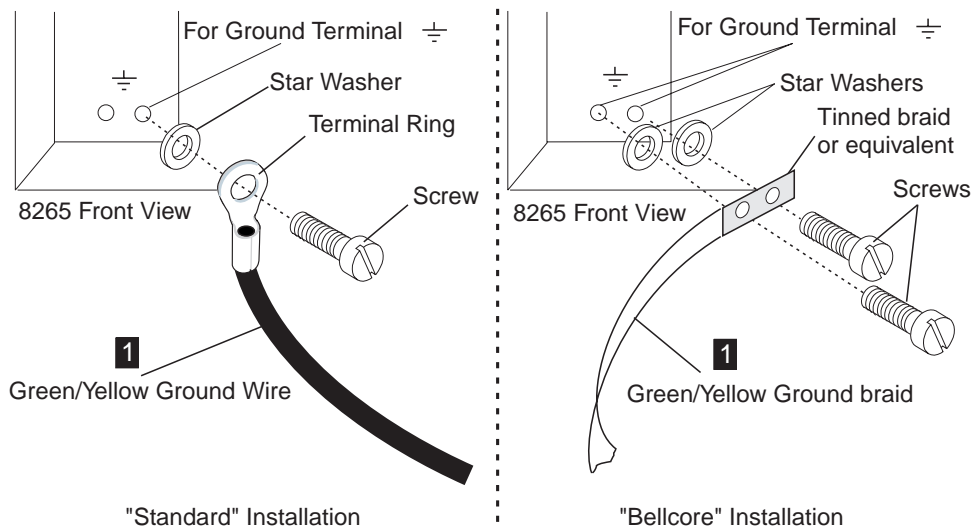
- 1) Grounding is ensured by the screws which secure the 8265 chassis on the rack.
- 2) Grounding is assured by wire **1** connected from the 8265 chassis to the rack.

Note: The ground wire **1** is not provided by IBM.

Note: All the previous measurements should indicate 0.1 ohms or less.

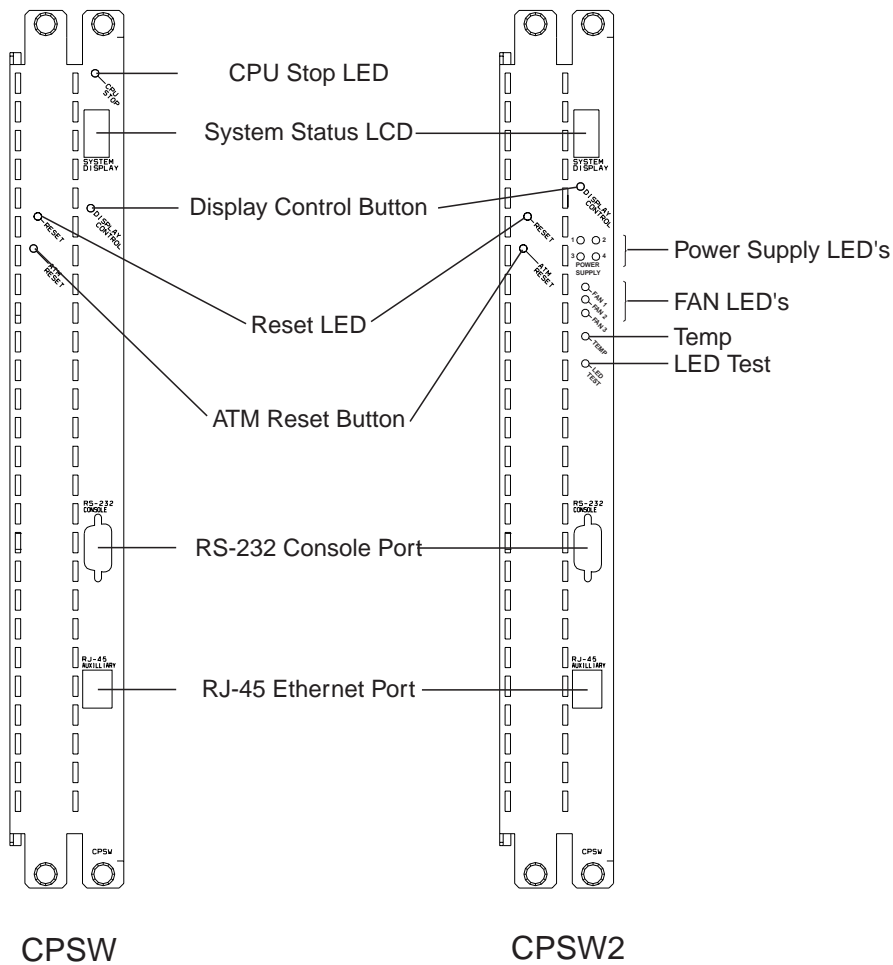
Figure 1-1. How to identify CPSW and CPSW2

In this manual, CPSW is the generic name for CPSW (Feature Code 6501) and CPSW2 (Feature Code 6502) unless otherwise specified.

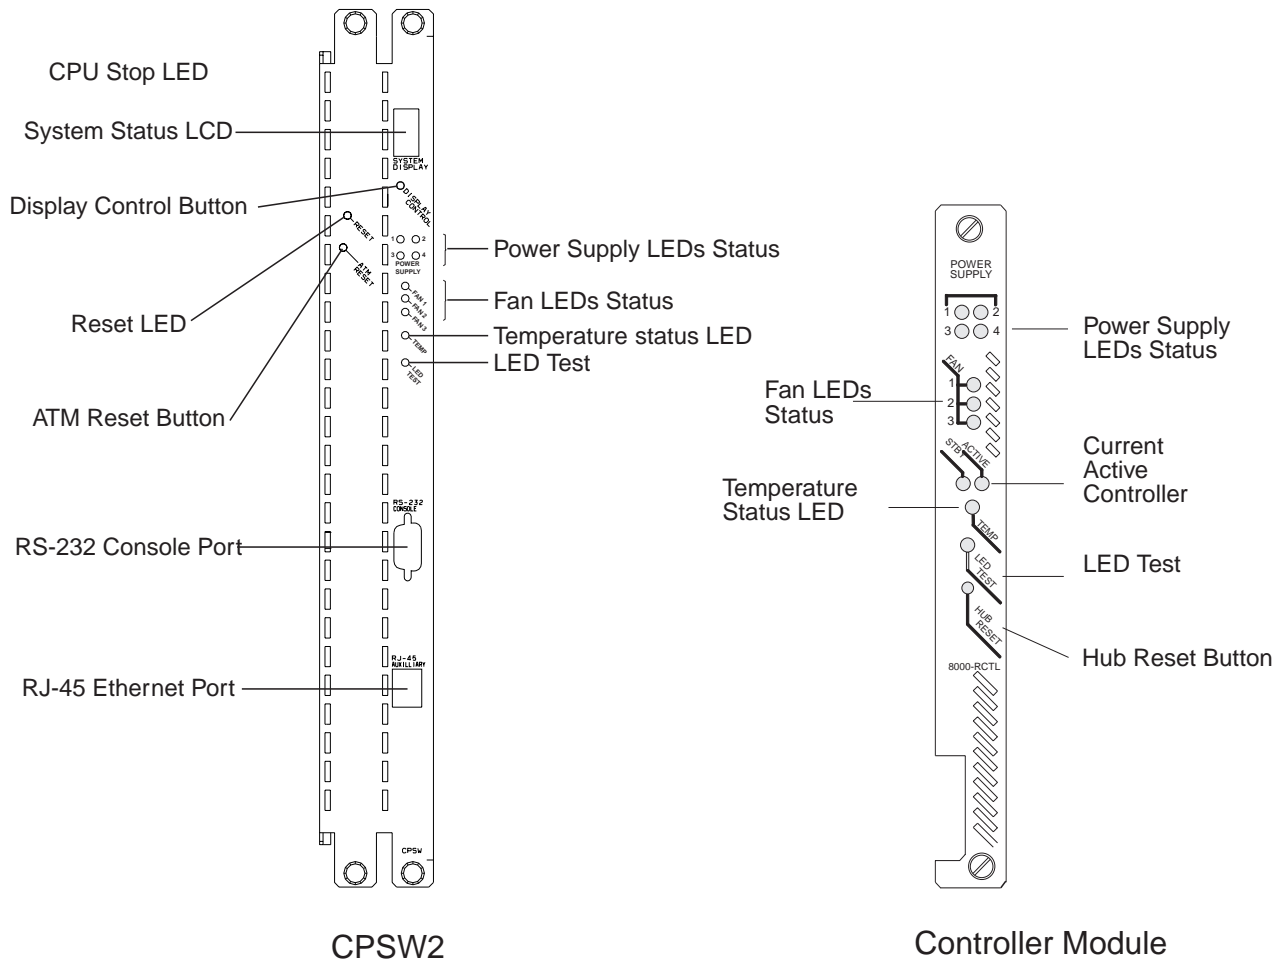
Figure 2-1. Controller Module and CPSW2

Symptom Explanation
8265 seems inactive
One or several LEDs located on the CPSW2 or on the controller module are OFF
All LEDs are ON

Do you have a CPSW2 installed in your 8265? (see Figure 2-1)

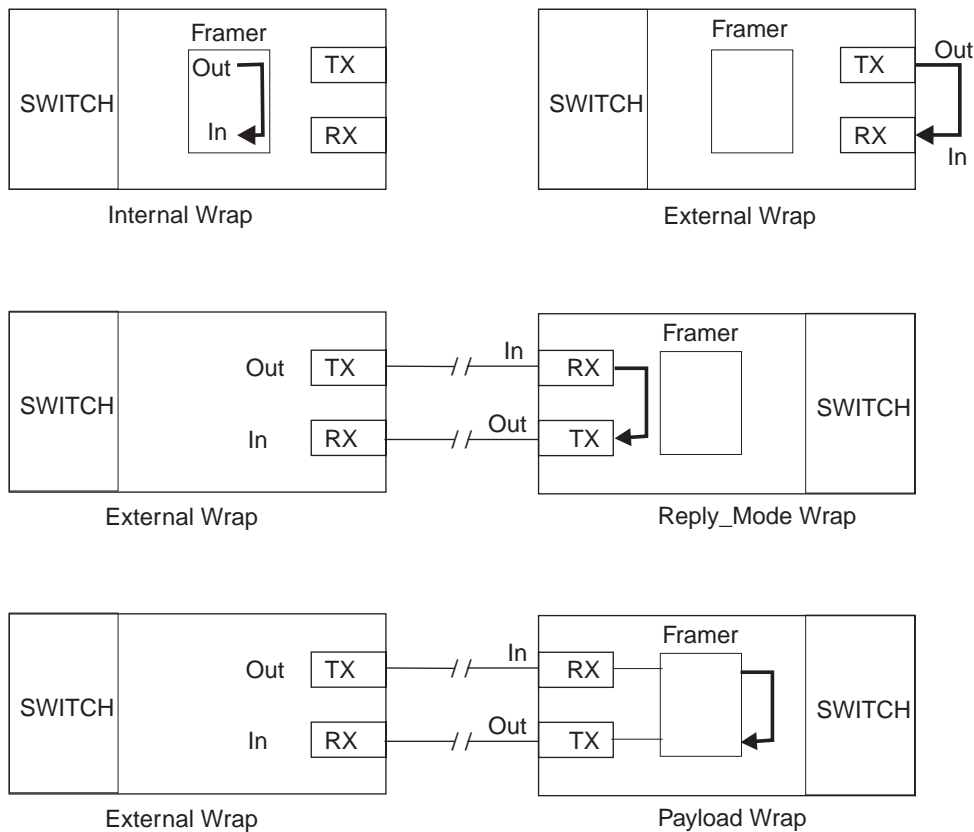
- Internal wrap: the data path stays inside the module.
- External wrap: a physical wrap must be *wired* from transmitter to receiver.
- Reply mode wrap: an internal wrap from the receive side to the transmit side allowing to exercise the whole path from a port to another one.
- Payload wrap: an internal wrap from the receive side to the transmit side allowing to exercise the whole path from a port to another one including transmitter, receiver and framer of remote module.

The following drawings show the operating mode of the four wrap levels.

Note: On a 4-Port 155 Mbps module, a port can be configured in reply mode and another port of the same module in wrap external.

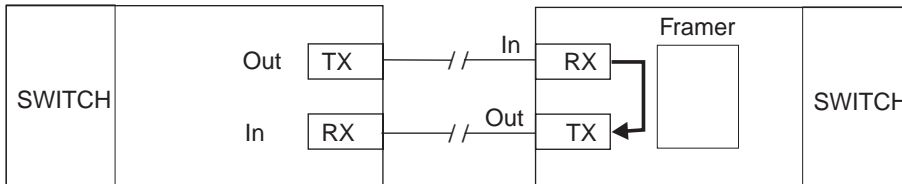
- **Far_End_Mode wrap:** This test put the remote port in **reply mode wrap**. Starting a **Far_End_Test** on local console allows to test the link. The test result appears on local console.
- **Far_End_Payload wrap:** This test put the remote port in **payload mode wrap**. Starting a **Far_End_Test** on local console allows to test the link. The test result appears on local console.

1 - Far_End_Mode Wrap
2 - Far_End_Test

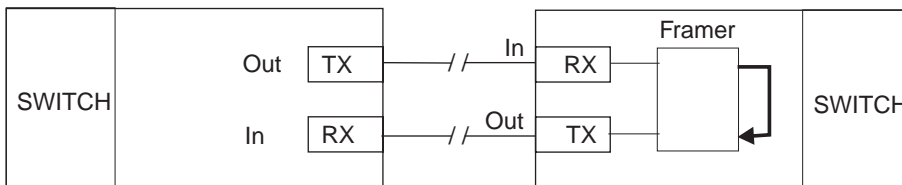
1 - Far_End_Payload Wrap
2 - Far_End_Test

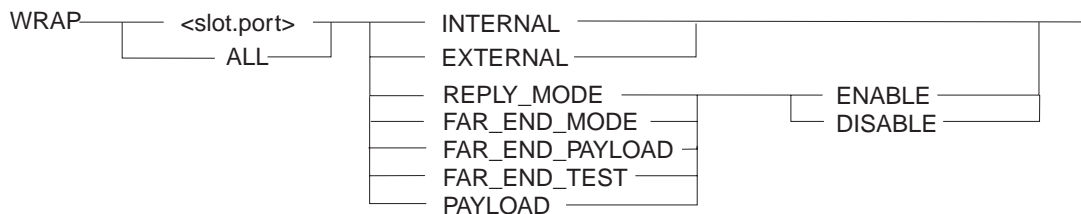
The syntax of the command to issue is:

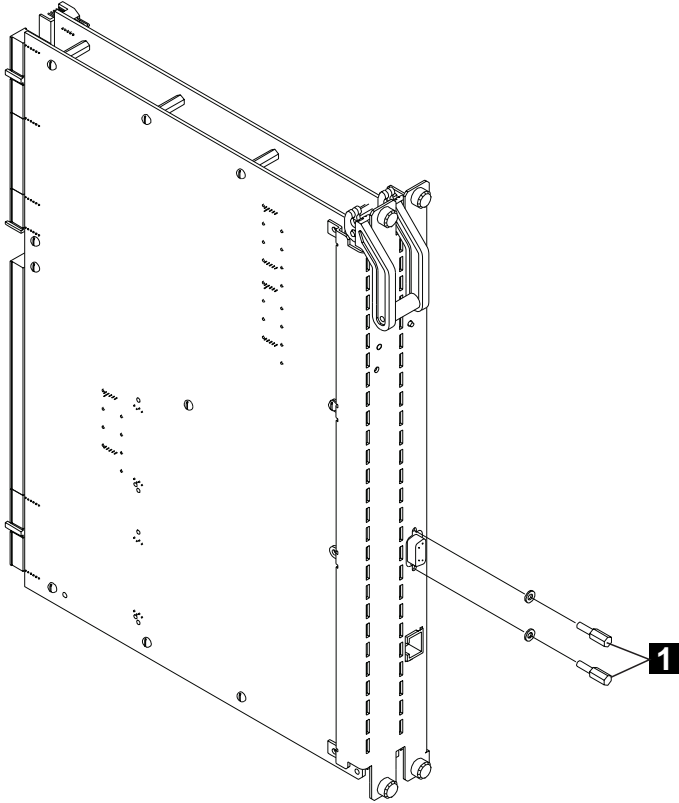
1. Remove the CPSW from the 8265.
2. Unscrew the two RS232 connector screws **1** on the face plate.

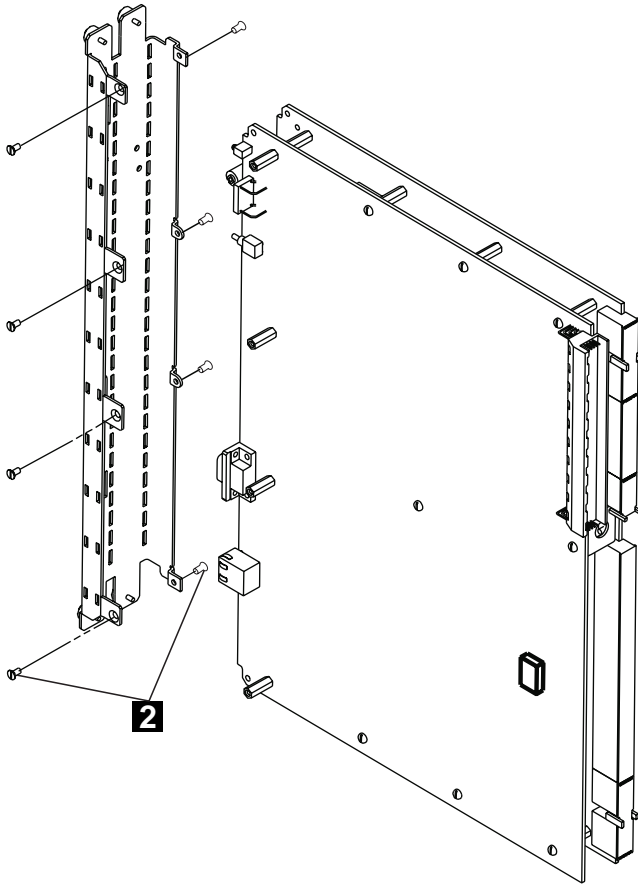
3. Unscrew the eight screws **2** from the face plate (4 each side).

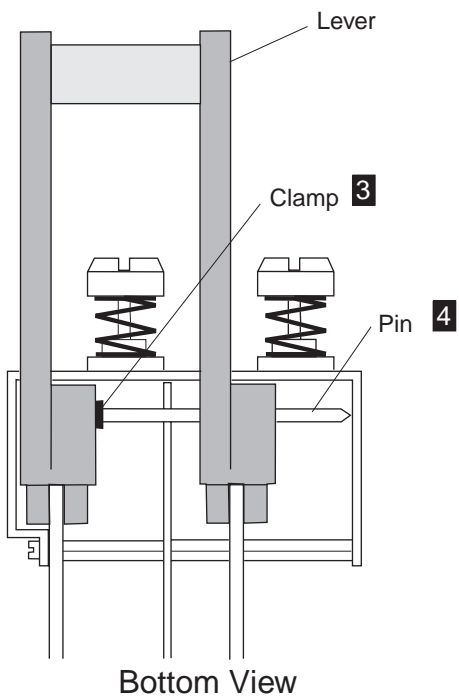
4. Remove the little clamp **3** from the upper and lower pins **4** . Remove the pins, then remove the levers and the face plate.

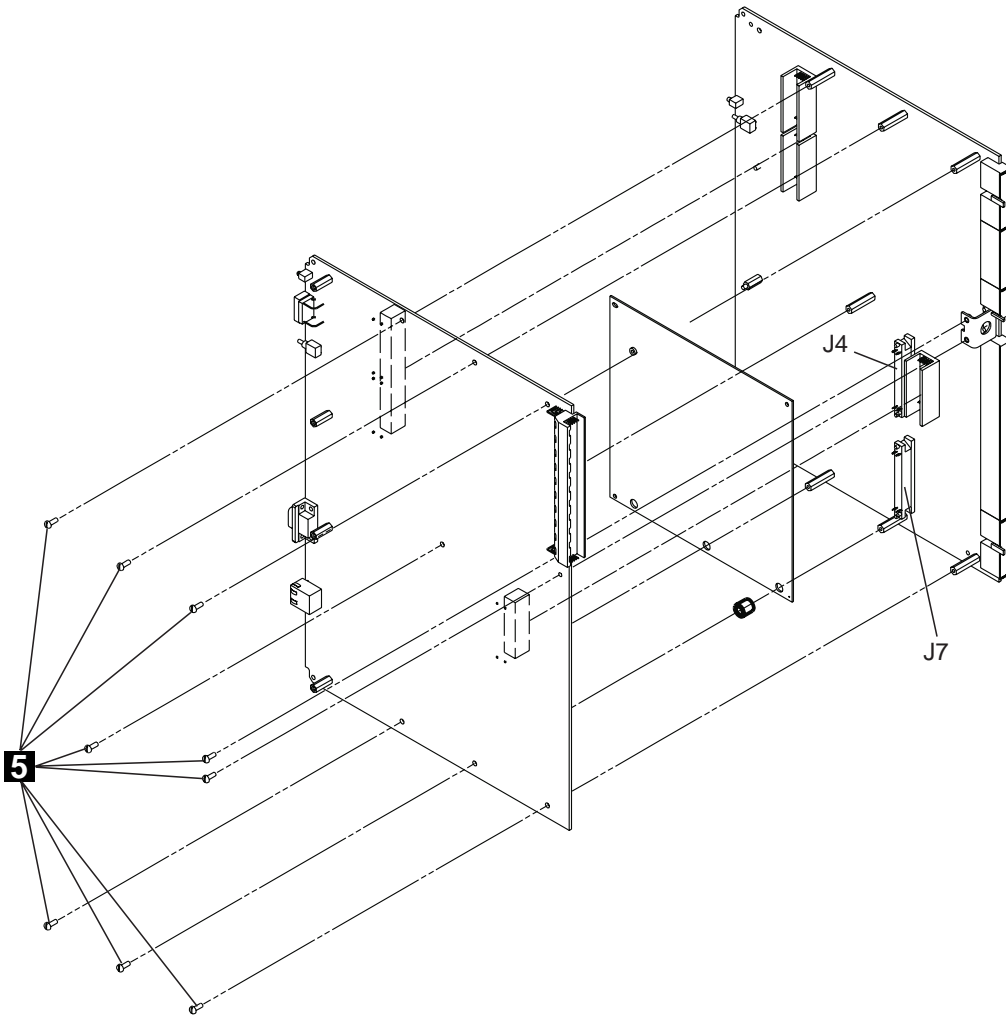
5. Unscrew the nine screws from CP side **5** and the two standoffs.

6. Unplug the CP from the switch card (two connectors, one near the PCMCIA and the other near the tri_channel).

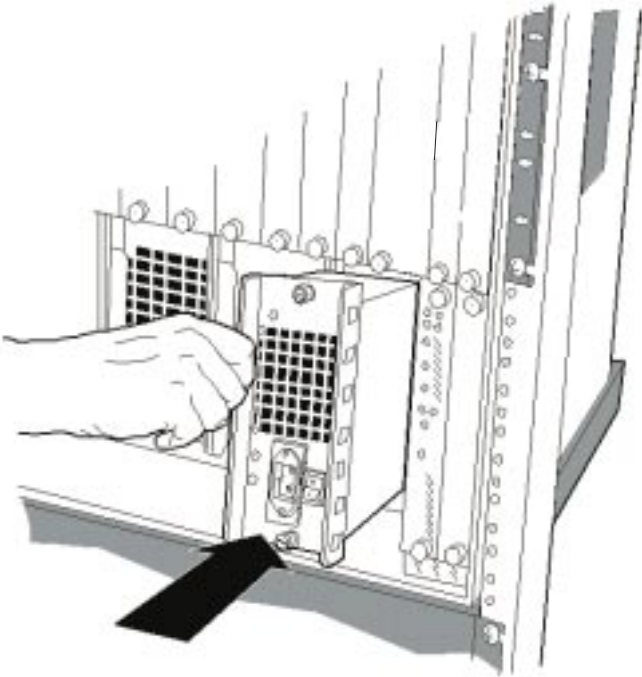
Figure 4-1. Replacing a Defective Power Supply

- 8** Carefully slide the power supply into the selected power supply slot (the same slot from which the defective supply was removed, or any other available power supply slot).

- 9** Hand-tighten the spring-loaded screws that secure the power supply to the front of the 8265.
- 10** Plug the power cord into the socket on the power supply.
- 11** Plug the power cord into the wall outlet.
- 12** Set the power supply's ON/OFF switch (I / O) to the ON (I) position. The replacement power supply is now fully operational.
- 13** Optionally, install the power supply bay grille:
 - a** Grasp both ends of the grille and place the two bottom tabs into the notches at the base of the power supply bay.
 - b** Flex the grille so the tab on each end of the grille can be fitted into the corresponding notches on the power supply bay.
 - c** Still flexing the grille, insert the tabs into each respective notch.

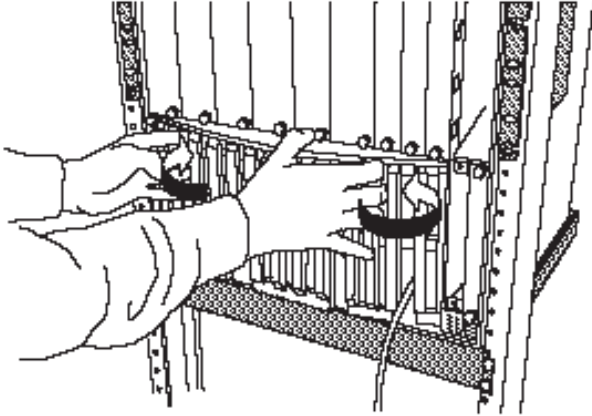
Figure 4-2. Power Supply Bay Grille Installation

d Once the tabs have been inserted in each notch, release the grille to complete the installation.

- 1** If installed, remove the power supply bay grille to gain access to the power supply bay (see Figure 4-2 on page 4-4).
- 2** Set the defective power supply's ON/OFF switch (I / O) located on the front of the supply to the OFF (O) position.
- 3** Remove the power cord from the wall outlet.
- 4** Remove the power cord from the power supply socket.
- 5** Loosen the spring-loaded screws that secure the power supply to the front of the 8265.
- 6** Pull the power supply straight out from the chassis, making certain you do not damage the connectors on the rear of the supply or those on the power switching board.
- 7** Remove the replacement power supply from its shipping box and set the power supply's ON/OFF (I / O) switch to the OFF (O) position.

- 1** If installed, remove the power supply bay grille to gain access to the power supply bay (see Figure 4-2 on page 4-4).
- 2** Set the defective power supply's ON/STANDBY switch to the STANDBY position.
- 3** Turn off the power source circuit breaker, protecting the power supply you want to remove.
- 4** Unplug and remove the keyed cable connector from the power supply socket.
- 5** Loosen the spring-loaded screws on the power supply faceplate.
- 6** Carefully pull out the power supply from the slot of the chassis.
- 7** Remove the replacement power supply from its shipping box and set the power supply's ON/STANDBY switch to the STANDBY position.
- 8** Plug the keyed-connector into the power supply socket.
- 9** Carefully slide the power supply into the selected power supply slot (the same slot from which the defective supply was removed, or any other available power supply slot).

- c. Still flexing the grille, insert the tabs into each respective notch.
- d. Once the tabs have been inserted in each notch, release the grille to complete the installation.
See Figure 4-2 on page 4-4.

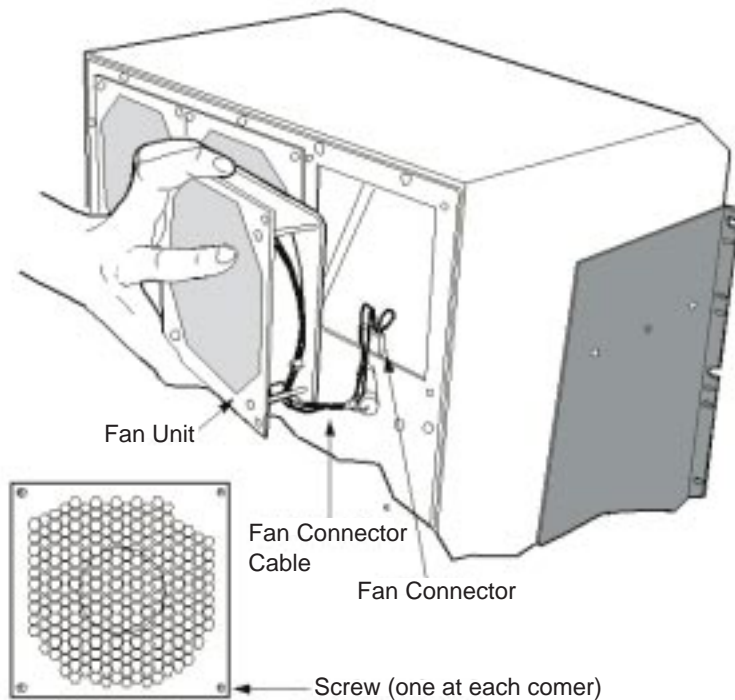
Figure 4-3. Replacing a Defective Fan Unit

- 1 Remove and save the four corner screws that attach the fan unit to the rear of the 8265.
- 2 Carefully pull the fan unit straight out from the 8265 fan bay and, before completely removing the fan, grasp the four-position fan connector cable and disconnect it from the 8265 (see Figure 4-3).

- 3 Remove the replacement fan unit from its shipping box and carefully slide the fan into the slot formerly occupied by the faulty unit. Connectors on the installed fan must be firmly seated in the corresponding 8265 connectors.

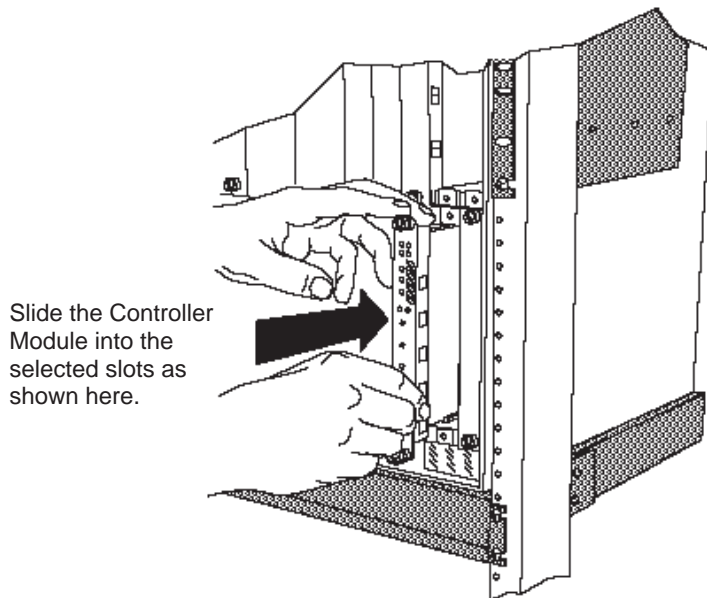
Figure 4-4. Installing a Controller Module

- 1 Loosen the screws at the top and bottom of the module faceplate until the screws disconnect from the switch.
- 2 Grasp the end of the module ejector at the lower left corner of the faceplate, and pull it down. This action causes the ejector to exert pressure on the switch, forcing the Controller Module out of the slot so its faceplate can then be grasped.
- 3 Grasp the faceplate and pull the Controller module straight out of the slot.

Note: Each 8265 Controller module is equipped with an ejector that helps you to remove the Controller module. This ejector can be in any position when you install the Controller module.

- 4 Lock the ejector into place by applying pressure to the Controller module faceplate with one hand as you pull up on the end of the ejector. Ensure that the Controller module remains fully seated in the backplane connector as you close the Controller module ejector.
- 5 Lift the end of the ejector until the ejector locks into place.
- 6 Complete the installation by hand-turning each of the spring-loaded screws at the top and bottom of the module in a clockwise direction. Do not overtighten the screws.

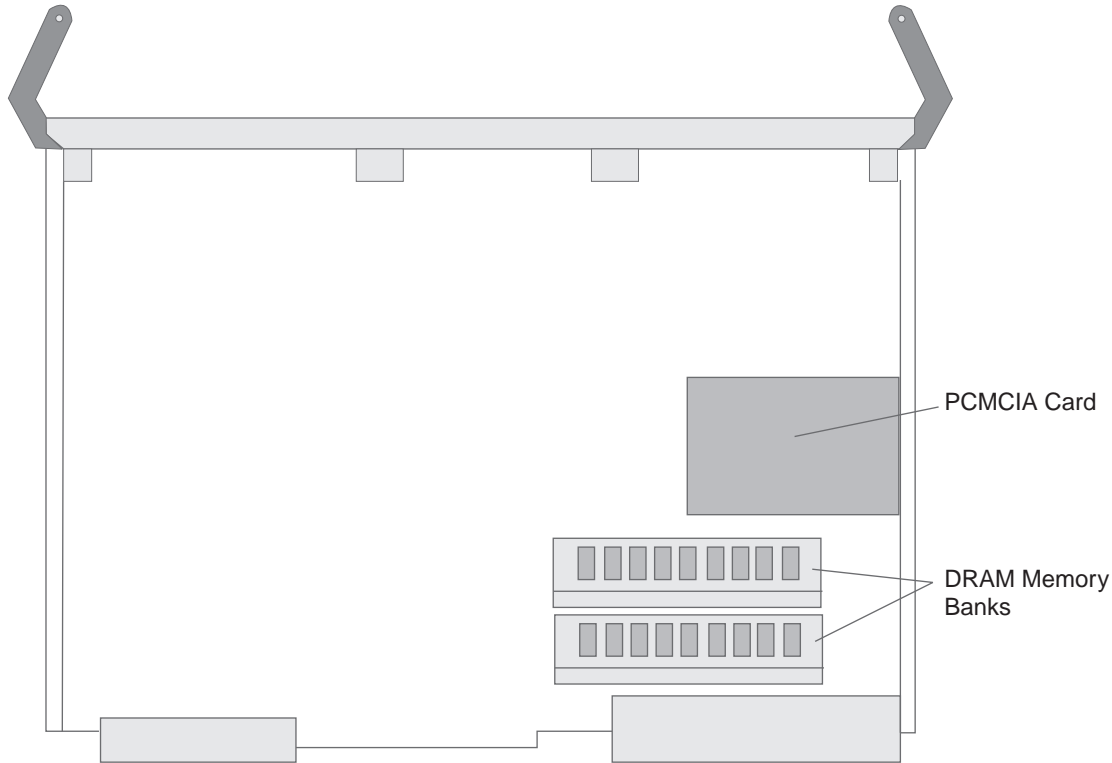
- 1 Remove the CPSW module (see “CPSW / CPSW2 Exchange” on page 4-9).
- 2 Locate the PCMCIA card.

- 3 Remove the PCMCIA card by pressing down the small lever on the left of the slot.
- 4 Position the new PCMCIA card so that it is just above the slot on the CPSW module, making sure that the edge with the connectors is inserted first.
- 5 Push gently downwards until the card clicks into place. If the card does not seat properly, turn the card over and try again. The card will not click into place when inserted back-to-front.
 - a Insert the CPSW module in its slot position by matching the top and bottom board guides as you slide the module cleanly into place (by pressing evenly on the top and bottom of the faceplate).
 - b Fasten the spring-loaded screws on the top and bottom of the front panel of the module to the chassis using your finger. Do not over-tighten.
- 6 If the 8265 is already powered on, press the LED Test button to ensure that all LEDs are functional (optional).

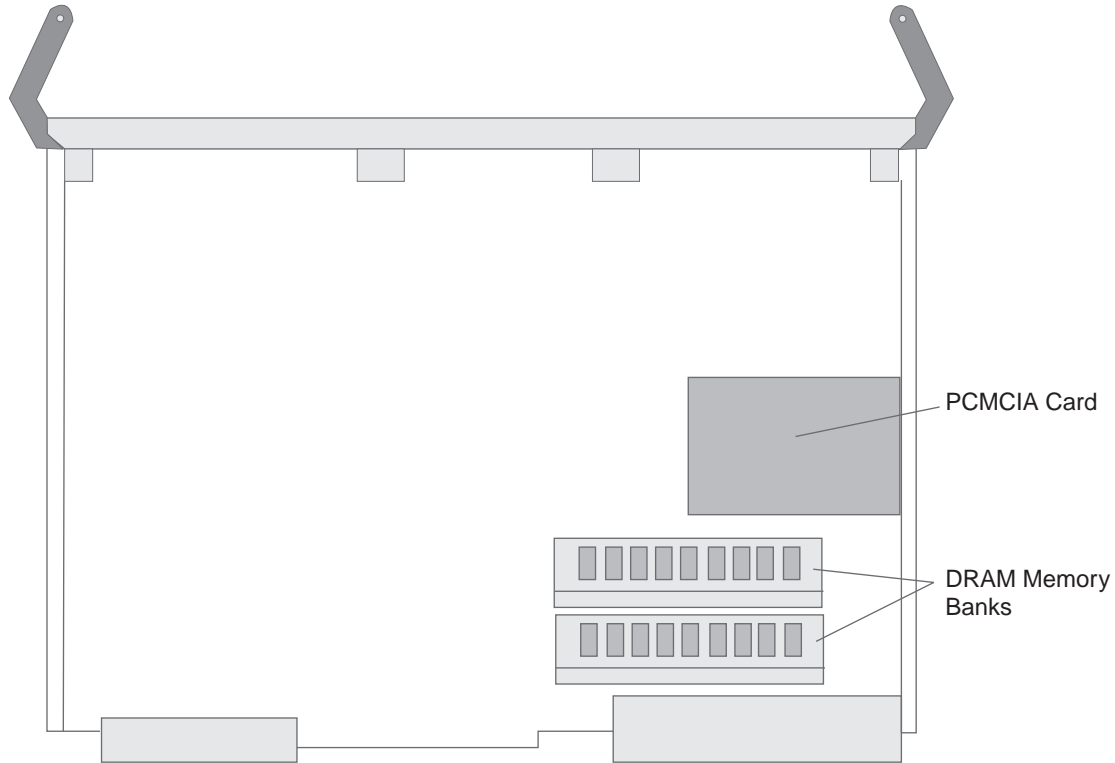
- 1 Remove the CPSW module (see “CPSW / CPSW2 Exchange” on page 4-9).
- 2 Locate the defective memory module

- 3 Remove the memory module by releasing the clips at either end of the module, then slide the module upwards gently and lift out.
- 4 Position the new module above the socket on the CPSW module, making sure that the notched end with the notch is facing to the rear of the module.
- 5 Gently insert the module into the socket at 45 degrees.
- 6 Push gently downwards on the module until it clips into place.
- 7 Re-install the CPSW module:
 - a Insert the CPSW module in its slot position by matching the top and bottom board guides as you slide the module cleanly into place (by pressing evenly on the top and bottom of the faceplate).
 - b Fasten the spring-loaded screws on the top and bottom of the front panel of the module to the chassis using your finger. Do not over-tighten.
- 8 If the 8265 is already powered on, press the LED Test button to ensure that all LEDs are functional (optional).

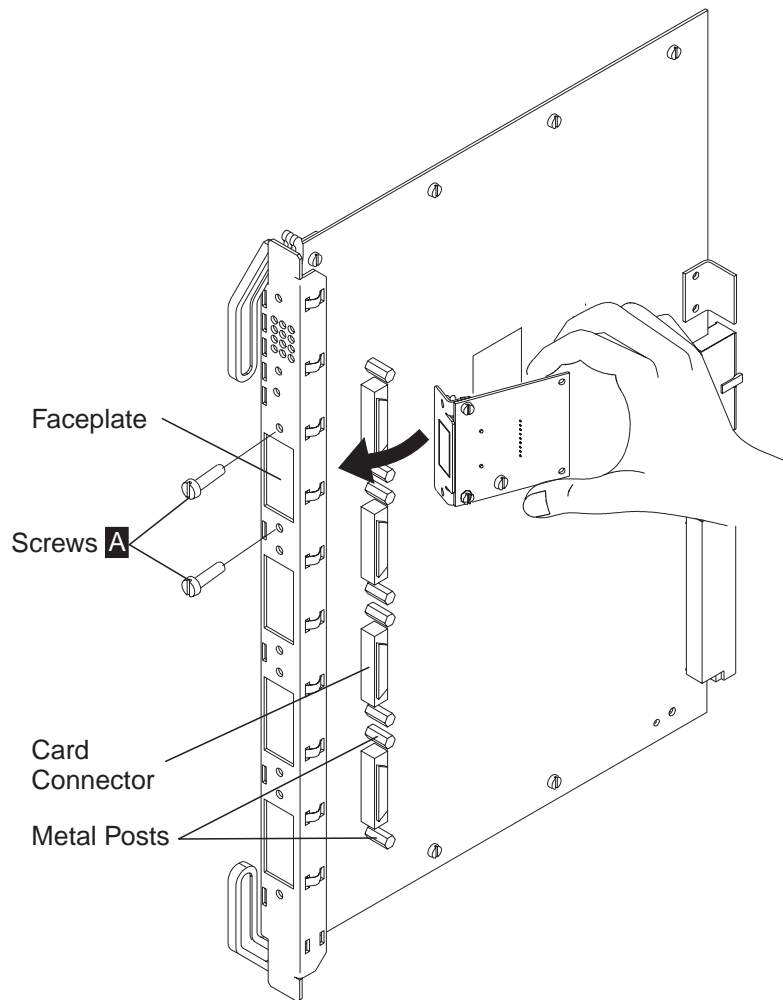
5 Removal and Installation of I/O Card on the 155 Mbps Module Motherboard

- a** If you have to exchange the module, remove **all** the screws **A** from **all** I/O cards installed on the module.
- Exchange the module.
 - Reinstall all the I/O cards using screws **A** on the new module.
- b** If you have to exchange a defective I/O card remove the screws **A** from the defective I/O card.
- Remove the defective I/O card.
 - Reinstall the new I/O card using screws **A** on the module.

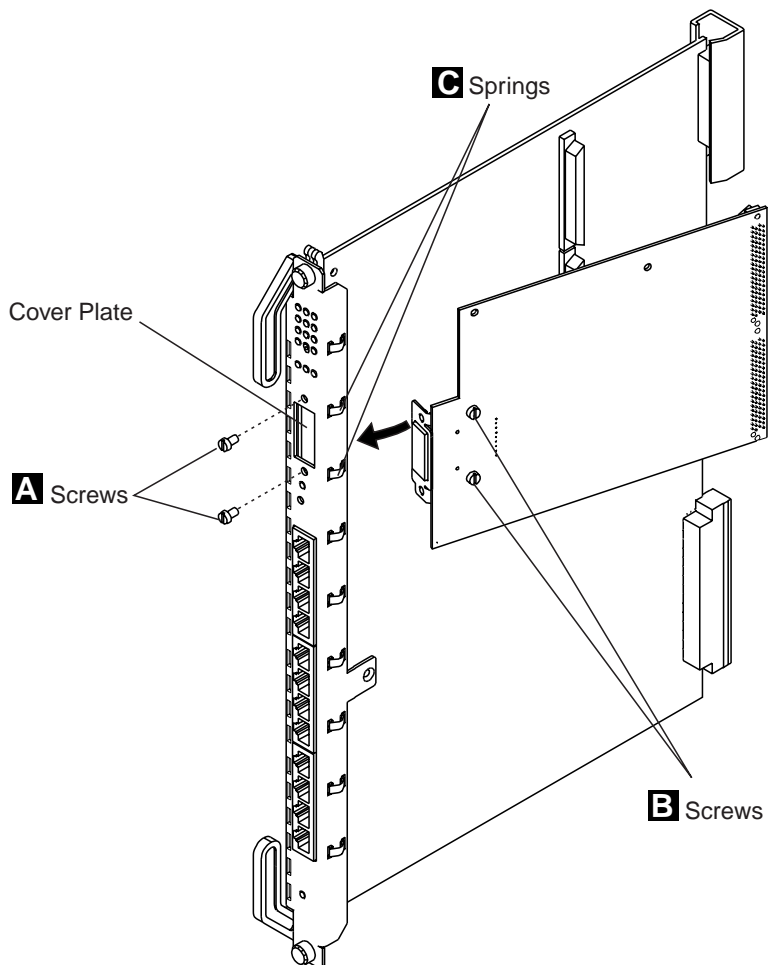
6 Removal and Installation of I/O Card on the 25 Mbps Module Motherboard

- a** If you have to exchange the module, remove the screws **A** from the I/O card installed on the module.
- Exchange the module.
 - Reinstall the I/O card using screws **A** on the new module.
- b** If you have to exchange the defective I/O card remove the screws **A** from the defective I/O card.
- Remove the defective I/O card.
 - Reinstall the new I/O card using screws **A** on the module.

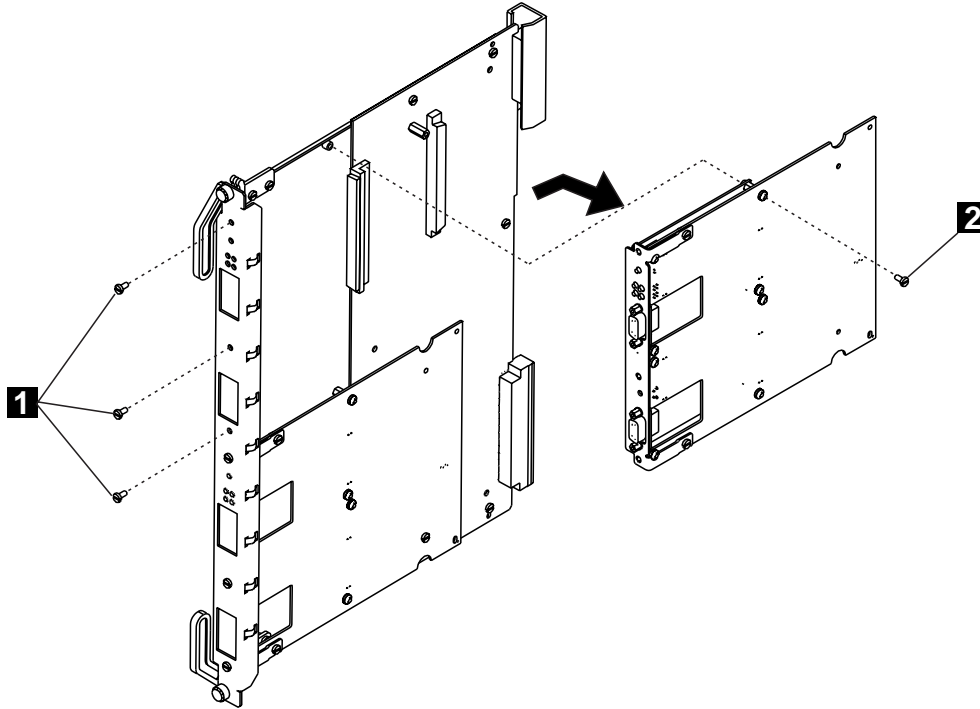
Figure 4-5. Removing the Motherboard

- Remove a defective I/O card and install a new I/O card on the module,
or
 - Remove I/O card from a defective module and reinstall the I/O card on the new module.
- a** Detach the motherboard by removing the four screws (**1** and **2** in Figure 4-5) that hold the motherboard to the module. Retain the screws for reattaching the motherboard.

- b** Disconnect the motherboard connectors and lift the motherboard out of the module.

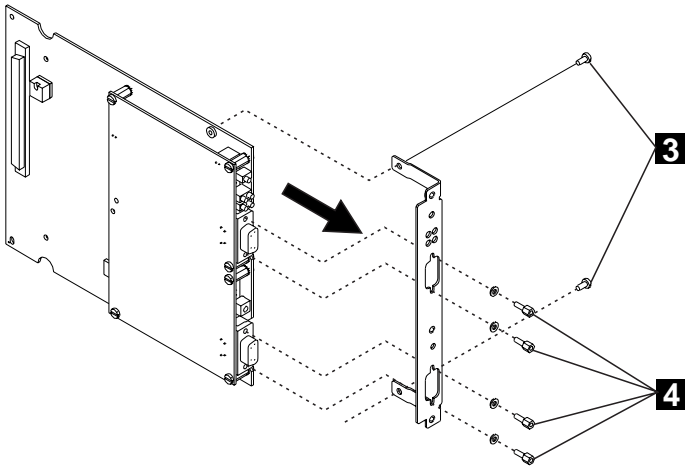
Figure 4-6. Removing the Faceplate Bracket

- c** Remove the faceplate bracket from the motherboard by removing the screws and posts (**3** , **4** in Figure 4-6). Retain the screws, the posts, and the bracket.

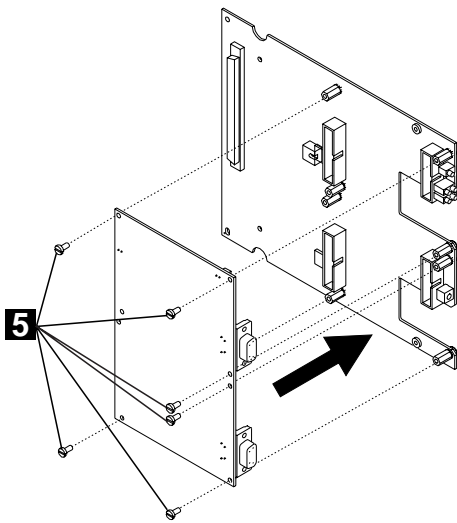
Figure 4-7. Attaching the I/O Card

- d** Detach the I/O card from the motherboard by removing the six screws (**5** in Figure 4-7).

- e** Install the I/O card on the motherboard and secure it with the screws **5** .
- f** Attach the faceplate bracket to the motherboard using the six screws (**3** , in Figure 4-8 on page 4-17).

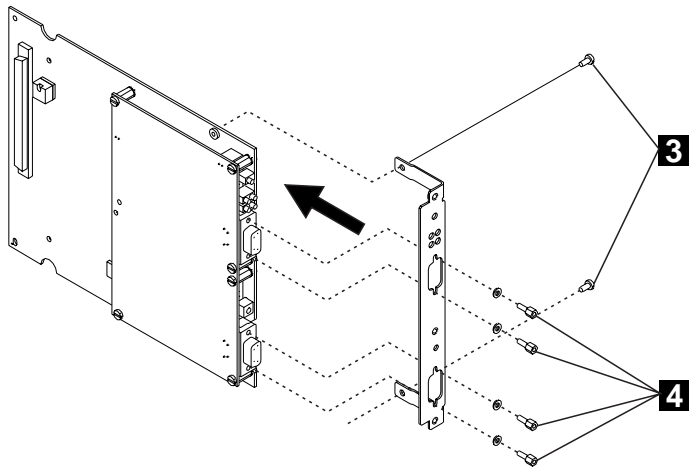
Figure 4-8. Attaching the Faceplate Bracket

- g** Using a screwdriver, attach one post (**4**) onto each side of each of the two ports on the I/O card.
- h** Hold the motherboard so that the connectors and screw holes are aligned correctly on the module. Then gently push the card downwards until you hear it click into the motherboard connectors.

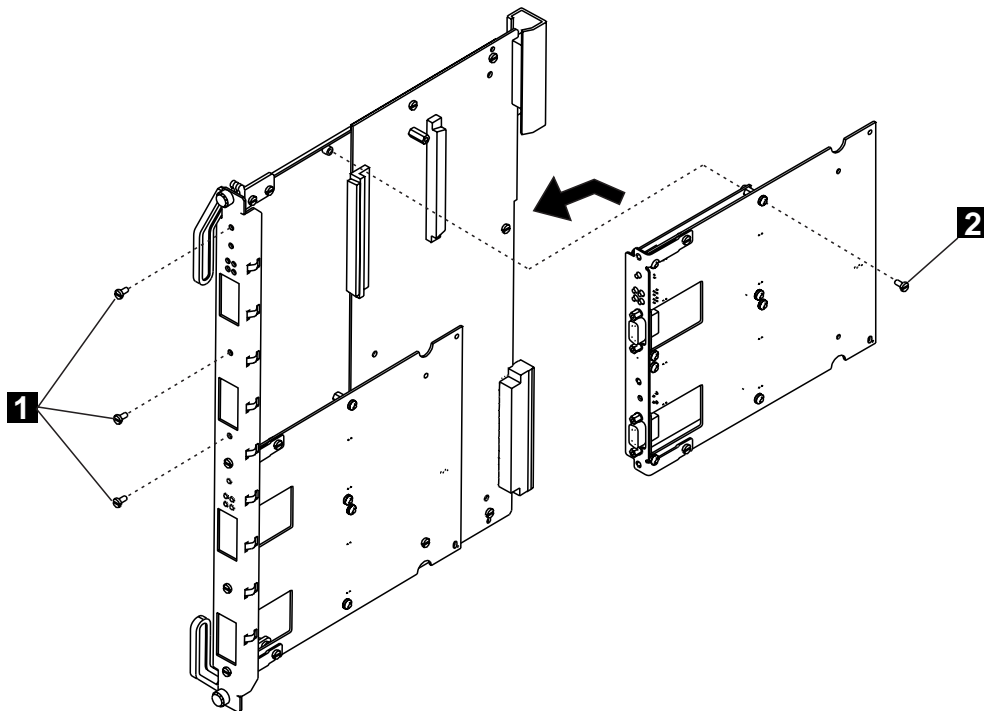
Figure 4-9. Reattaching the Motherboard

- i** Reattach the motherboard to the module using the four screws (**1** and **2** in Figure 4-9) that originally held the motherboard.
- j** Go to **9** on page **4-20** .

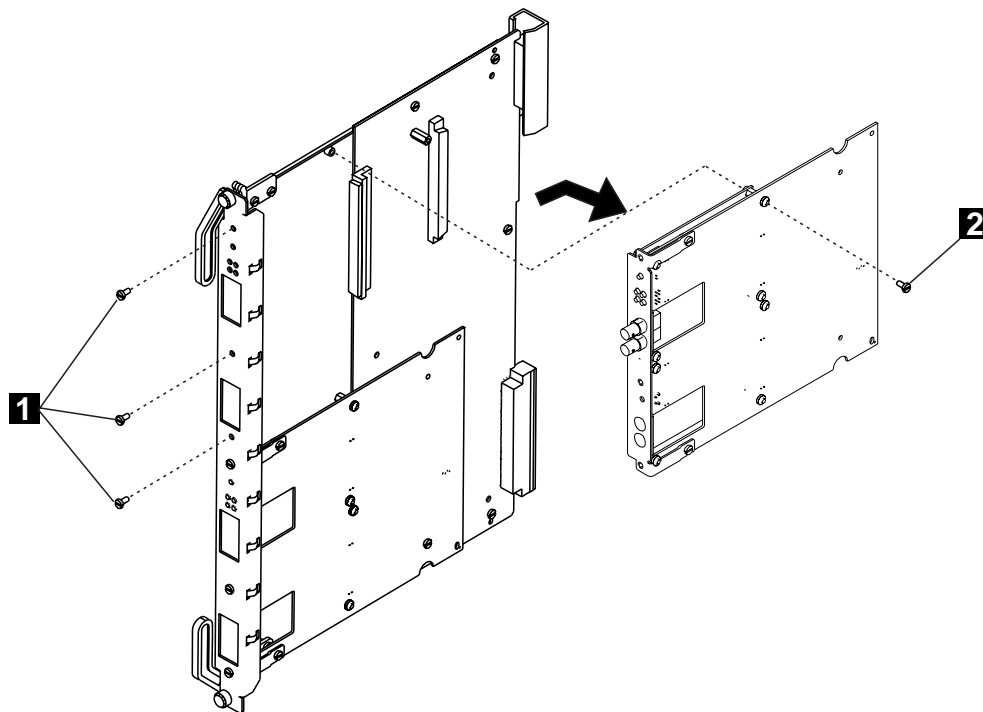
Figure 4-10. Removing the Motherboard

- Remove a defective I/O card and install a new I/O card on the module,
or
 - Remove I/O card from a defective module and reinstall the I/O card on the new module.
- a** Detach the motherboard by removing the four screws (**1** and **2** in Figure 4-10) that hold the motherboard to the module. Retain the screws for reattaching the motherboard.

- b** Disconnect the motherboard connectors and lift the motherboard out of the module.
- c** Remove the faceplate bracket from the motherboard (**3** in Figure 4-11 on page 4-19), retaining the screws and the bracket.

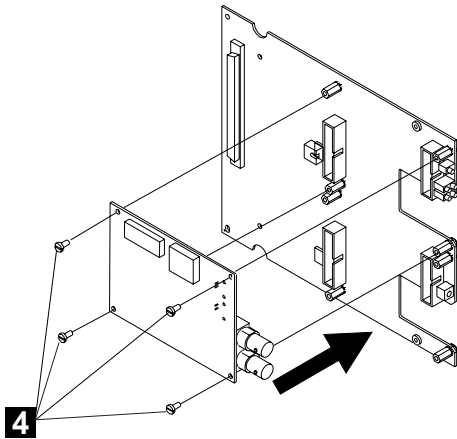
Figure 4-12. Attaching the I/O Card

d Detach the I/O card from the motherboard using the four screws (**4** in Figure 4-12).

Note: The I/O card must be installed in the **top position**.

e install the I/O card and secure it with screws **4** .

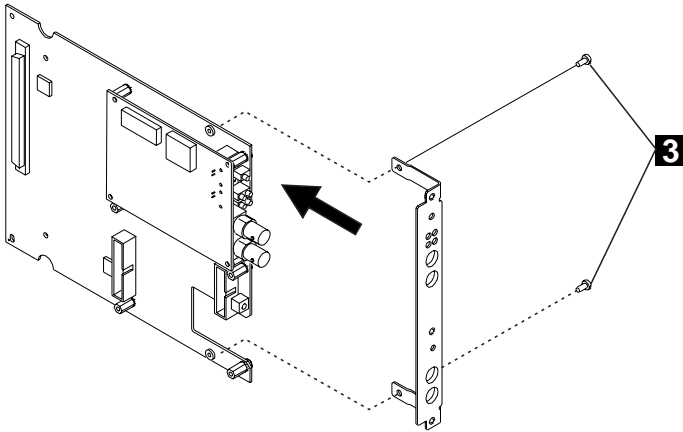
Figure 4-13. Attaching the Faceplate Bracket

f Attach the faceplate bracket to the motherboard using the two screws (**3** in Figure 4-13 on page 4-20).

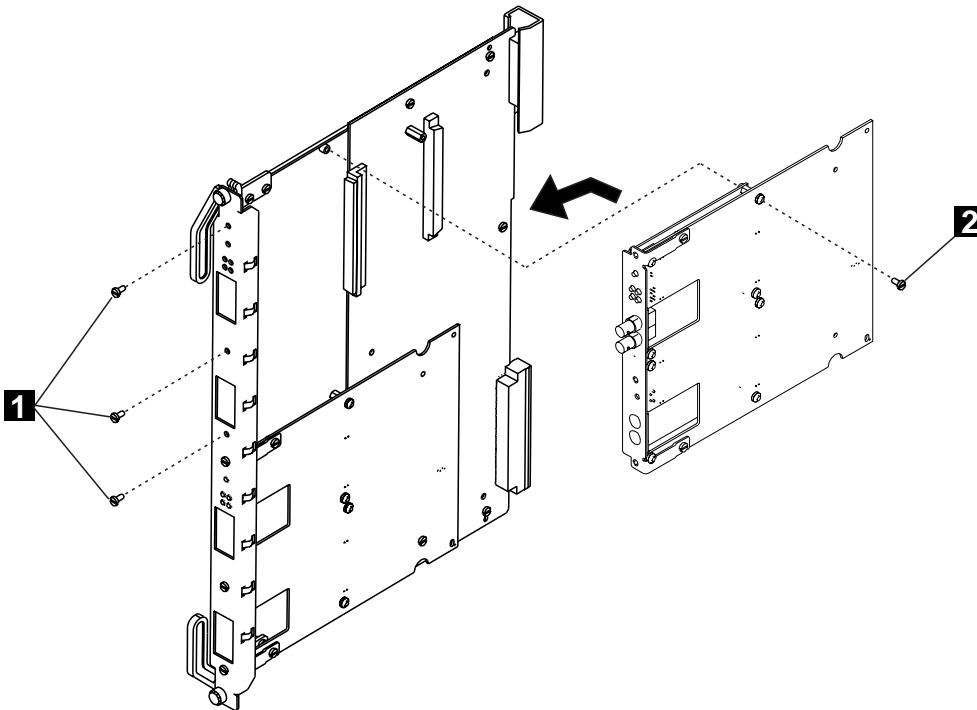
Figure 4-14. Reattaching the Motherboard

- g** Hold the motherboard so that the connectors and screw holes are aligned correctly on the module. Then gently push the card downwards until you hear it click into the motherboard connectors.
- h** Reattach the motherboard to the module using the four screws (**1** and **2** in Figure 4-14) that originally held the motherboard.

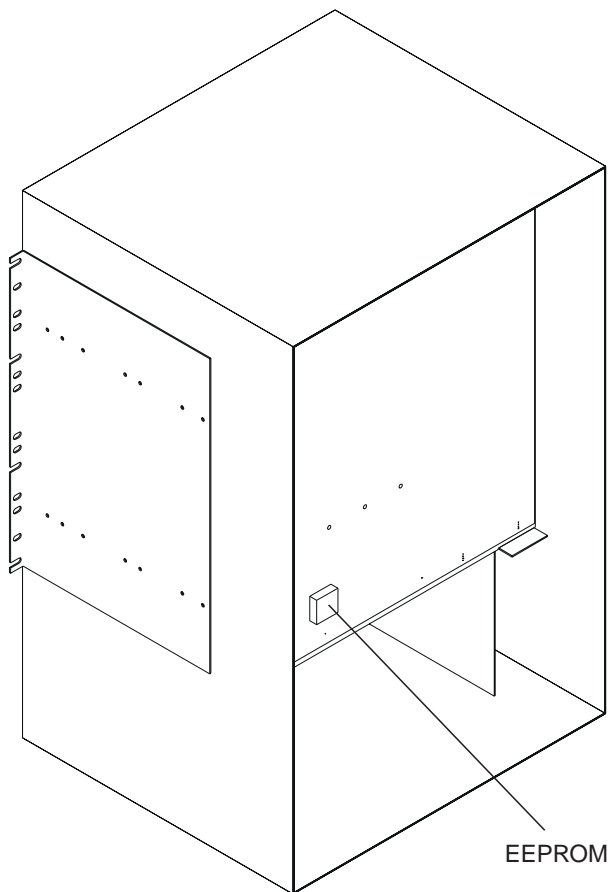
Figure 4-15. EEPROM Location

- 1** Remove the rear cover of the 8265 (22 screws).
- 2** Unplug the three fan cables from the 8265.
- 3** Locate the EEPROM on the backplane.

- 4** Unplug the EEPROM.
- 5** Plug the new EEPROM on the socket.
- 6** Re-plug the three fan cables previously removed.
- 7** Re-install the rear cover of the 8265 and secure it with the screws previously removed.

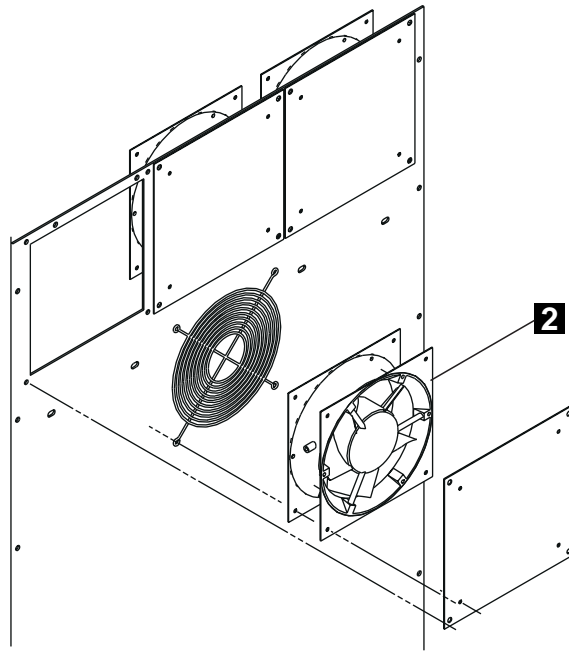
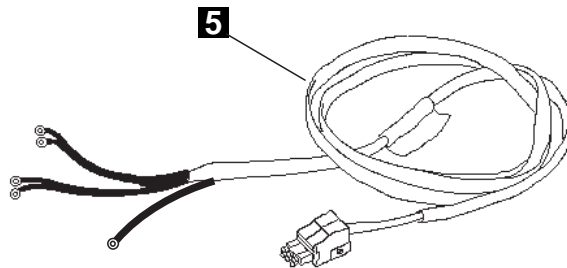
Parts Listing

Index	FRU No.	Description
1	26L0112	17 Slots chassis including: - Power board distribution - Board 17 slots - Fan Assembly (3)

Index	FRU No.	Description
2	25H1798	Fan Assembly
3	25L9923	Power Supply -48 V dc
4	10J2682	Power Supply 415W
5	02L4055	Power Cord -48 V dc
