REBUILDING IN THE AFTERMATH OF AN EARTHQUAKE

USING LOCAL SKILLS AND KNOWLEDGE

technical brief

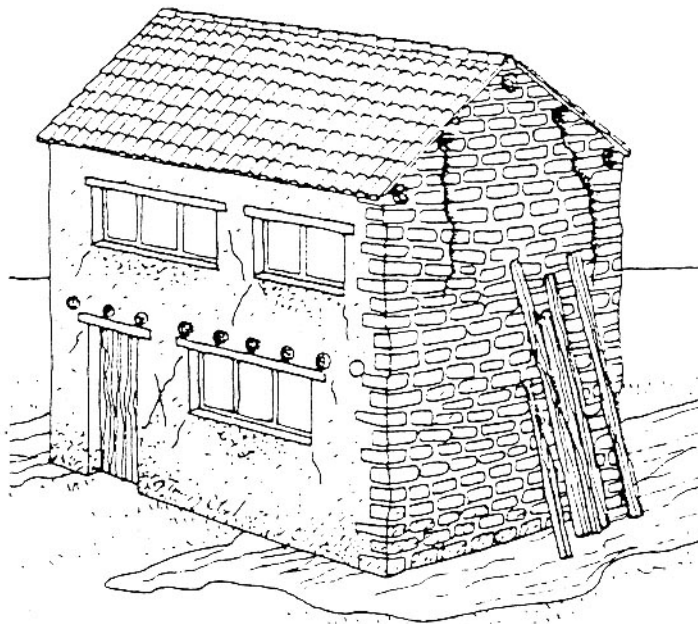
Figure 1: Many traditional stone and earth buildings are not built to withstand seismic activity, and are prone to crack and even collapse.

The most common failures in damaged buildings were the shattering and buckling of the outer face of stone masonry walls because of the lack of through stones, and corner failure in stone and brick masonry. Many walls had collapsed, including load-bearing walls, and there were also many partial and total roof collapses. In RCC (reinforced cement concrete) structures the shear failure of brick masonry was apparent where there was a vertical opening between brick joints. Surprisingly, foundation settlement was uncommon in most of these houses.

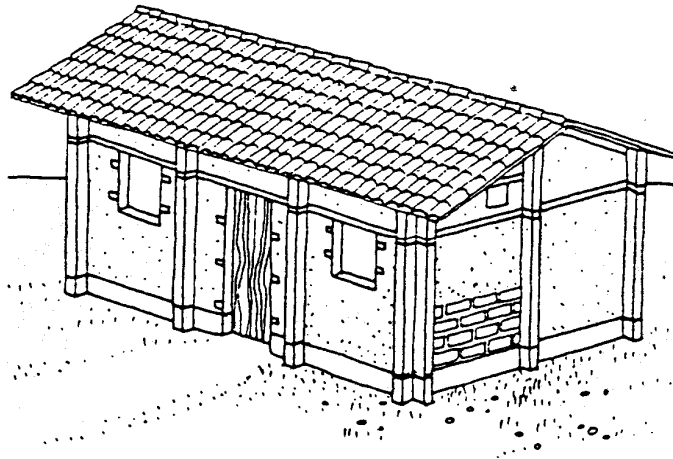
Figure 2: Once an appropriate site is chosen, the house should be built using good quality materials. A low one-storey building in a square (with reinforced corners) or circular shape is best. (Illustrations from *Earth Construction: A comprehensive guide* by Hugo Houben and Hubert Guillaud. IT Publications, London, 1994.)

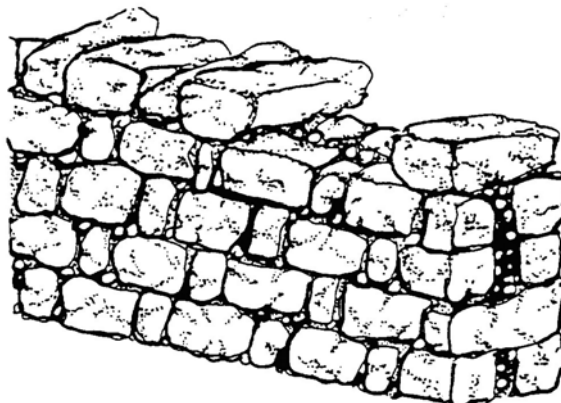
Figure 3: The use of long through-stones in a stone wall will make the wall more stable. (Illustration from Technical Principles of Building for Safety by Andrew Cobum, Richard Hughes, Robin Spence. and Antonois Pomonis. IT Publications, London, 1995.)
